Dun Laoghaire Harbour

Inventory of Structures, Buildings and Elements

Prepared By: Shaffrey Associates Architects for Dun Laoghaire Harbour Company

July 2007

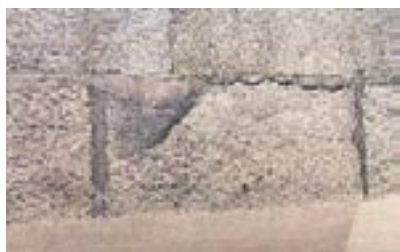
Cement joints causing stone decay.

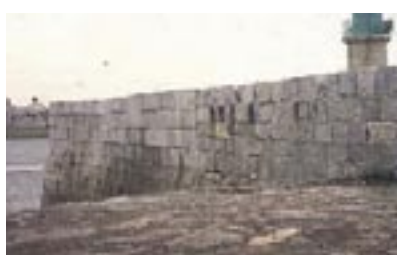
Outer granite wall to rounded pier end.

There is serious erosion on the seaward side of the granite wall to the rounded pier end. Rough seas have undermined the concrete slabs that make up the sloping breakwater. Elsewhere the stone work is generally in fair condition. Erosion is mostly apparent on the top/coping stones and prevalent at stone arrises at joints, in particular where cement pointing repairs have been carried out. There is some graffiti evident on some stones. Remedial repairs have been carried out in inappropriate cement based ribbon pointing. Ferric oxides are visible on faces of stone blocks, possibly from embedded iron and/or the matrix composition of the stone. The joints of the ground surface granite paving are generally open with some cement infill in areas. Vegetation is evident in sheltered areas, but not excessive. Sections of the ground surface have been overlaid crudely with concrete and the junction between concrete and the granite coping stones of the inner wall edge are notably ragged. The stone work at the pier end is of particularly fine quality design and craftsmanship. The iron handrail serving the steps to water level has corroded badly and there is further corrosion of services conduits.

- ✦ Stone: replace concrete repairs/replacements with matching stone above water level; remove graffiti; remove corroded iron fixings where these are causing decay of the stone and replace with non-corrosive material, e.g. stainless steel; monitor and treat organic growth with approved biocide as necessary, taking care not to destroy any significant plant and or wildlife species.
- ✦ Pointing: retain any original sound mortars. Rake out replacement cement mortars and repoint using hydraulic lime mortars based on analysis of historic mortars. Point all open joints following similar approach.

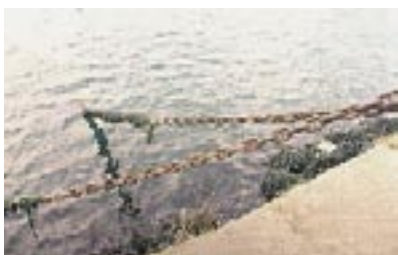
5th kant, rusted iron fixings.

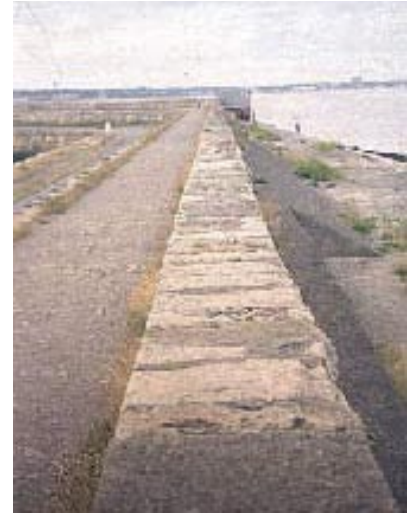
View of 5th kant showing corner with 4th kant. The ground surface of upper and lower walkways is patchy and uneven with extensive vegetation growth.

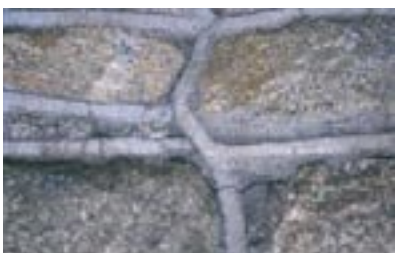
Detail of poor cement strap pointing to coursed rubble, upper wall, 2nd kant. This is accelerating decay of the stone.

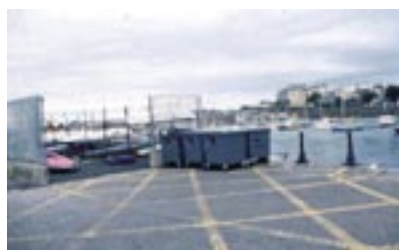
Unsympathetic ground surface to foreground.

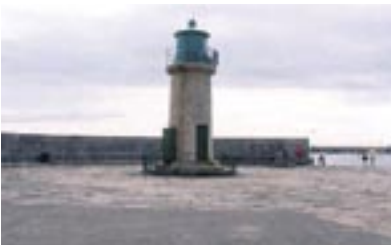
Note poor concrete patch repairs to paving.

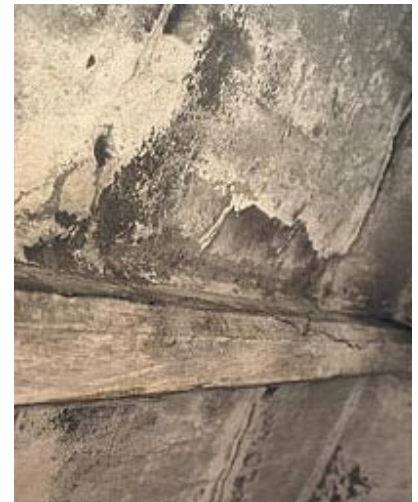
Corroded concrete rib beam to interior.

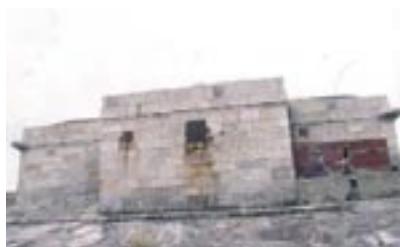
Rear elevation, note corroded tank.

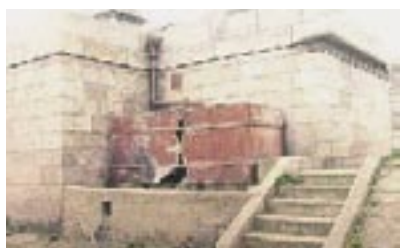
Detail of corroded tank. This corrosion inevitably leads to stone decay. The use of concrete such as for the plinth is inappropriate for an historic structure such as this.

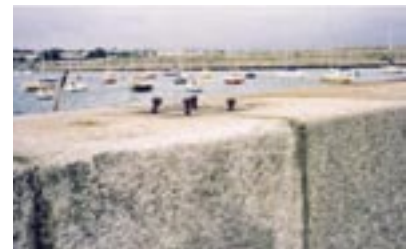
Trader's Wharf, rusted iron fixings, inner wall.

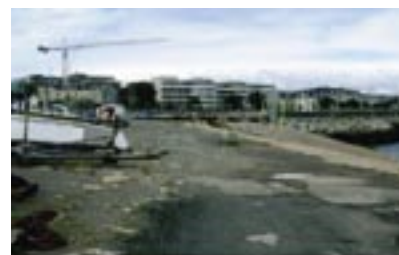
Uneven surface, boatyard.

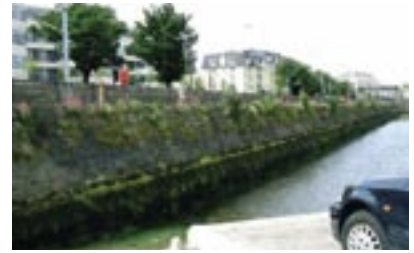
Ramparted wall to road. Extensive vegetation growth is damaging the fine stonework.

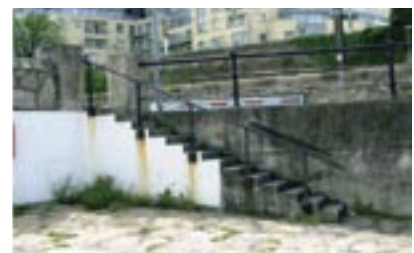
Concrete steps from Coal Harbour to road. Note original granite paving and also extensive rust staining from iron railings.

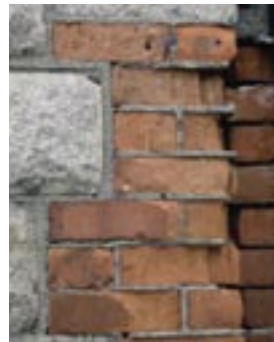
Detail of spalling brickwork to corner.

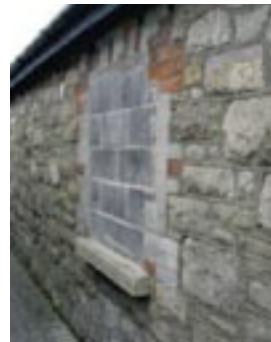
Shored-up window opening to side wall with inappropriate cement based repairs to brick reveals.

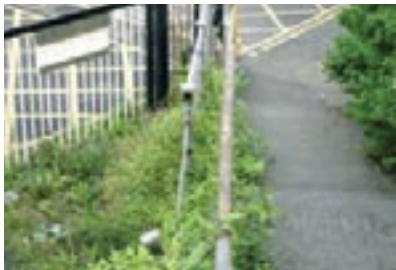
Steps adjoining tunnel. Note range of original railings running parallel to the modern range. The reinstatement of the former is recommended.

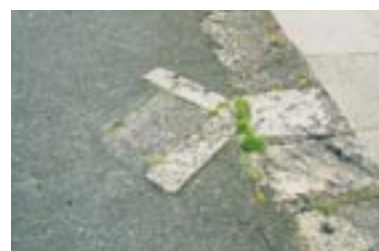
Detail, remnants of granite to 2nd kant, upper walk way. Care should be taken to ensure that historic elements such as this are retained after resurfacing.

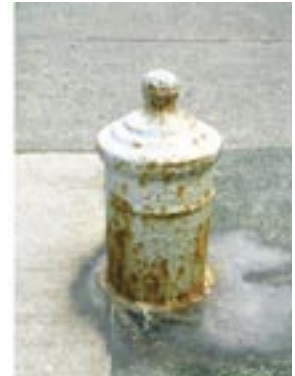
Cast iron mooring post. Note extensive rusting.

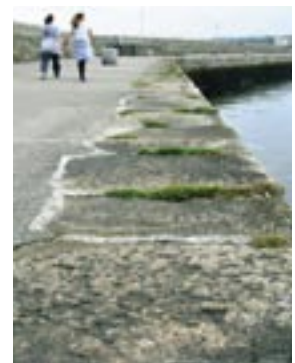
Edge of lower walkway. Note vegetation growth to joints.

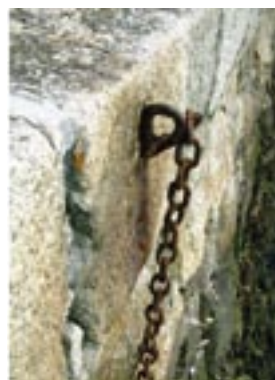
Edge of lower walkway. Note open joints and rusting fixings.

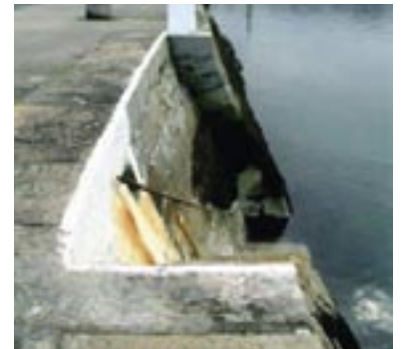
Steps into harbour, 4th kant. Note extensive rust staining from corroding iron handrail and also open joints to stonework.

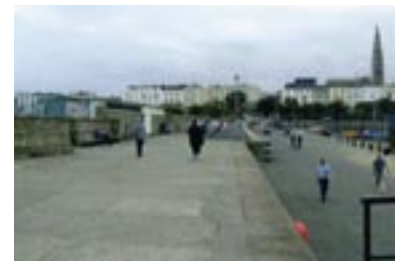
General view of 4th kant looking southwards, showing patchy and inconsistent ground surface. A coherent ground surface plan is required along the entirety of the pier, taking care to preserve the fine stone edging.

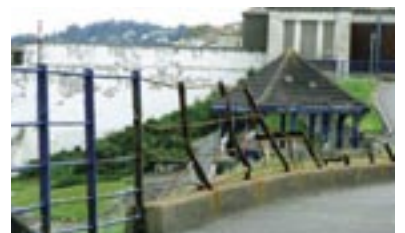
Damaged section of railings requiring replacement. Note general air of dereliction created by the neglected Baths in the background.

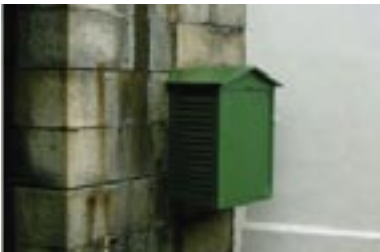
Exterior wall with attached service box. The stonework requires repointing. Note also rust staining from internal iron fixings.

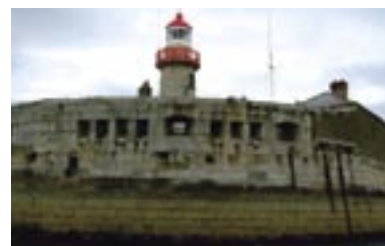
View of Battery from harbour. Note rusted pipes discharging from W.C.s. Internal iron fixings have caused extensive rust staining.

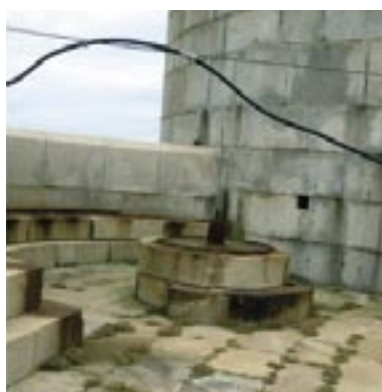
Extensive rust staining to stonework. Note also unsightly cables.

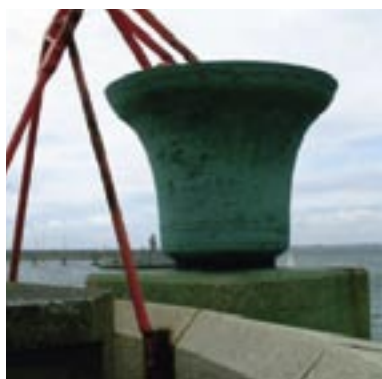
Copper bell on concrete plinth attached to Battery wall and machine room. Relocation is recommended.

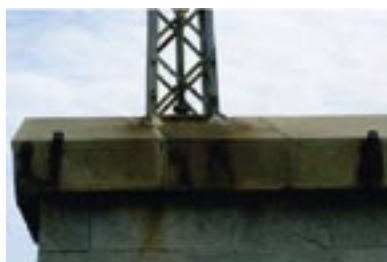
Detail showing rust damage.

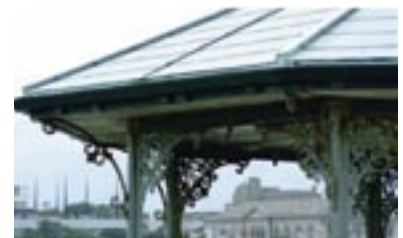
Detail, bandstand. Note rusting iron brackets.
