# Harbour Master's Lodge Dún Laoghaire

A case study on retrofitting historic fabric while preserving architectural heritage

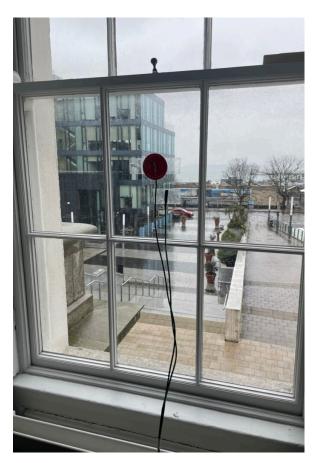
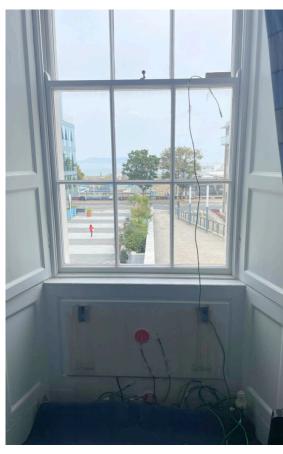
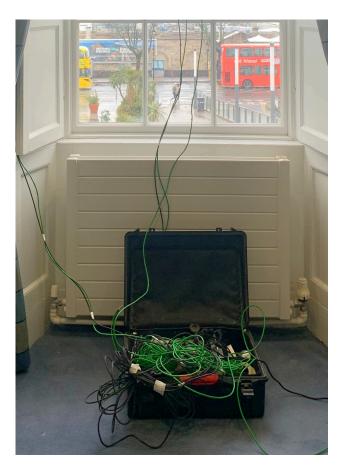
Thermal transmittance and surface temperature monitoring sensors attached to the single glazing and wainscot panels behind the radiators.

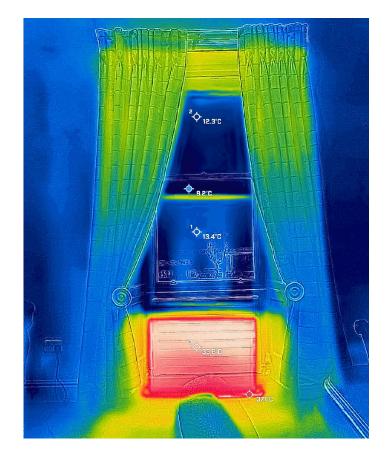
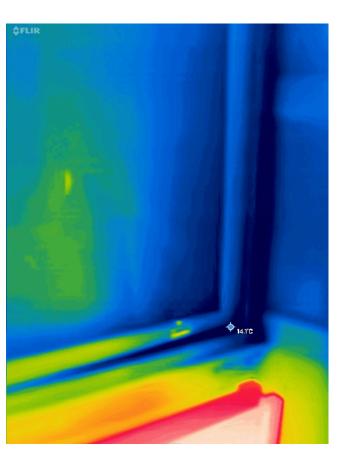
a) Thermal image illustrating surface temperature of single glazing as low as 9 °C at junctions. b) Thermal bridges observed at the corners suggesting heat loss through gaps.

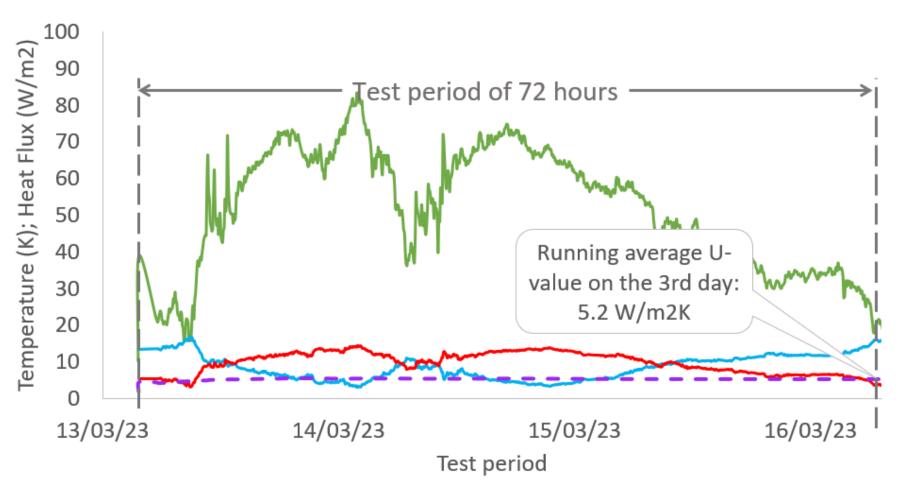
U-value of the single glazing

Effective u-value of single glazed windows: **5.2 W/m2K** Effective u-value of wainscot panels: **1.2 W/m2K**

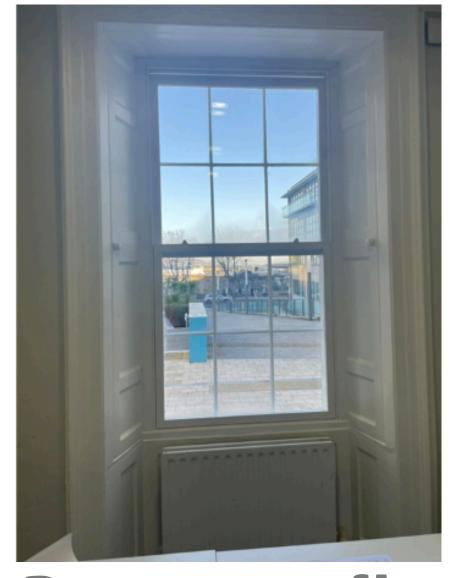
Post-retrofit

The results show a ~50% reduction in the effective u-value of windows and 77%-87% reduction in the case of the wainscots.
