COAST GUARD STATION HARBOUR ROAD DÚN LAOGHAIRE

ARCHITECTURAL HERITAGE SURVEY

22nd July 2025

Historic Building Consultants Old Bawn Old Connaught Bray

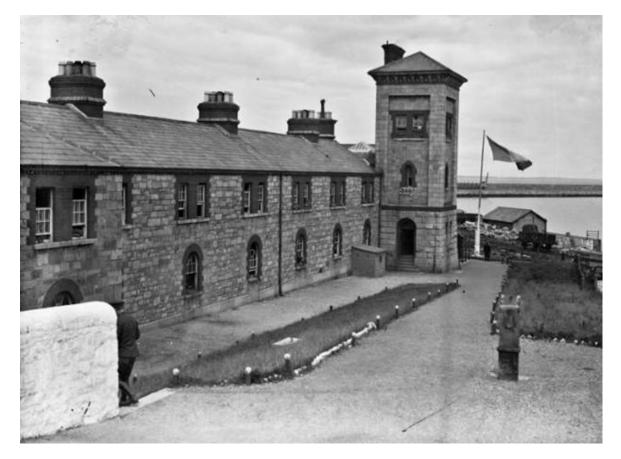
Plate 1: Coast Guard Station in about 1924

Examination of the photograph in Plate 1 shows that the upper floor windows on the western side of the terrace were six-over-six sliding sashes at that time, while those on the lower floor had spoked upper sections of the top sash. Neither of those styles are the styles that are found on site today, indicating that these windows have been replaced since the 1920s.

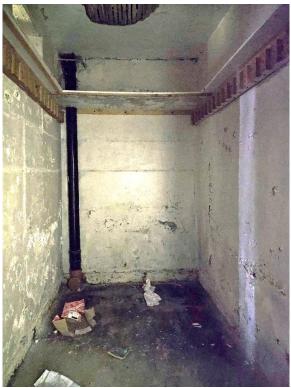
Plate 63: View into store

Leading off the lobby that accesses the bathroom is a store that is divided from the bathroom by masonry walls. The ceiling is of lath and plaster and has failed in part. The store is accessed via a timber-sheeted door with high level ventilation holes. Within the store is a shelf at high level that runs around three sides of the store, below which are boards to which blocks of timber are fixed. Above the shelf on the eastern side is a ventilation grille that opens onto the stairway. In the south-eastern corner a cast-iron soil pipe descends from the room above.

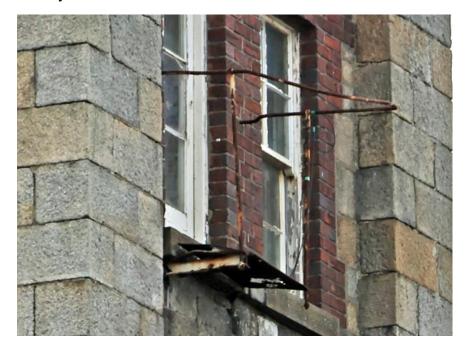
Plate 136: Balconette at northern window on second floor

As noted above, one window on the second floor of the tower, on the northern side, is a timber casement, while the other window is a four-over-four sash similar to the others on that floor. The casement gave access to a small iron balconette that is now in poor condition. This consisted of an iron plate laid horizontally as the floor of the balconette and supported on two cantilevered iron brackets, of which only one now survives. Two wrought iron bars rising vertically from the outer corners of the iron plate support a horizontal wrought iron bar as a protective railing, now badly bent.

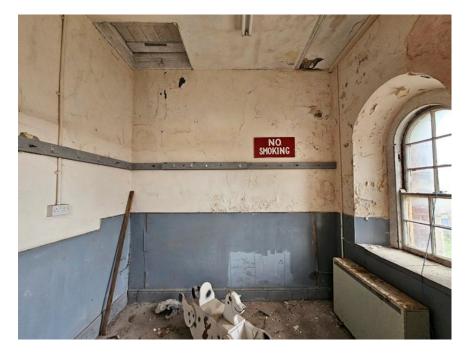
Plate 147: Northern wall of ground floor

The western wall of the ground-floor room is plain, except for a timber rail fixed to the northern, western and part of the eastern walls on which are fixed aluminium alloy hooks of relatively late date. The walls are painted, the lower part in a different colour, and the paint is peeling in a number of places.

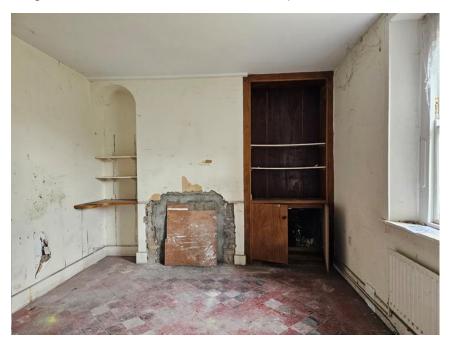
Plate 210: View to north in living room

The living room at the rear, or eastern, side of the house is entered via a hollow door set in a plain timber architrave. The walls are plastered and painted and the ceiling is flat, without a cornice. At the northern end of the room a chimneybreast projects, the niche to the left being arched, while that to the right is not and has a built-in cupboard. The hearth has no chimneypiece and the plaster has been cut back, revealing the brick structure, with cement repairs evident.
