advice series

THE CONSERVATION OF PLACES OF WORSHIP

An Roinn
Ealaíon, Oidhreachta agus Gaeltachta
Department of
Arts, Heritage and the Gaeltacht

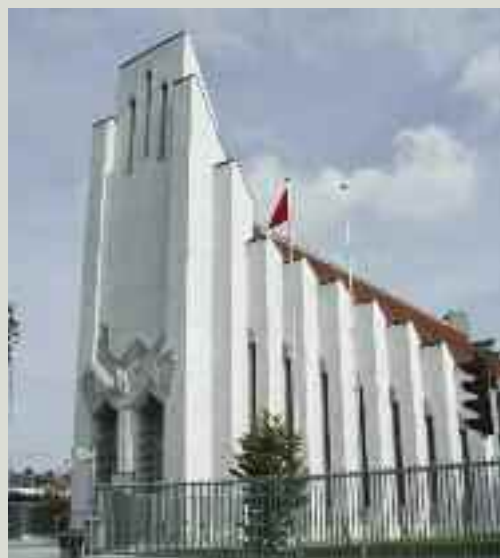
The Church of Christ the King was designed by American architect F Barry Byrne who had trained with Frank Lloyd Wright in Chicago. Constructed in reinforced concrete using strong geometric forms, the church was built to cater for the growing Catholic population in the expanding suburbs of Cork City

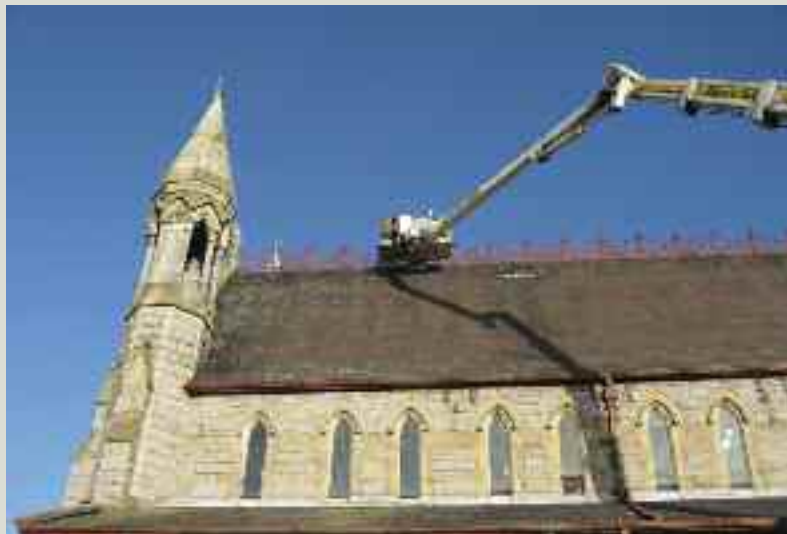
The inspection of a church requires that close attention be given to roof coverings and rainwater goods, the elements that are hardest to reach. Neglect of the roof will, however, manifest itself in a myriad of problems throughout the fabric, starting, as seen here, with blockage of the rainwater goods

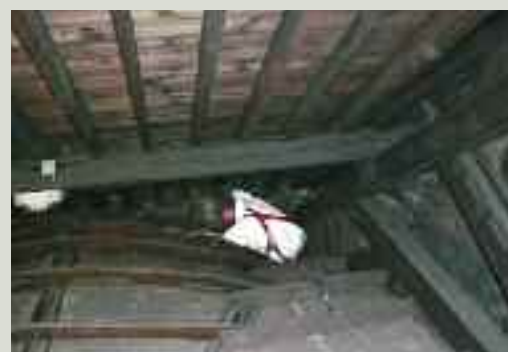
A quinquennial inspection is a detailed examination of the whole of the structure, including areas that are hard to reach such as roof spaces. Fitting electric lighting makes inspection of these areas easier and safer, thereby reducing the risk of damage from unnoticed water ingress. Note that a safety harness is being used because of the fragile nature of the ceiling construction

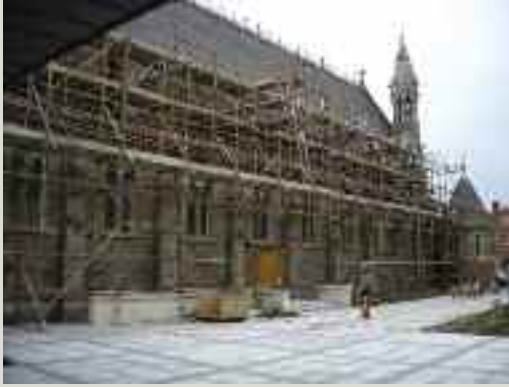
The erection of scaffolding may be necessary to allow safe access to high roofs, turrets and other features and can be an expensive undertaking. Advantage can be taken when scaffolding is in place to co-ordinate a series of maintenance and repair works at high level, designed in compliance with the health and safety method statement

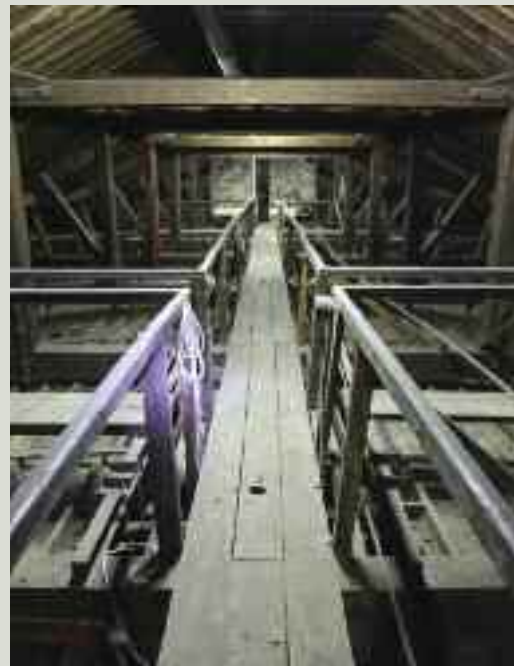
Installing a walkway with handrails secured to the joists allows for adequate and safe access for inspection and maintenance of the internal fabric of the roof space

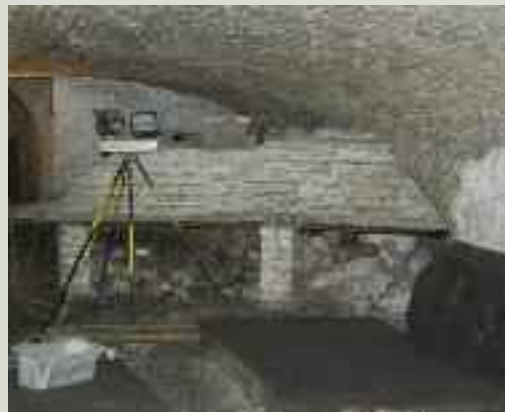
Inspecting a crypt presents risks such as trip hazards, toxic fumes, asbestos and rodent or fungal infestation. Personal protective equipment and adequate lighting are essential to reduce the risk of accident to the inspector or damage to the structure

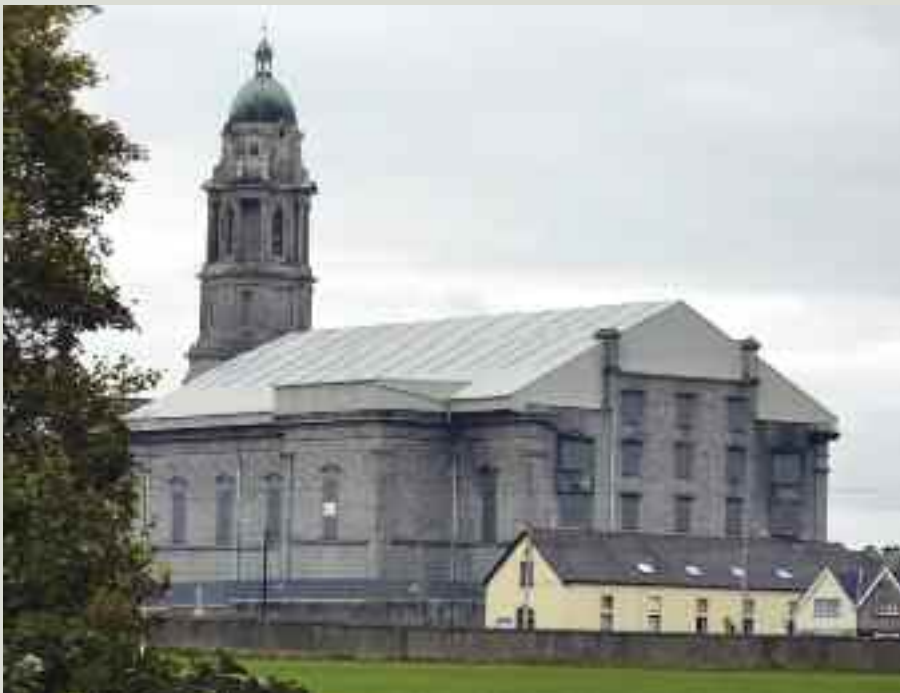
If disaster strikes a church it is advisable to provide prompt protection from the additional damage caused by the elements by fitting a temporary roof and securing the openings

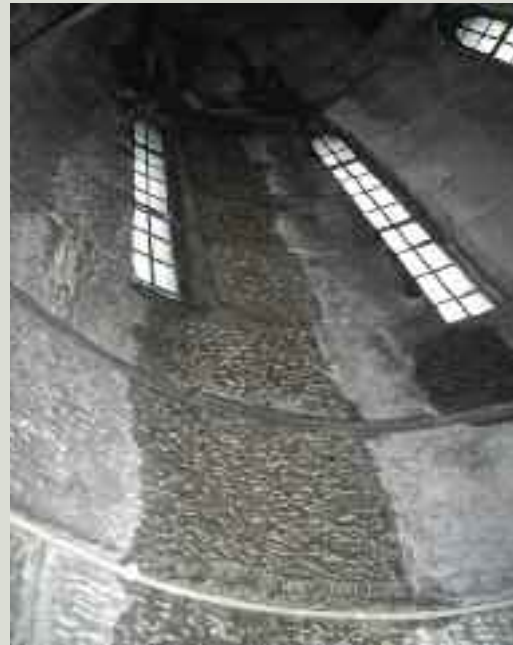
Difficulty of access no doubt contributed to lack of maintenance of this church tower, resulting in ingress of water to saturation level in the masonry. This will lead inevitably to serious damage unless it is remedied

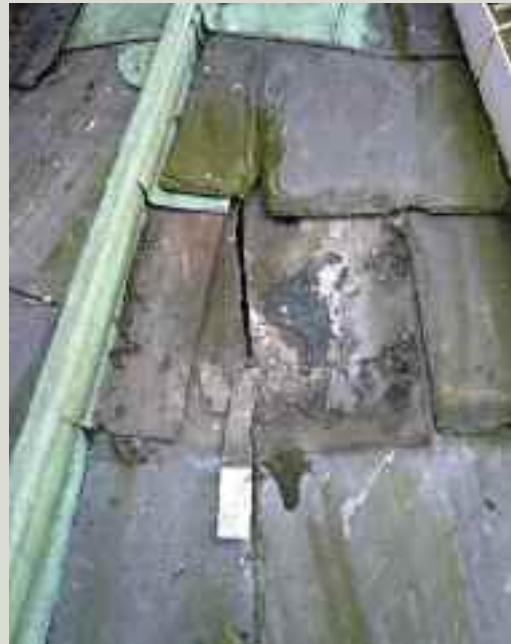
A previously repaired slate slipped off this chancel roof (the clip or tingle remains), revealing a hole in the covering and leaving some of the copper flashing vulnerable to uplift

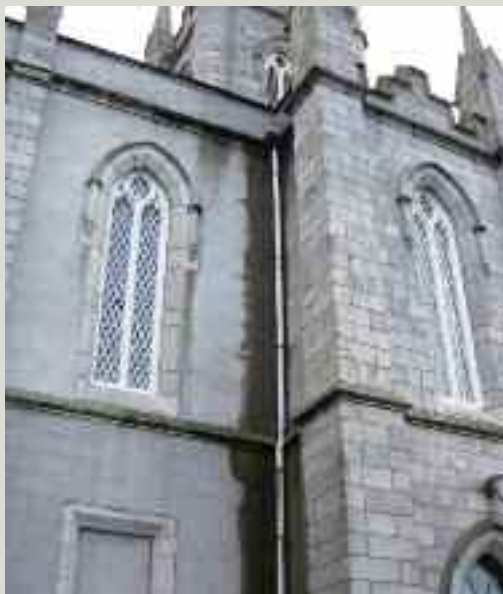
Walls will quickly become saturated if rainwater cannot be shed effectively from the roof. Staining, discolouration and plant growth behind and beside downpipes are signs of problems at eaves or parapet level that require immediate attention

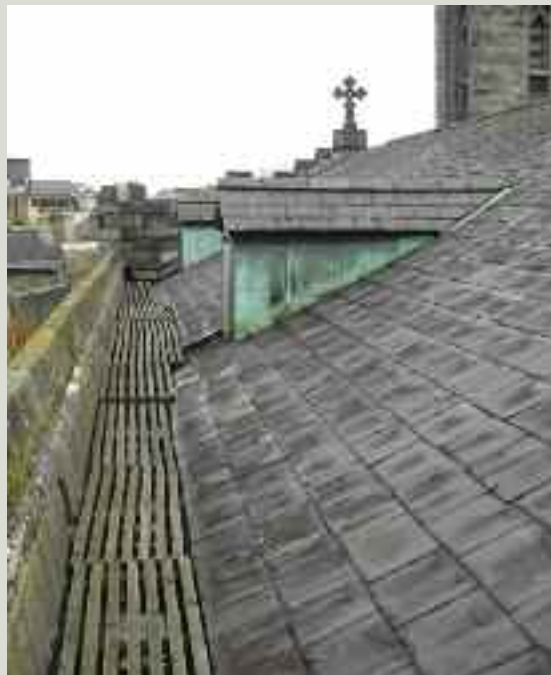
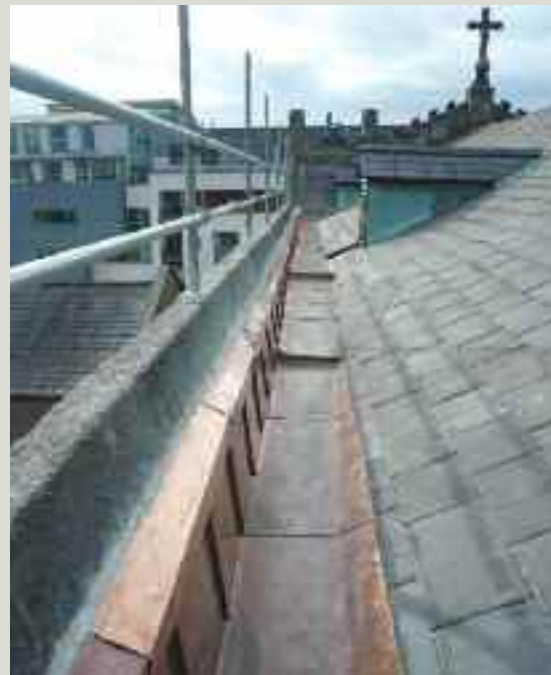
The failed copper guttering and parapet flashings on this church (left) were replaced with new copper guttering and flashing and the stone cleared of growth (right). The snow, or access, boards were not replaced as these can constitute a significant trip or fall hazard at roof level, particularly when they are in poor condition

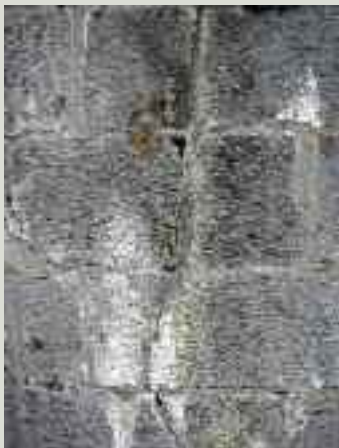
This wall has become overly rigid due to the use of cement mortars, which resulted in the mortar becoming harder than the stone. Structural movement in the church is seen in the vertical cracking through the ashlar stones rather than the mortar

repointing and coatings are not only technically damaging but also visually intrusive. Where possible, later cement pointing and plastering should be removed and replaced with an appropriate lime-based mix. Because cement mortar is so strong the misconception has arisen that the main purpose of the mortar is to glue or bind the stones or bricks together, whereas its true purpose is to fill the gaps between the individual masonry units and keep them apart and to facilitate the evaporation of any water absorbed by the wall. Equally, an external coating should provide a soft, sacrificial layer that weathers back slowly rather than creating a hard, impermeable and inflexible outer shell.

As damaging as the removal of lime coatings from rubble walls, is the grit-blasting of ashlar or coursed rubble, particularly so when this is followed by the application of cement pointing. The use of abrasive systems to clean historic stonework has the potential to cause irreparable damage. Harsh and aggressive abrasive treatments damage the surface of the stonework, removing tool marks and years of aesthetically enhancing patination, while also increasing water-penetration into the stone. In certain circumstances, the use of small air abrasive tools and finer abrasives in the hands of a highly skilled and careful operative may be appropriate, but the hazards are significant.

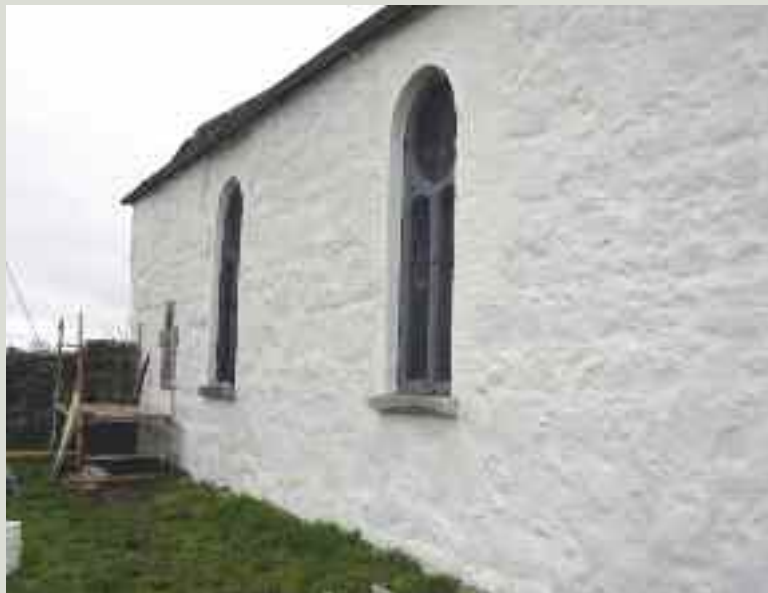
The rubble walls on this medieval parish church were stripped of roughcast cement render and re-rendered using a soft lime mortar. This helped the interior of the building to dry out, assisting to preserve the significant Romanesque stone carving

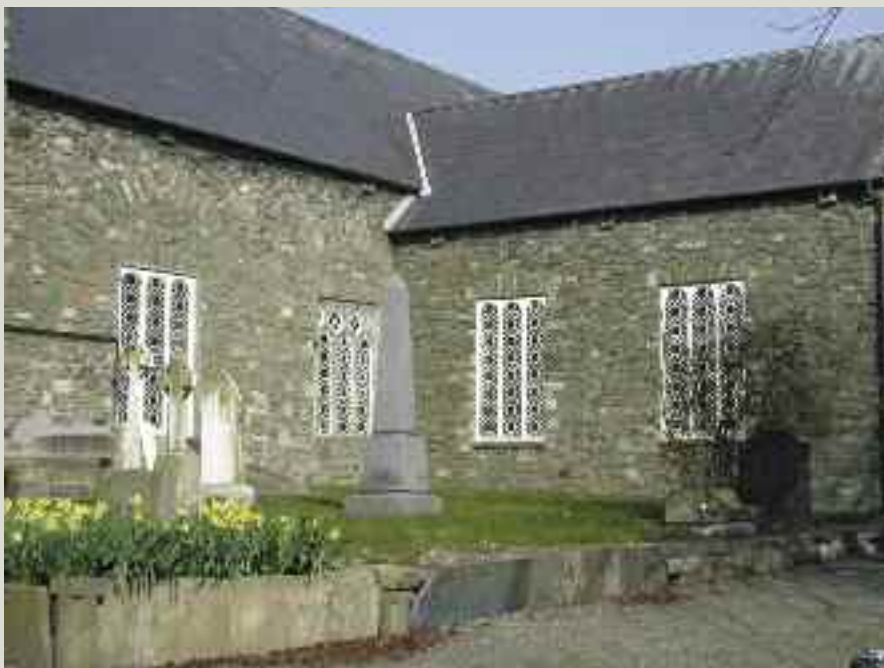
The grounds of this extended and altered medieval church have served as a graveyard for about six centuries, leading to a build-up of levels next to the church walls. Due to the archaeological sensitivity of a site such as this one, any proposals to lower the ground near the walls should be approached with caution, and expert advice followed

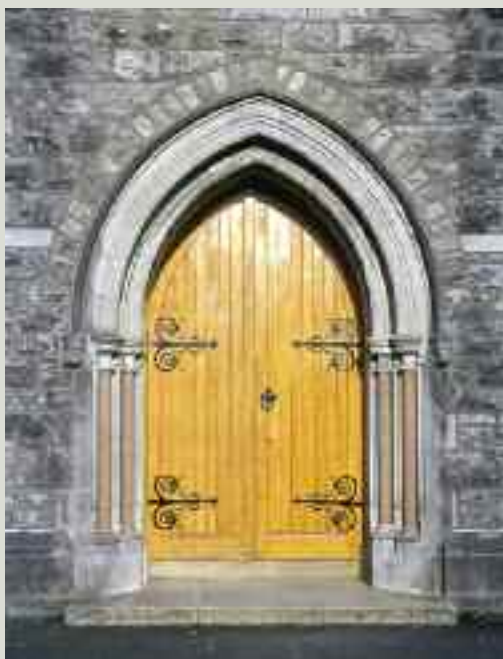
Historic doors and door furniture should be maintained and repaired as necessary in line with best conservation practice

Original external doors are typically well-proportioned, attractively detailed and well-made using robust timber. They should be retained wherever possible and repaired, and only replaced as a last resort. Where a replacement is unavoidable, an exact copy should be made using good quality well-seasoned pine, or Douglas fir, with accurately profiled mouldings. The use of standard doors from catalogues is unlikely to be appropriate in a historic building and should be avoided. Original doors and windows should be repainted periodically and, where new replacements are required, these should be given a painted, rather than a stained finish, except where there is evidence of staining or graining being the original historic finish. Where a door has deteriorated beyond the point of reasonable repair, its original door furniture and fixings may well be perfectly salvageable and should be reused on the replacement door.

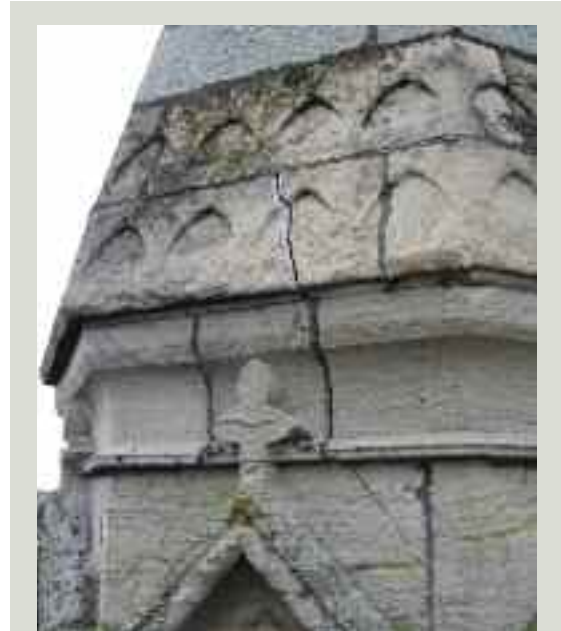
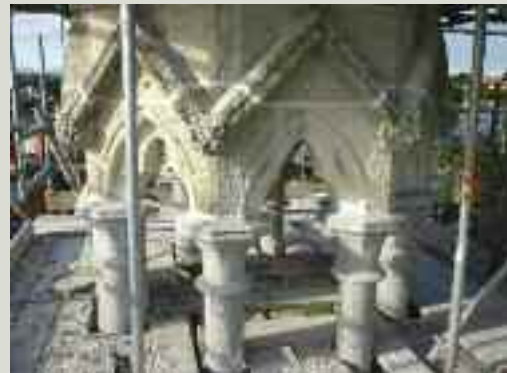
This Bath stone turret, which is also a bell-tower, is in a highly exposed location. Several stones cracked due to rusted cramps and the poor condition was exacerbated by previous misguided cementitious repair. New stainless steel collars and ties were fitted and the turret was repointed

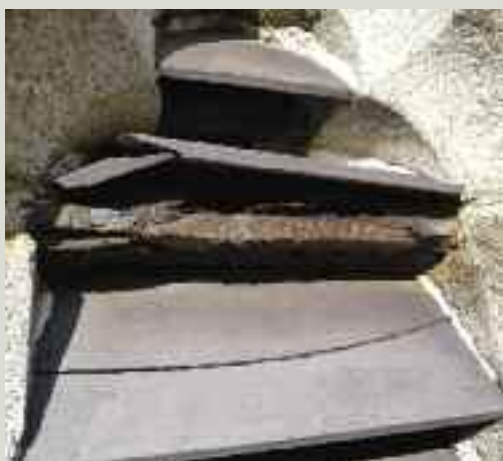
Embedded metal tie bars in this bell tower corroded and expanded, causing fractures in adjacent granite and slate louvres. Part of the repair solution involved installing a cathodic protection system to reduce the corrosion rate of the embedded ironwork

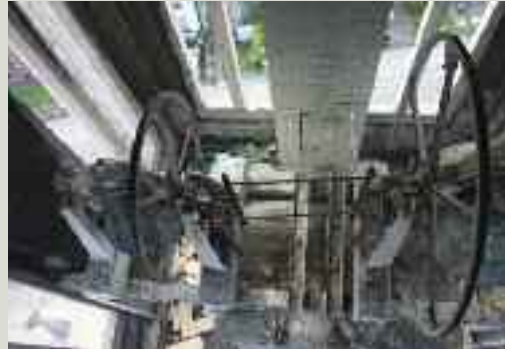
This belfry was photographed prior to work commencing on the steeple (but after the louvres were removed to provide more light for the duration of the project). In common with all such areas, the signs of pigeon infestation are everywhere, however the structure and bell mechanism are in a reasonable condition

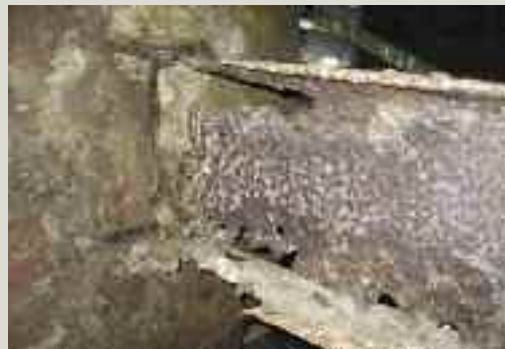
The extent to which driving rain and lack of a protective coating can damage bell supports is shown by this badly corroded steel beam

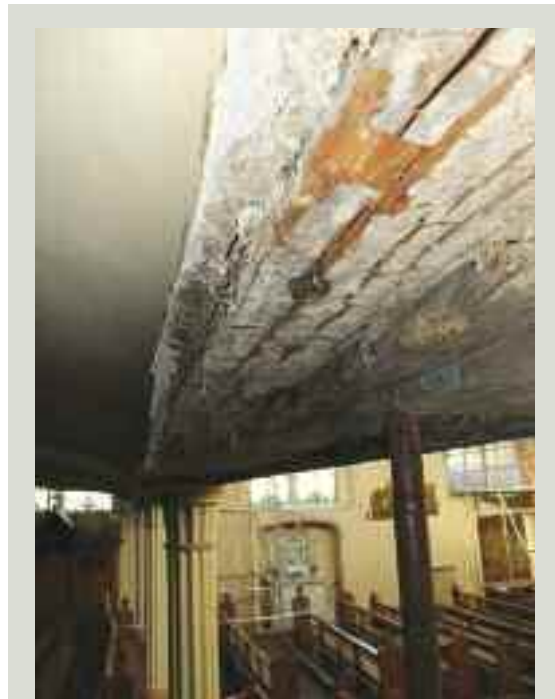
Regular inspections and scheduled maintenance work should prevent rot from taking hold to the degree that it causes structural damage, as has happened to this beam which supports an organ gallery

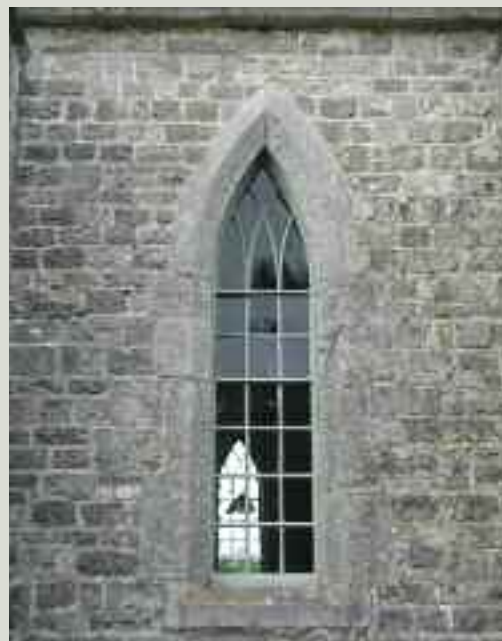
The simple iron glazing in the lancet windows of this rural Board of First Fruits church is enhanced greatly by the survival of crown and cylinder glass. The windows, and the church, are clearly well cared for

century churches, the original clear glass has survived in either leaded lights or metal-framed lights. This glass predates the era of modern and regular float glass and has a delightful rippled quality, producing subtle distortions. Every effort should be made to protect such glass.

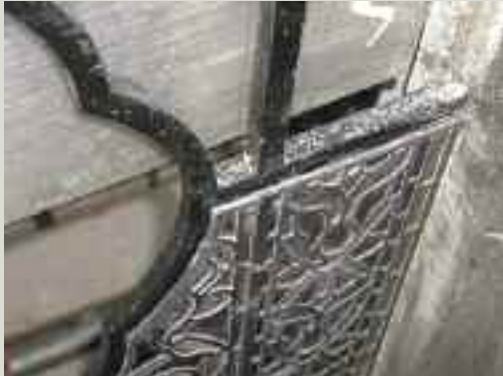
Substantial iron bars are required to support large stained-glass windows. Often the ironwork is shaped to mirror the borders of panels, especially where continuing a horizontal or vertical line would be visually disruptive of the design. This conserved panel has been refitted and a copper band is visible that will secure the panel to a saddle-bar

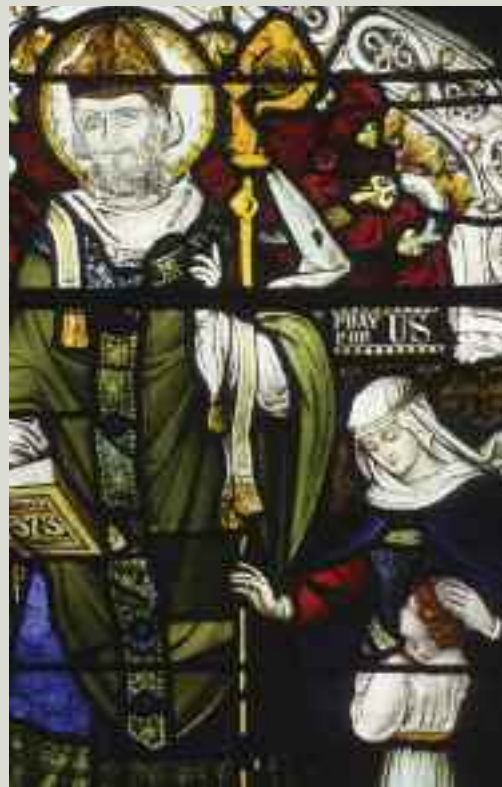
In this example, the face of Saint Brendan and some other intrusions do not match the quality of the original glass-painting

Glass is breakable! Damage to stained glass can be caused by accident or by vandalism. However, some of the most insidious damage is that caused by unskilled restorers who, at some time in the past, have replaced original pieces of glass with poorly matching replicas, known as intrusions. Unfortunately there are few glass-painters nowadays with the skills required for drawing the cartoon, selecting the glass and matching the style of glass painting. It is all too easy to compromise the integrity of a window by the introduction of poor quality intrusions.

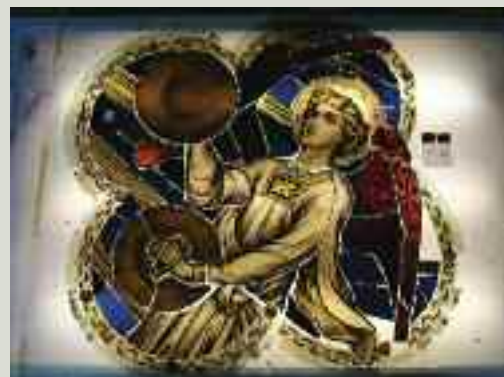
An expert conservator will examine the condition of the window, identify causes of damage, present repair options and carry out the works, at all times guided by internationally recognised principles of best practice

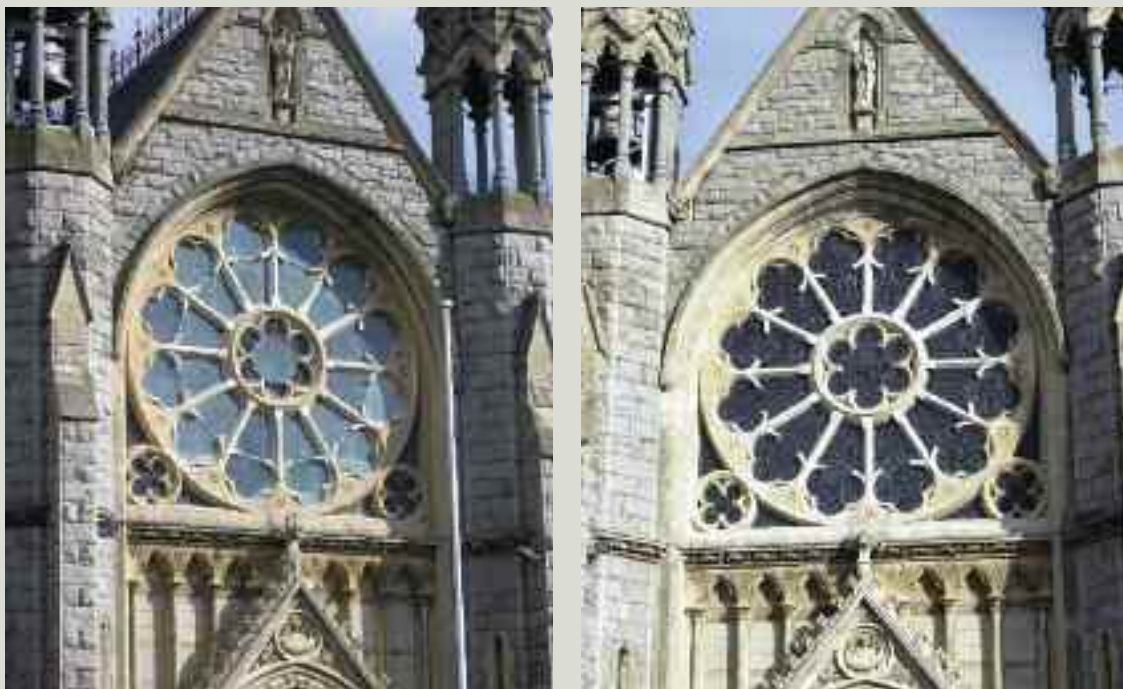
The storm glazing of this rose window was removed and powder-coated stainless-steel wire guards were fixed to the masonry. As a result the window is less likely to suffer from the effects of humidity and heat on the glass and leadwork. There is no loss of clarity to the stained glass and the stone tracery reads more clearly from the exterior

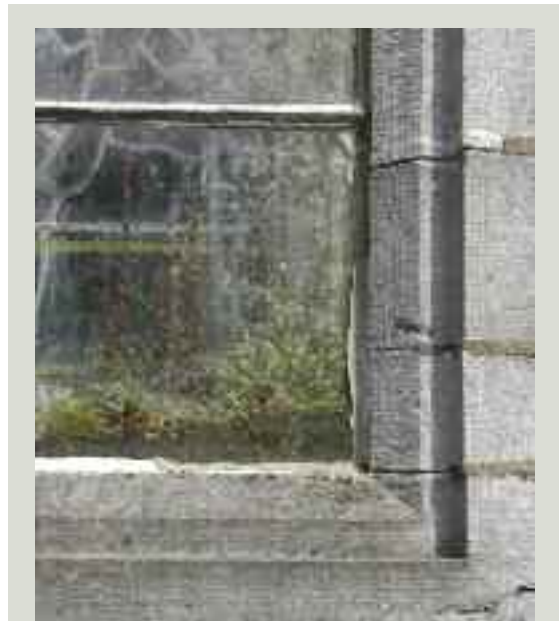
Sealed, or inadequately ventilated, storm glazing provides an opportunity for the growth of vegetation, which damages the stained glass as well as being unsightly

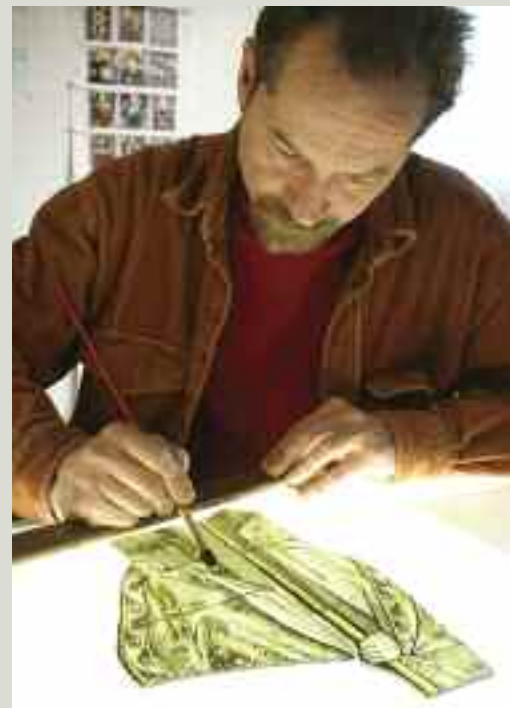
Traditional techniques of painting faces, drapery and other detail must be studied by the stained-glass conservator, each used for painting missing pieces as his or her experience judges them to be appropriate

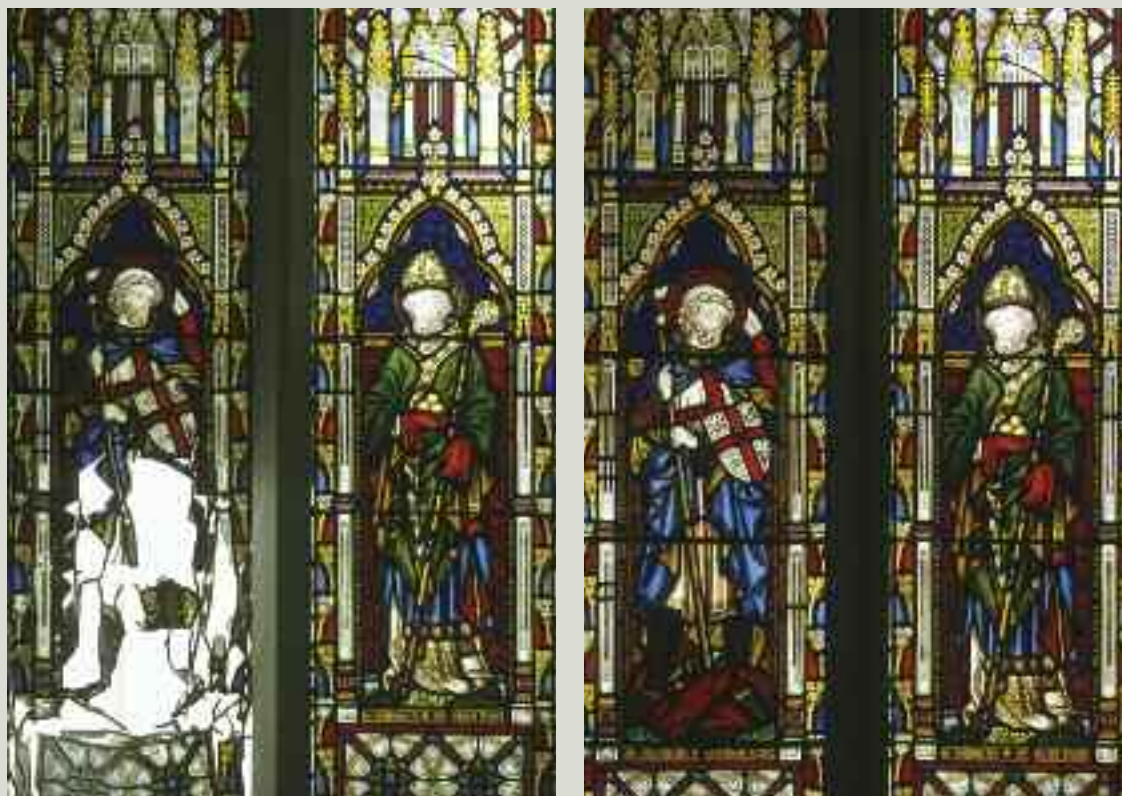
The damage to this window (left) was extensive. Repair (right) consisted of lamination of fractured panes, introduction of carefully chosen and painted intrusions, and re-leading the panels using all surviving pieces

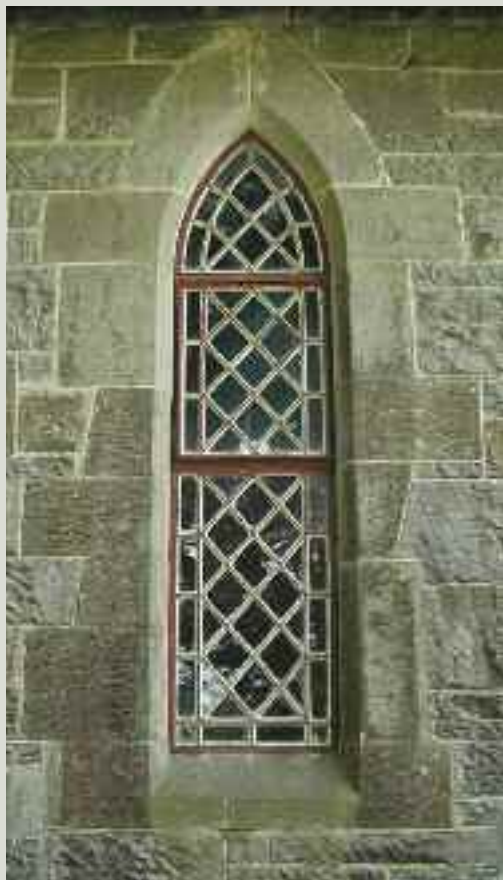
Where there is delicate glass in the window care should be taken when attempting to open a hopper light. Where windows have not been opened in a long time, general maintenance or repair may need to be carried out first

The relatively small outlay involved in overhauling casements and hopper lights and the effort involved in arranging for them to be opened regularly is more than repaid by the immediate benefits to be gained to the health of the building. In a small single-cell church it may be that only two working hopper lights, at diagonally opposite corners of the building, are needed. More will be required in a larger church. A good routine is to open these regularly, for example immediately after churchgoers leave following a service, when the internal atmosphere is warm and the moist air can readily escape.

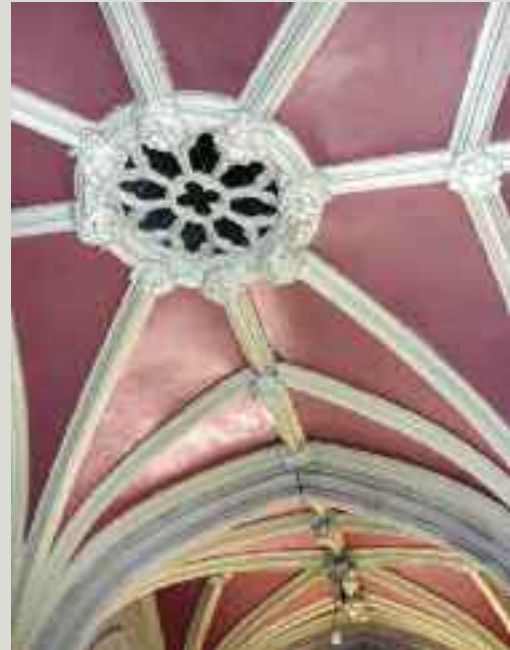
Ceiling grilles should be checked to ensure that the warm, humid air rising into the roof space is ducted through and discharges to the exterior to avoid raising the moisture content of the roof timbers to a level that might make them vulnerable to insect or fungal attack

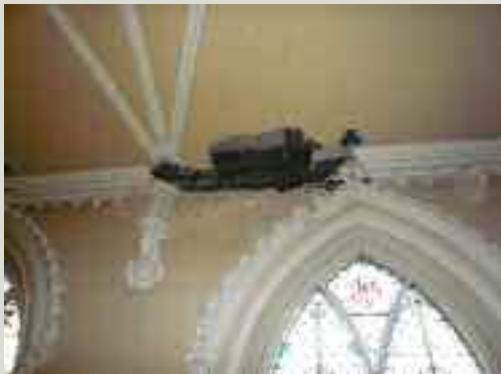
Neglect of the roof of this church led to moisture ingress and timber decay, resulting in serious damage to decorative plasterwork. Investigations determined the extent of the problem, which was remedied using traditional plaster repair methods and the removal of as little structural timber as necessary

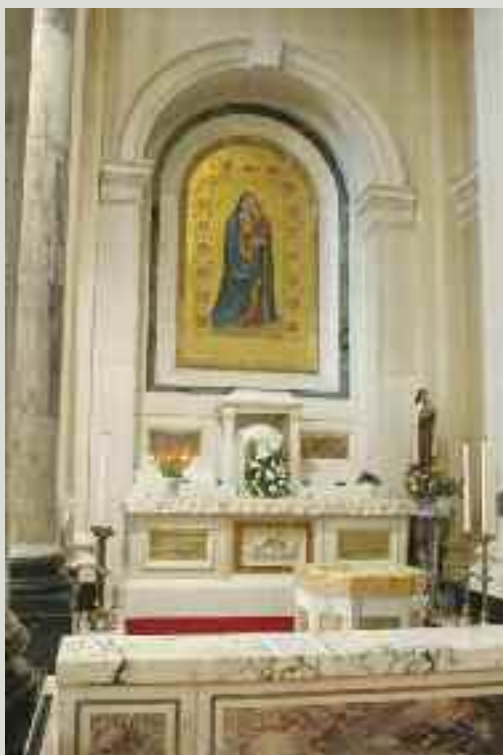
This richly decorated Neoclassical baptistry is separated from the body of the church by Connemara marble columns, which have polished black limestone plinths. The Carrara marble-clad niche houses an Italian gold-leaf mosaic panel

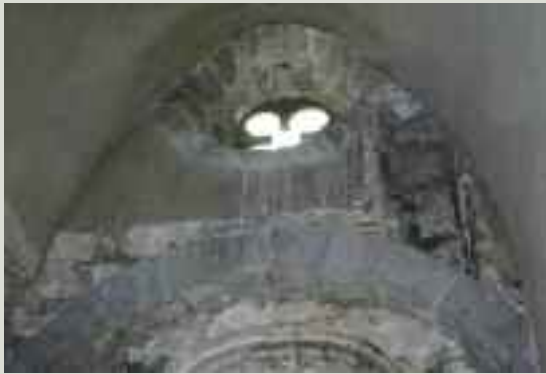
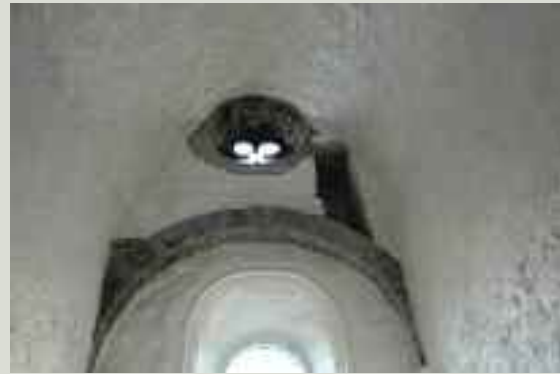
The cement plaster on this Romanesque church, which was damaging the stonework and associated timbers, was carefully removed and replaced with a soft lime plaster

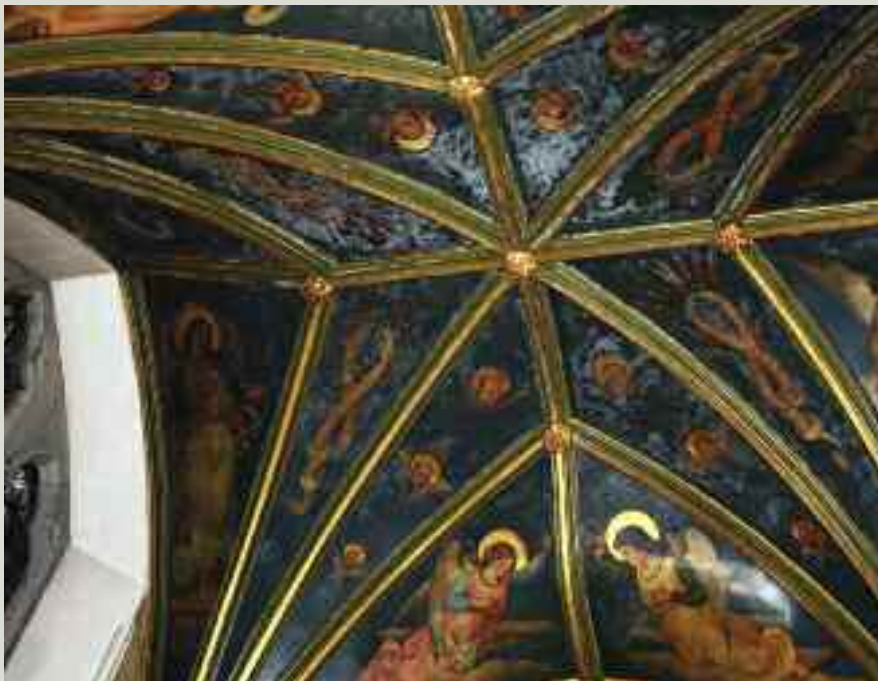
The vaulted ceiling of this late nineteenth-century cathedral is claimed to have been painted by an Italian artist. The black background contributes to the dark atmosphere of the interior, but as an original feature of the design it forms part of the character of the protected structure and should not be altered in any redecoration of the interior. Cleaning and conservation of paintwork and gilding of this quality requires specialist skills

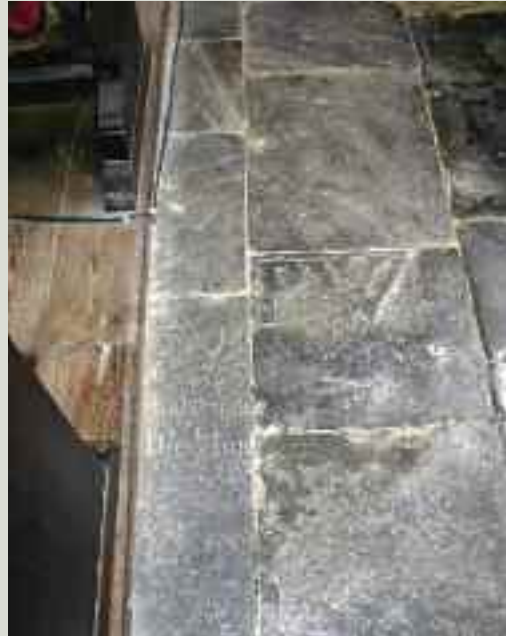
Floor surfaces may be of significance for historic or social reasons. The paving of this cathedral floor contains cut down and reused grave slabs

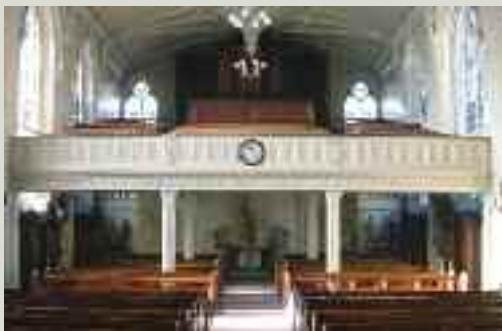
The gallery of this church is finely detailed and contributes significantly to the spatial quality of the nave

Galleries are usually constructed with timber beams, supported on timber or cast-iron columns. It is important that the floor joists in galleries are not notched to take building services as this reduces the strength of the structural members and may lead to excessive deflection. The staircases leading up to galleries may contain fine historic joinery and should be preserved accordingly. Steps are usually timber but some are of stone, and may have worn nosings from long use. Often old staircases are felt to be unsafe due to the low heights of handrails, wear on the treads or the steep pitch of their flights. Each case should be assessed individually and the patterns and frequency of use taken into consideration before deciding whether or not an intervention is necessary to make the staircase safer or more accessible. Where pews run right up to the front edge of a balcony the height of the effective guarding might be dangerously low requiring a simple rail to improve safety (possibly set back behind the gallery front).

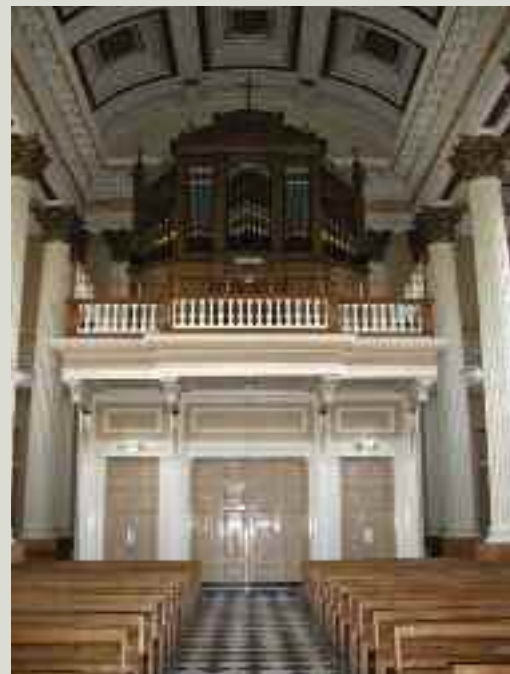
Organs are often immense fixtures, but their very size masks a vulnerability towards environmental changes. They require dry, stable conditions and expert care

Organs require specific temperature and humidity conditions to be maintained to prevent them going out of tune. Usually a specific heating system local to the organ is employed for this purpose. If an existing system is being altered in a church with an organ the impact of the new heating output needs to be considered.

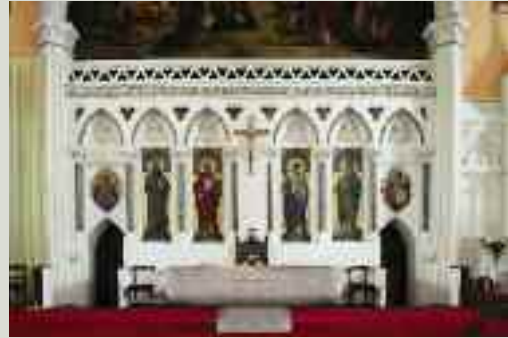
The noted church architect J J McCarthy most likely designed this Gothic Revival reredos in 1860 when he is recorded as having been commissioned to design the high altar for SS Peter and Paul, Ennis. It was executed in carved stone by noted church decorators John Hardman and Company of Birmingham, a firm closely associated with A W N Pugin. The post-Vatican II granite altar table is an unobtrusive introduction

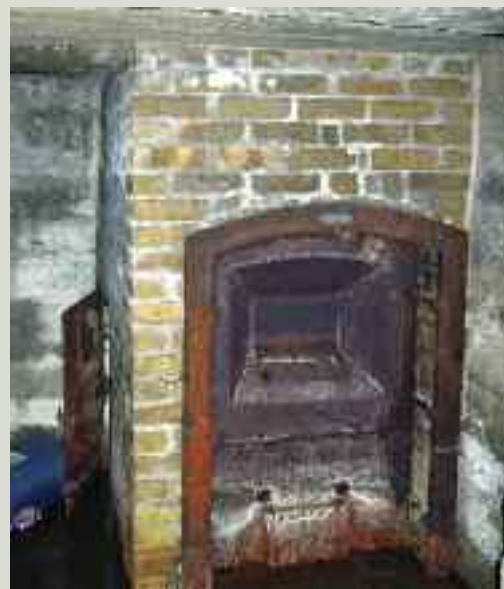
Several elements of a historic heating system often survive, as at this church where both boiler and perforated floor grilles remain

Often due to a lack of funding for new heating installations, many older churches still contain remnants of antique heating systems which may be of considerable historic value. These may contain asbestos lagging and specialist advice should be sought about its removal. In some instances it may be desirable to retain parts of a redundant system for historical interest. The removal of elements of historic significance from a church may require planning permission. The advice of the architectural conservation officer in the local authority should be sought when considering any works of this type.

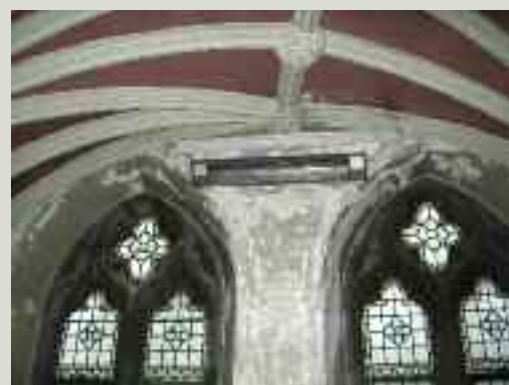
Church lighting and heating systems may evolve on an ad-hoc basis as funds become available. In this case, strip lights and electric bar heaters were fitted to some of the aisles. Conservation works to the church will include the removal of these fittings and repairs to the roof above to eradicate the damp in the wall

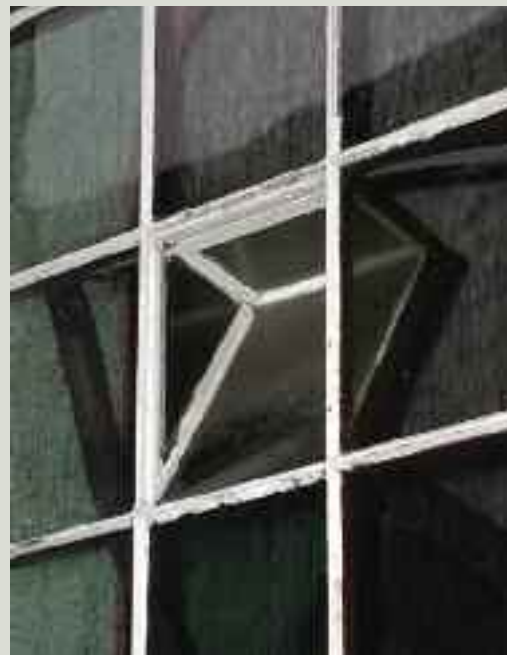
Original ventilators in the glazing should be repaired where necessary and opened after church services. Care should be taken in operating the mechanism to avoid damaging historic glass

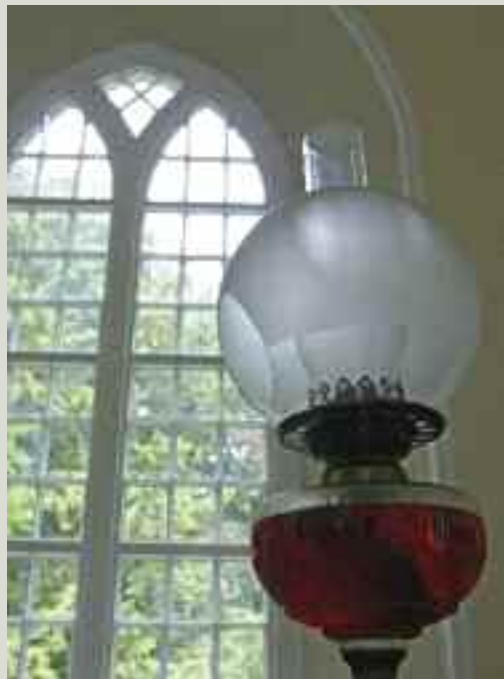
Historic light fittings should preferably continue in use and their light output augmented if necessary. Where new light fittings are required, it is recommended that the church authority obtains specialist advice in order that the scheme adequately addresses both the needs of the church users and the character of the interior

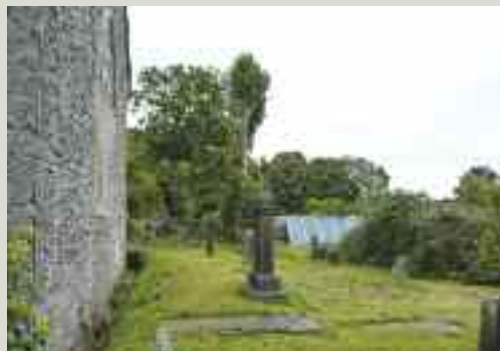
The decision to install solar, or photovoltaic, panels should be based on a thorough analysis of the needs of the building as well as of the site itself. The panels are sited in an unobtrusive part of the graveyard and all services are run on the surface. The panels are easily demountable

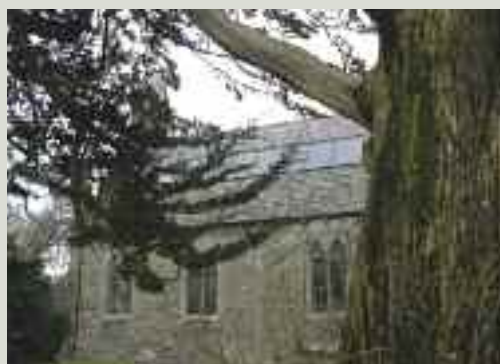
There may be an opportunity to install solar panels on the less visible slopes of a roof. In this case the heat generated by the panels is taken to an underfloor system providing a certain amount of background heating which keeps the building fabric in good condition (Image courtesy of Margaret Quinlan Architects)

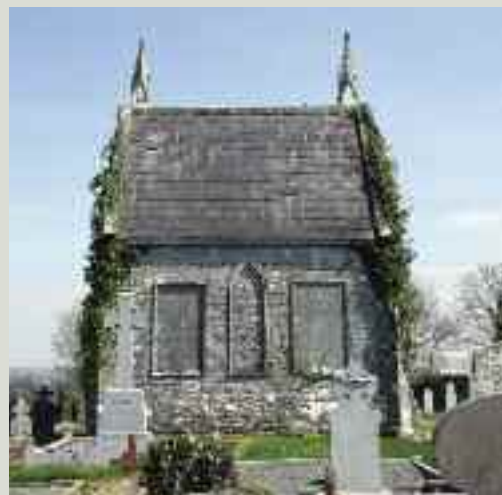
Some mausolea are shaped like miniature churches, containing high quality architectural details and materials. Mausolea require sufficient maintenance to prevent them slipping into a state of neglect, damaging the remains within and endangering visitors to the graveyard

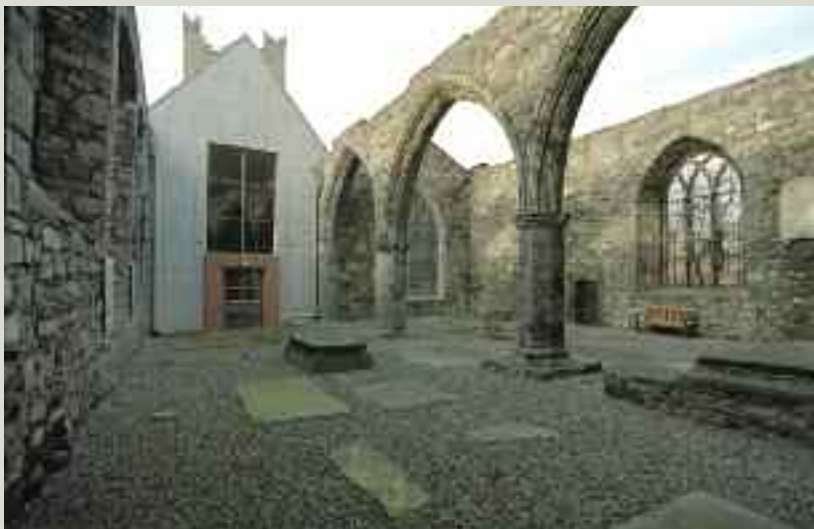
The medieval chapel of Saint Anne at Saint Audoen's Church of Ireland, Dublin was converted to a visitor centre in 2000. The work included re-roofing the chapel and the construction of a new east gable wall. The wall is a spare, modern intervention in a highly sensitive location facing onto the former Portlester Chapel and chancel of the medieval church

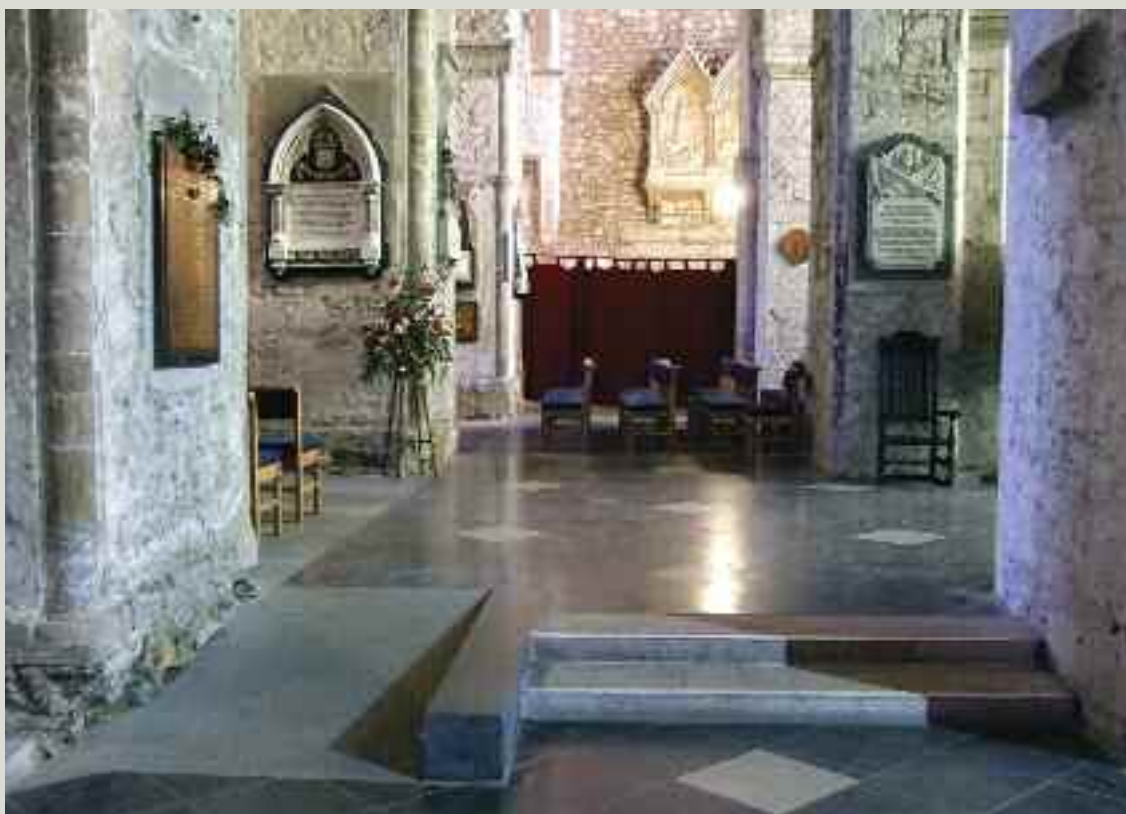
Improving access where there are several changes of floor level within a church requires careful consideration. Where the church is a medieval structure, there is the possibility of burials beneath the nave which preclude lowering of the floor level. Ideally, the improvement of access should be an integrated part of an overall conservation strategy

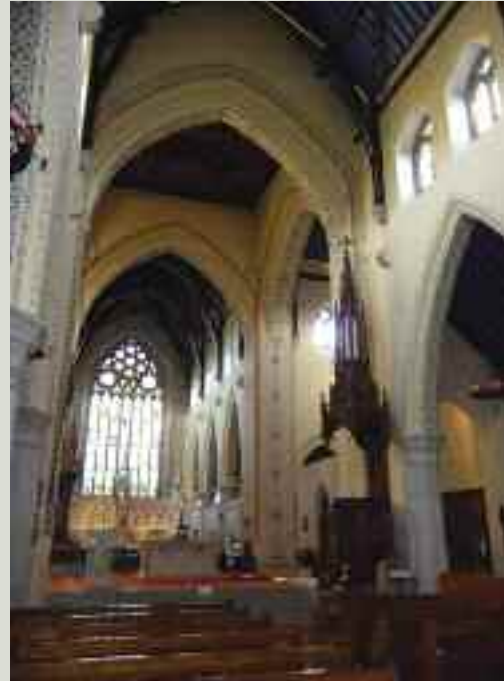
The A W N Pugin-designed Saint Aidan's Cathedral, Enniscorthy, County Wexford, underwent a programme of restoration in the 1990s, during which the cathedra and pulpit were reinstated. The altar table was placed on a dais under the tower and the altar rails have been removed. The magnificent marble reredos and choir screens survive

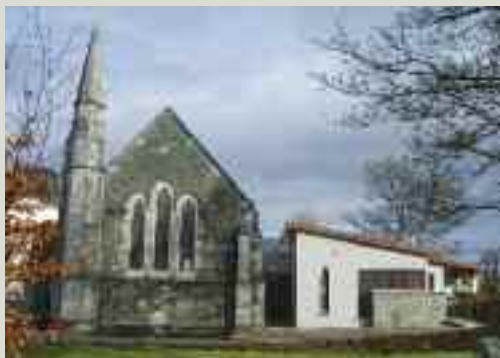
The Methodist Church, Killarney, County Kerry was extended to provide pastoral facilities. The extension was designed in a contemporary style that complements the original historic fabric (Image courtesy of Mott MacDonald Ireland Ltd)
