advice series

THE CONSERVATION OF PLACES OF WORSHIP

An Roinn
Ealaíon, Oidhreachta agus Gaeltachta
Department of
Arts, Heritage and the Gaeltacht

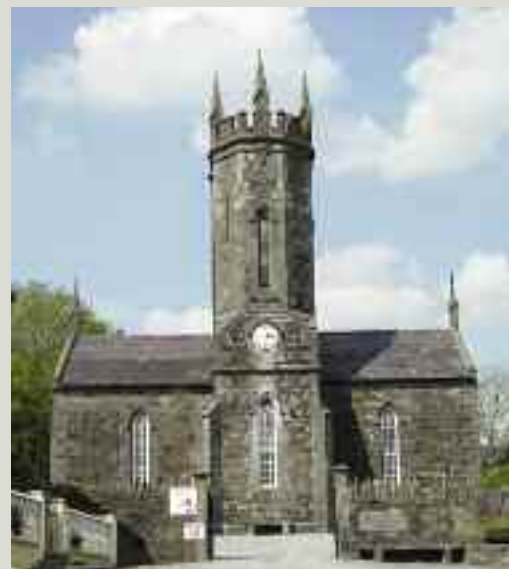
This impressive Gothic Revival Church of Ireland church of 1830 has been in use since 1986 as a cultural centre by Comhaltas Ceoltóirí Éireann. Externally it appears unchanged; internally it retains the pulpit, memorial plaques and other features

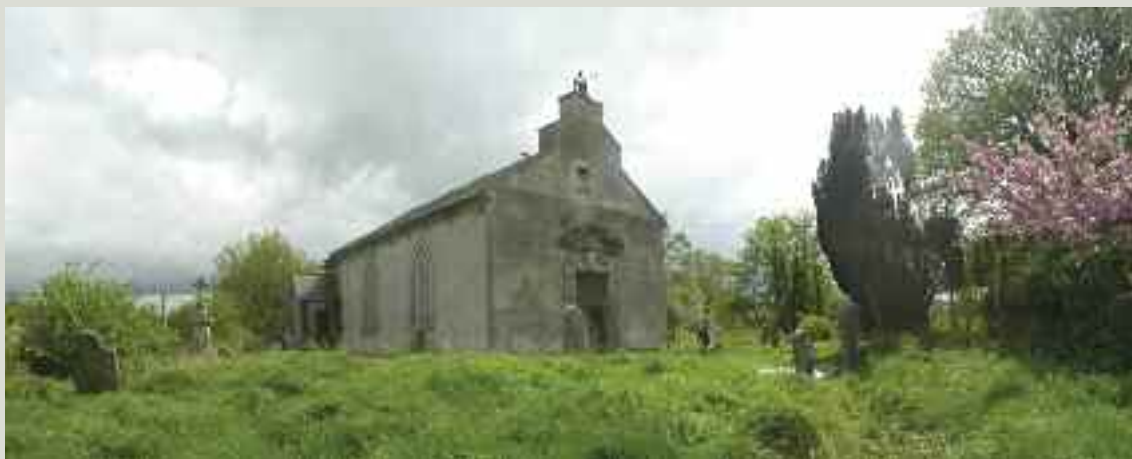
This redundant Church of Ireland church was 'mothballed' to prevent deterioration while decisions are made on its future

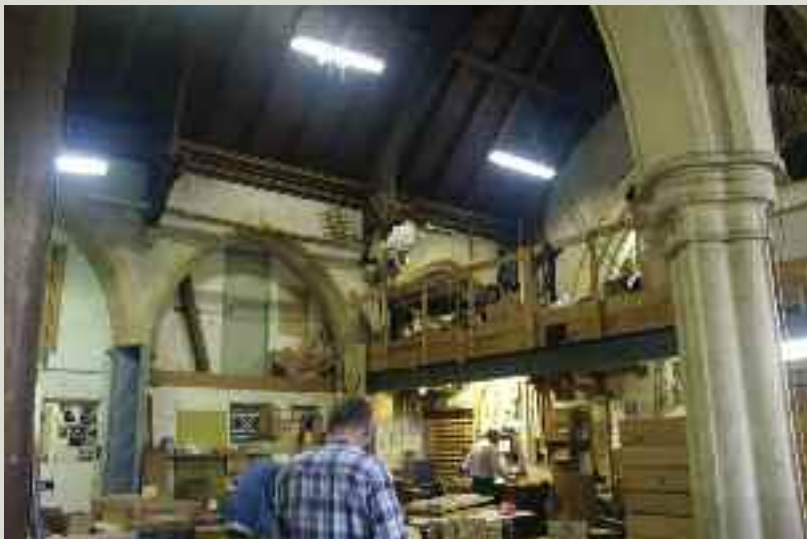
Occasionally, former churches are used as workshops for trades such as printing or joinery, which require large spaces such as are offered by a nave. This church was in use as an organ-building workshop from 1979 until 2008. The firm took great care to ensure that all the structures introduced into the building were freestanding. This church is once again in use as a place of worship.

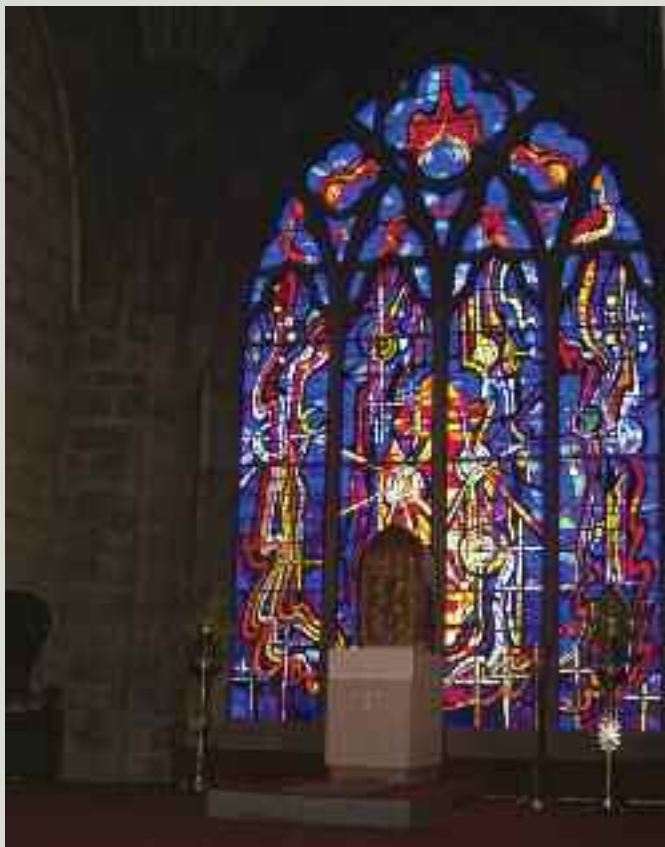
The east window of the multi-period Black Abbey Church, Kilkenny, founded in 1225, was fitted with stained-glass windows in the late-twentieth century, amongst many post-Vatican II changes. It provides a dramatic contrast to the nineteenth-century stained-glass windows elsewhere in the church designed by the studio of Earley and Powell
