Appendix E: Phase 1 Hydrogeology Assessment of the Cherrywood SDZ

Phase I Hydrogeology Assessment of the Cherrywood SDZ

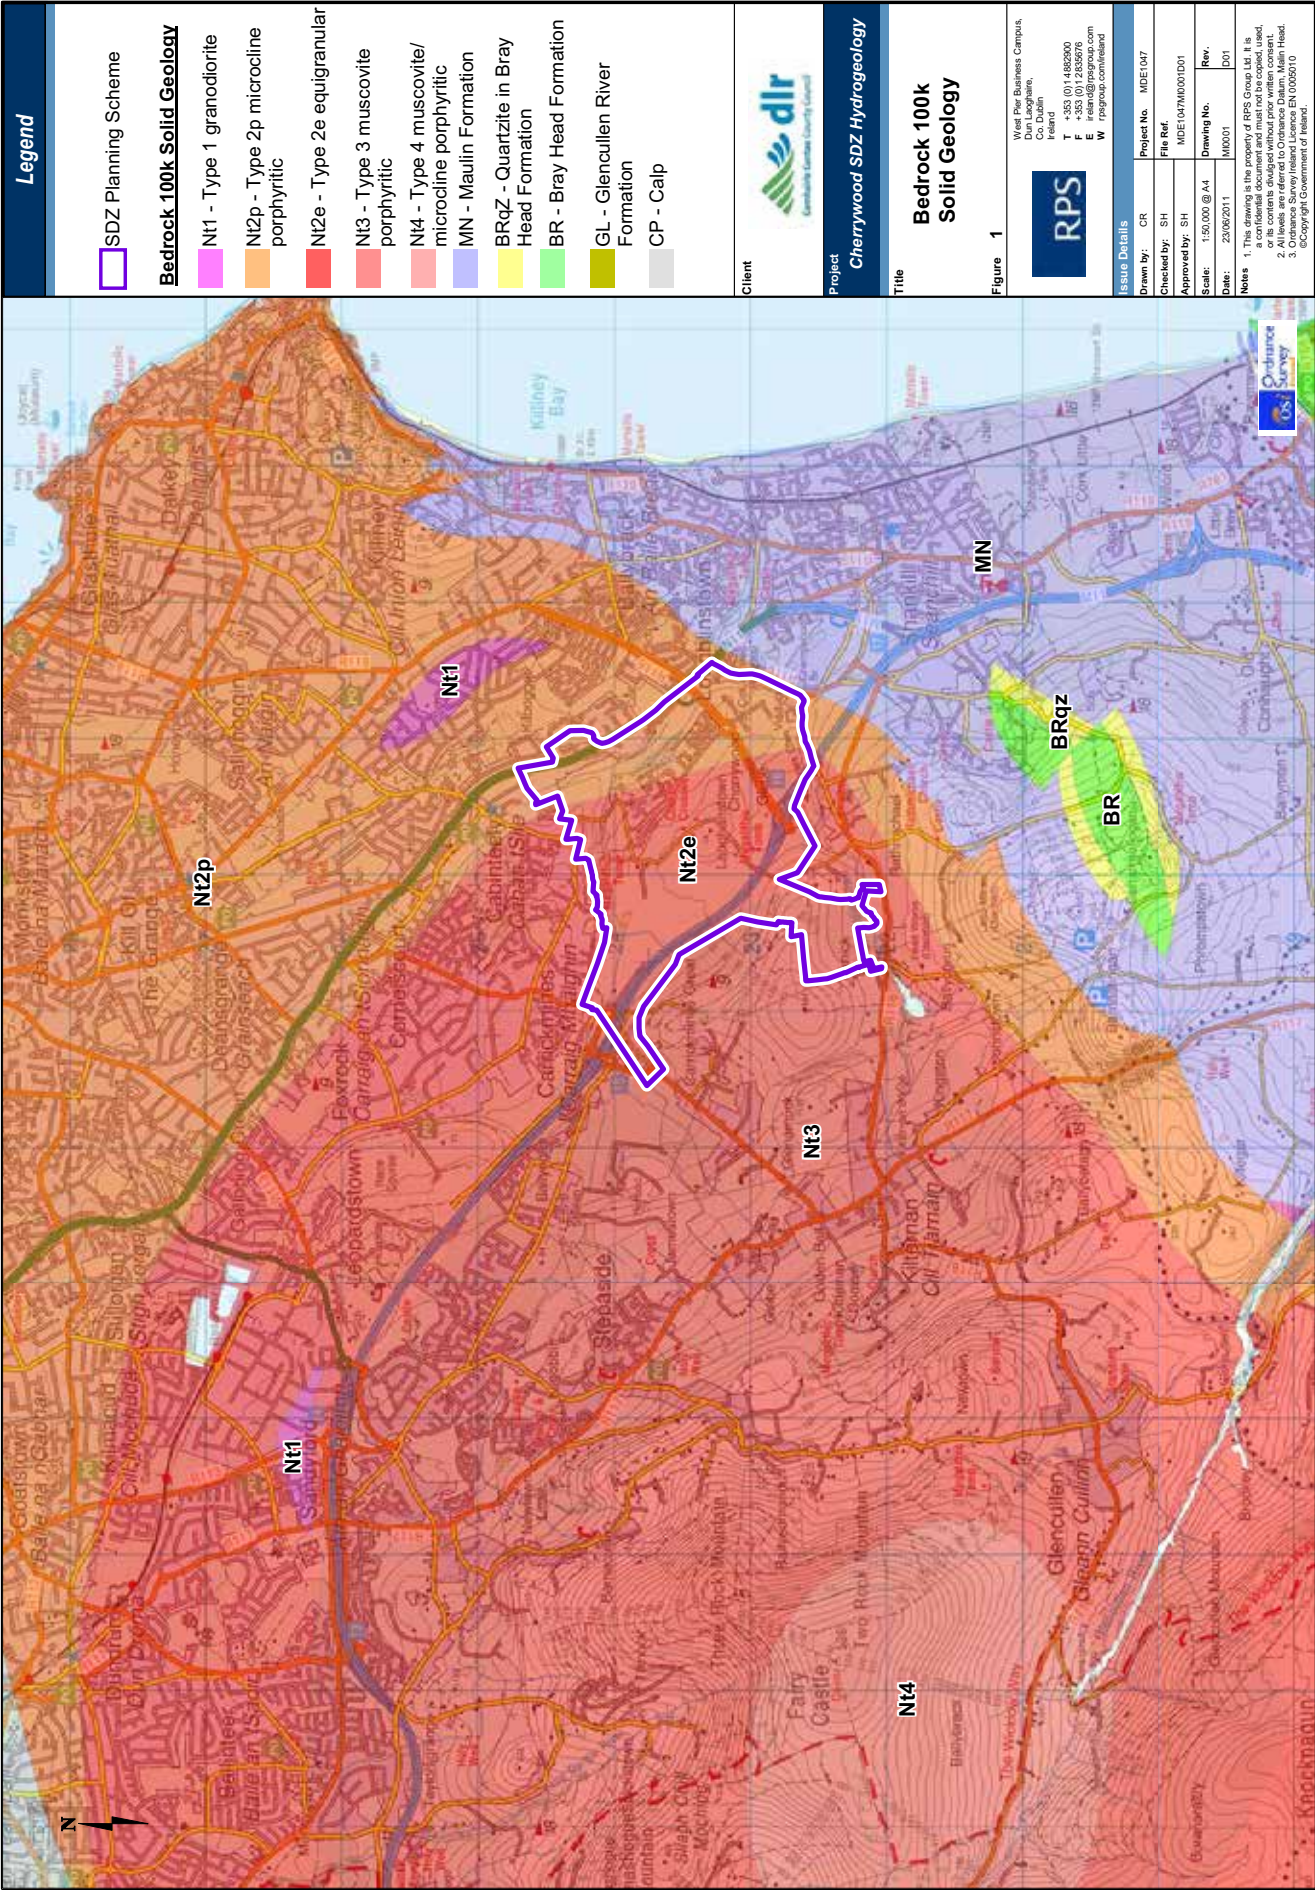
The GSI have identified the bedrock (**Figure 1**) underlying the site as comprising of Granite with a gradation between pale grey fine to coarse grained granite (Stratigraphic code Nt2e) in the west, to Granite with microcline phenocrysts (Stratigraphic code Nt2p) in the east. The bedrock is classified by the GSI to be a Poor Aquifer bedrock (PI), which is generally unproductive, except for local zones.

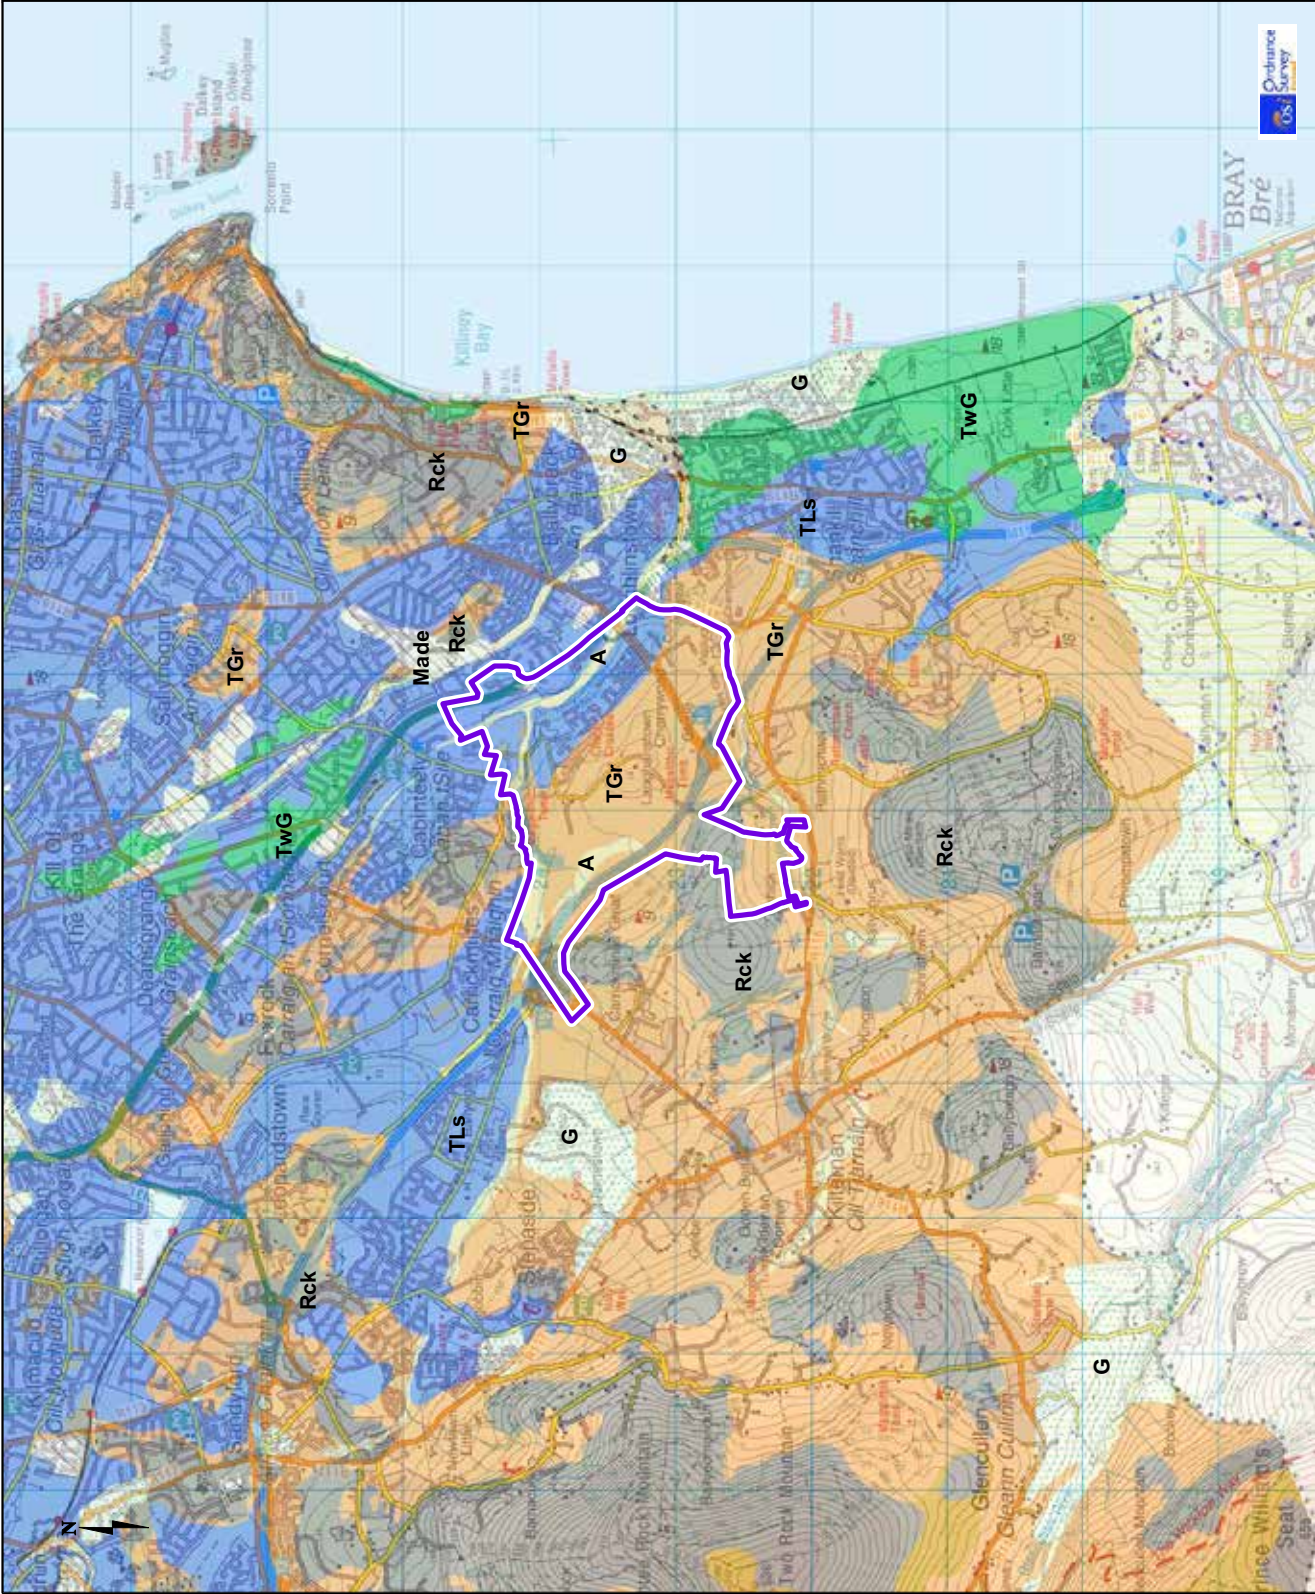
The GSI's subsoil Quaternary mapping for the area indicates that Granite Till (TGr) underlies the majority of the study area in the central part of the site with localised areas of bedrock outcrop (Rck) along the M50 and to the west of the M50 (**Figure 2**). Limestone Till (TLs) is mapped in the eastern part of the study area that coincides with the observed locations of tuffa springs (refer to **Section 4.2**) with Alluvium around the Loughlinstown River.

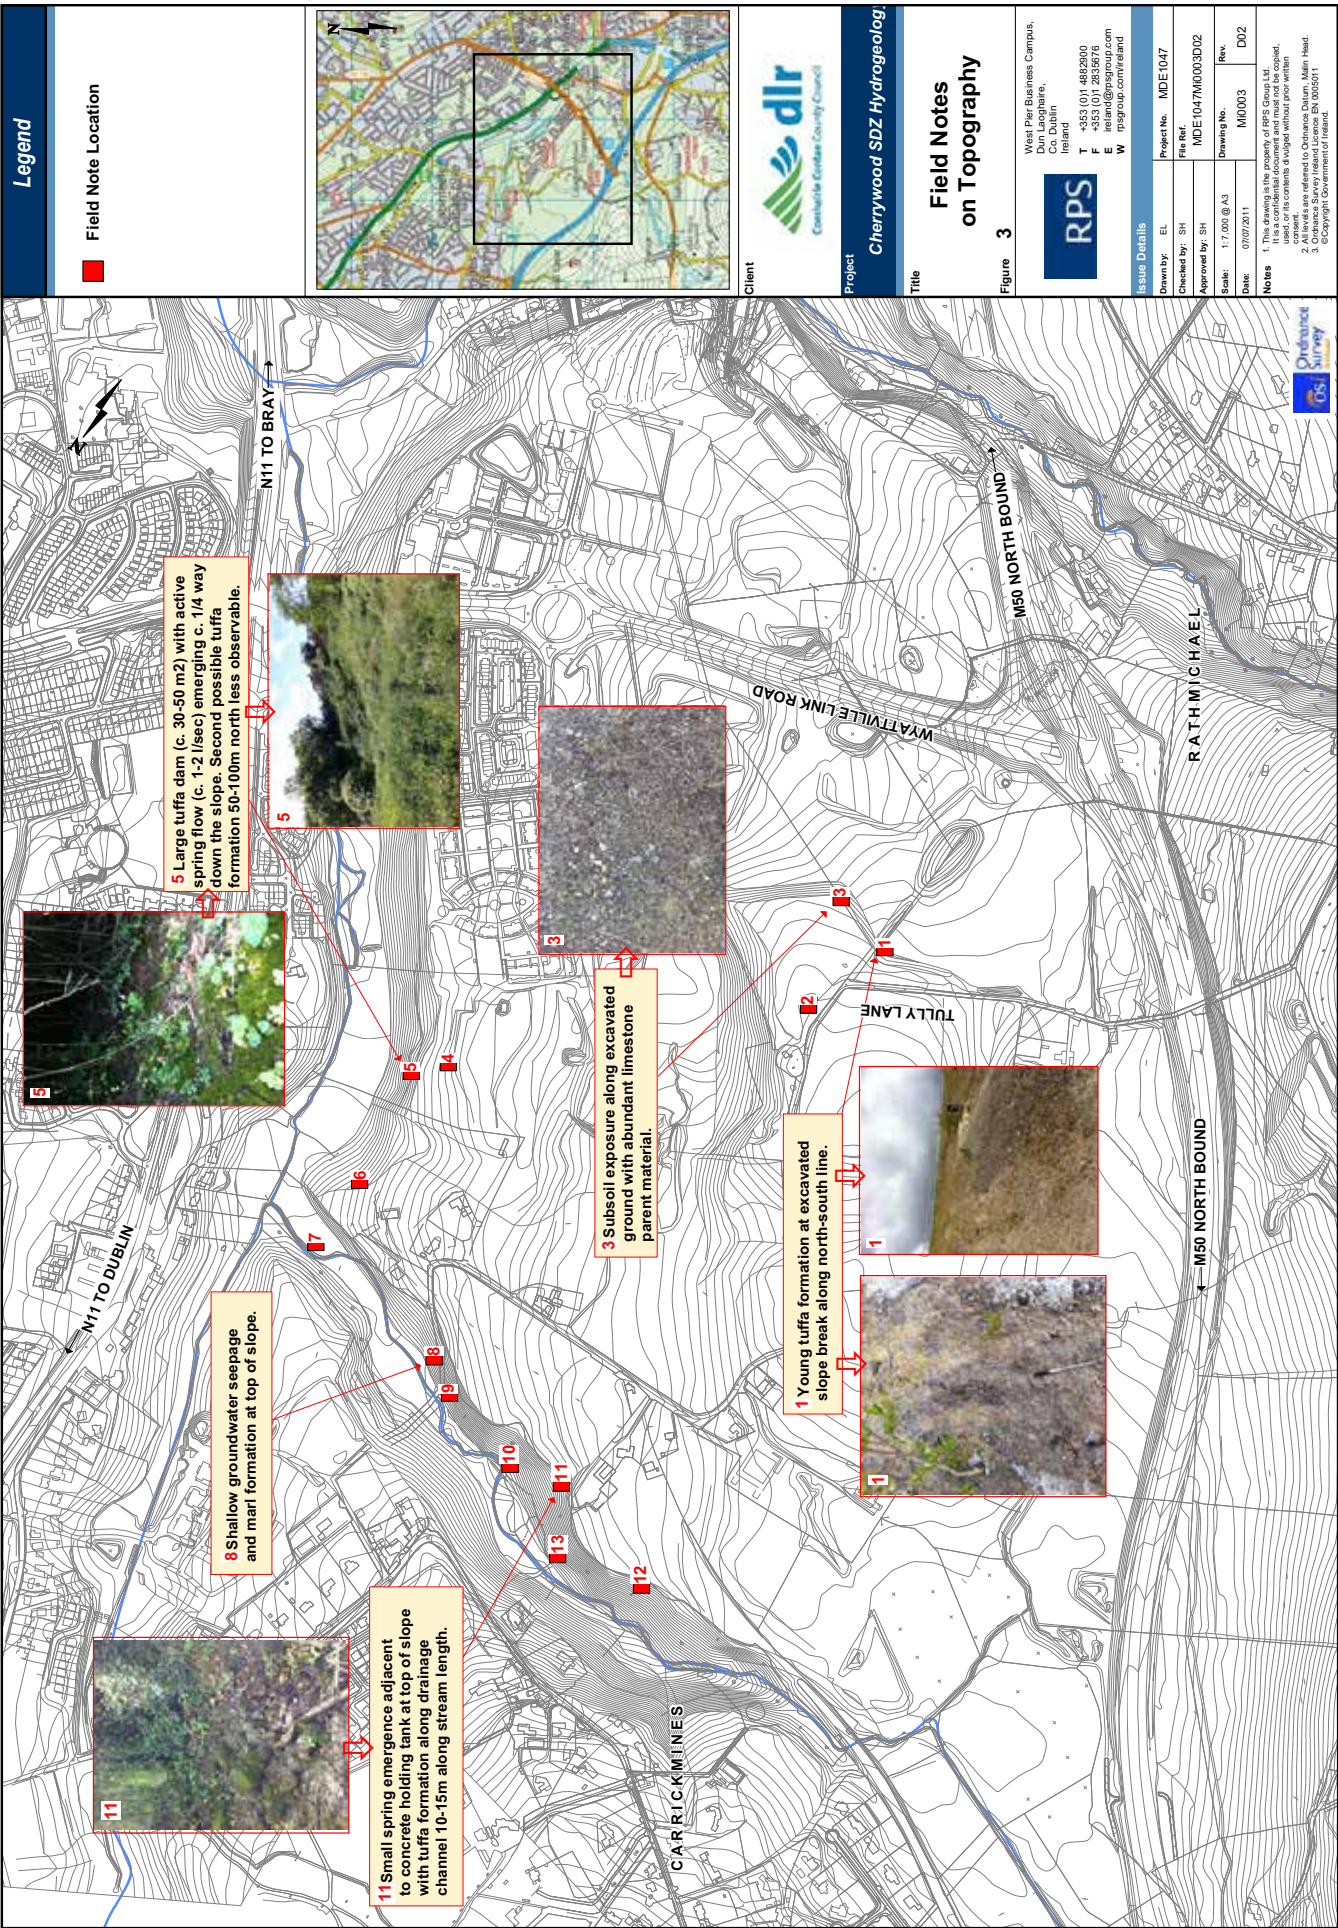
Figure 3 illustrates the locations of the observations made during the site walkover and **Table 1** provides a description of observations made during the walkover.

A complete description of notable field observations is contained in **Table 1** with locations illustrated in **Figure 3**. In summary, a small number of localised high quality tuffa spring formations were observed on the southwestern flank of the river valley to the southwest of the N11 (location 5 on **Figure 3**). The spring flows observed to be feeding one of these deposits was located approximately 1/4 way down the slope embankment, indicating a relatively shallow perched groundwater discharge at this location.

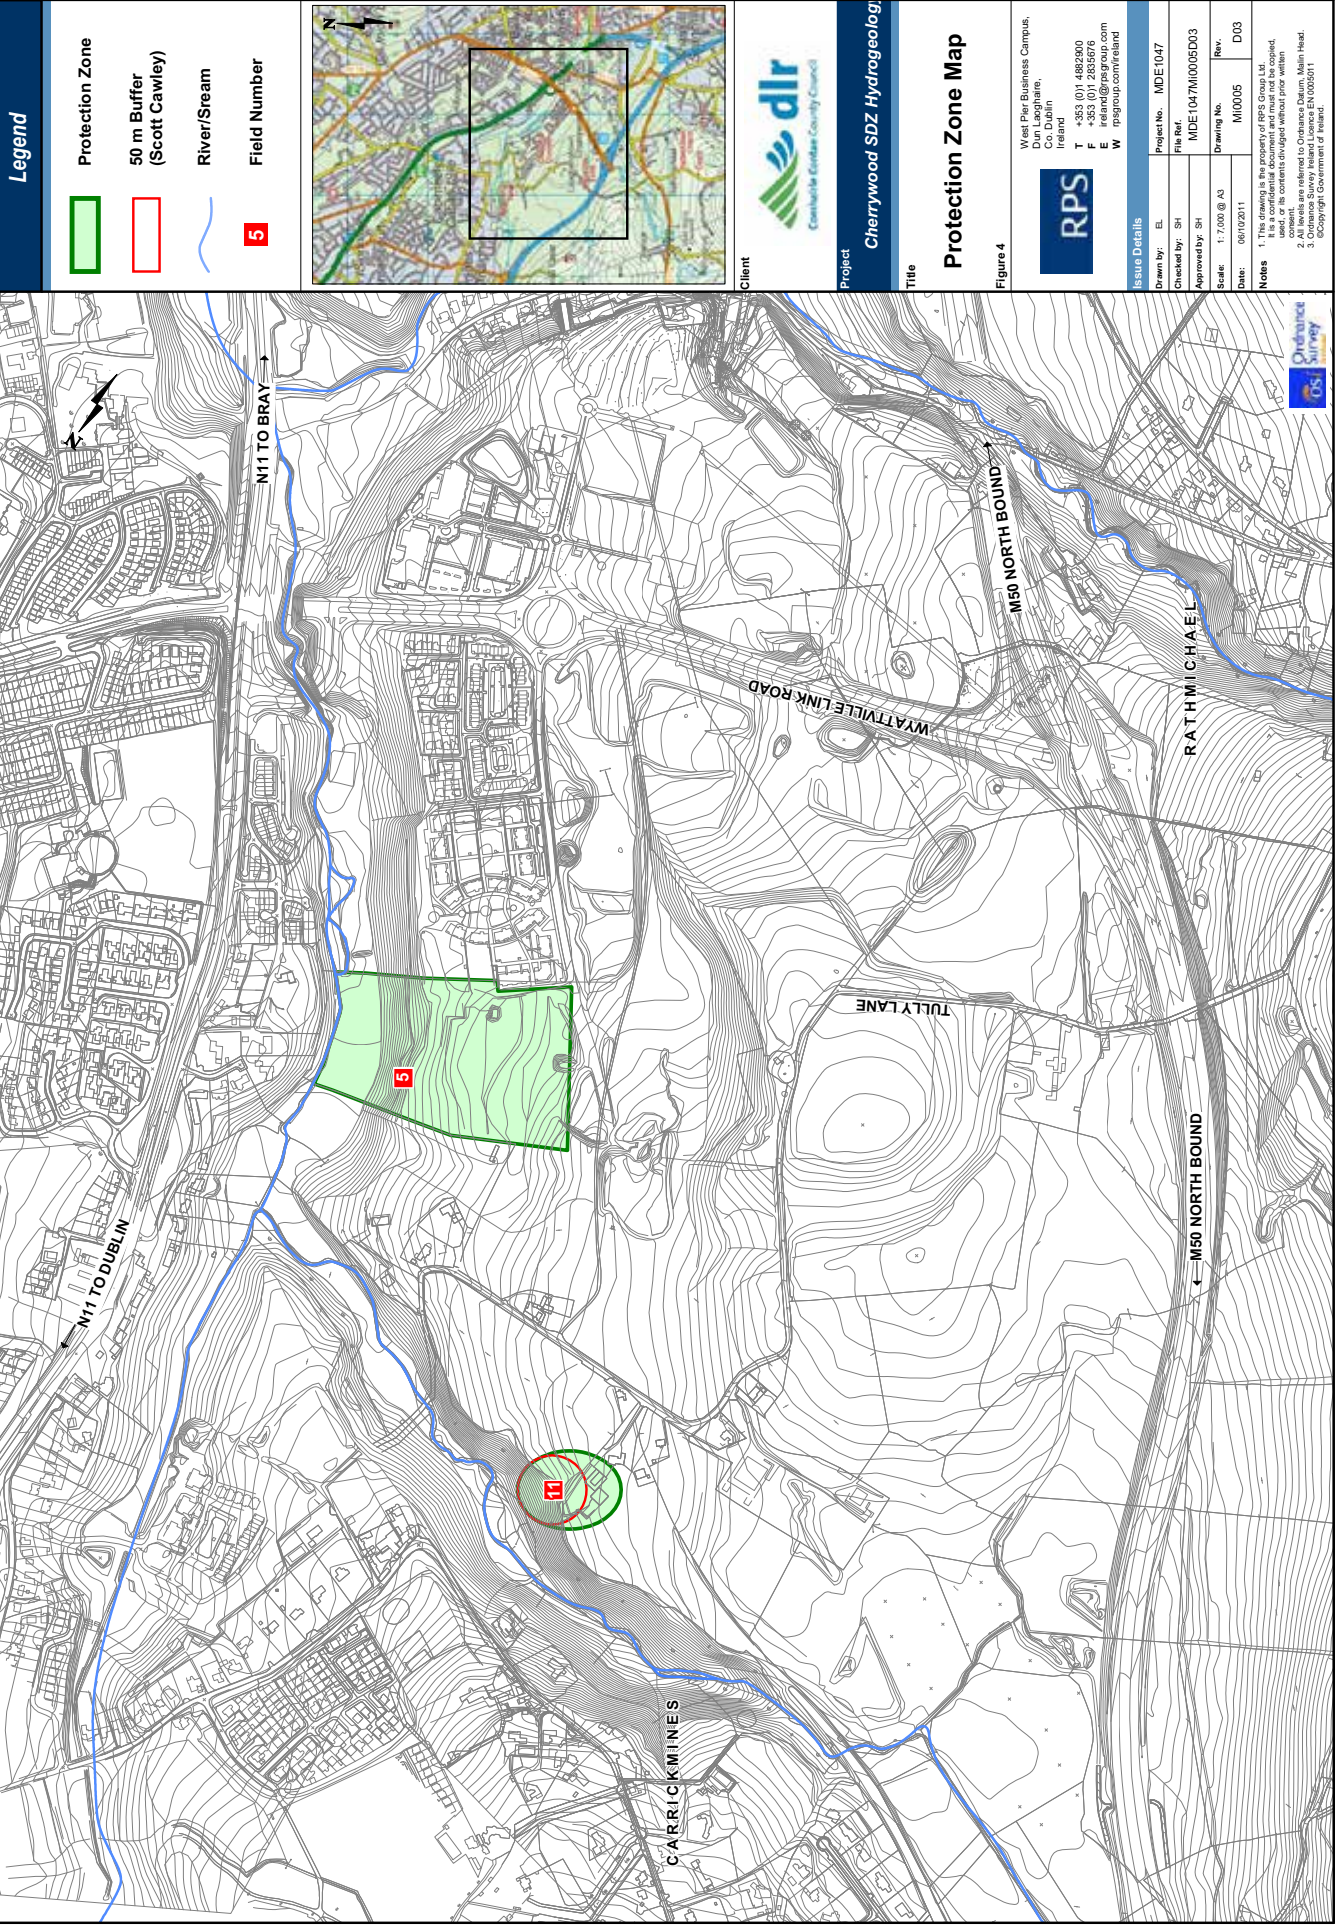
The protection zone (**Figure 4**) relevant to location 5 extends to the southwest and upgradient of the tuffa formation to where the land rises again out of a topographical dip approximately 25m/30m in that southwesterly direction. To the northwest the protection zone extends to the boundary line of neighbouring agricultural land where a drainage ditch has been dug. The southeast boundary of the protection zone is the previously developed land. The proposed protection zone covers an area of 380m by 230m. With further field investigations the protection zone may be refined and more accurately delineated.

The protection zone (**Figure 4**) relevant to location 11 coincides largely with the 50m buffer zone recommended by Scott Cawley. The protection zone has been extended 50m past the recommended buffer zone to the west of the tuffa spring formation, giving a 100m protection zone in this direction to allow for a conservative estimate in the length of the flow path to the tuffa spring. Topographic contours suggest that flows from the east are unlikely to be contributing to the tuffa spring at location 11.

A number of high level recommendations have been made in relation to potential mitigation principles for the SDZ design (e.g. avoidance of sensitive areas, use of SUDS systems and possible use of artificial recharge). In line with the avoidance principle two spereate protection zones have been developed to encompass the tuffa spring formations at location 5 and location 11 and the most likely catchment areas that feed the individual tuffa formations.

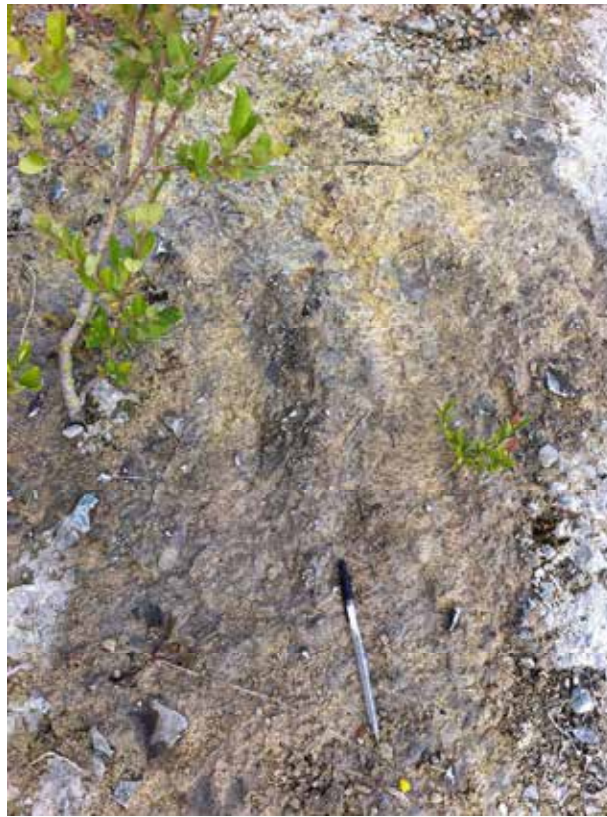
Photograph 1 – Close up view of new tuffa formation observed along slope break (ref Location 1 on Figure 3).

Immature recently formed tuffa as the result of recent earthworks exposing shallow perched groundwater tables and spring/seepage along new embankments. Several examples were evident along the northeast - southwest trending embankment to the northwest of the Wyatville Link Road (location 1 on **Figure 3**). Photographs 1 and 2 (**Appendix A**) illustrate this in close up and from a distance.

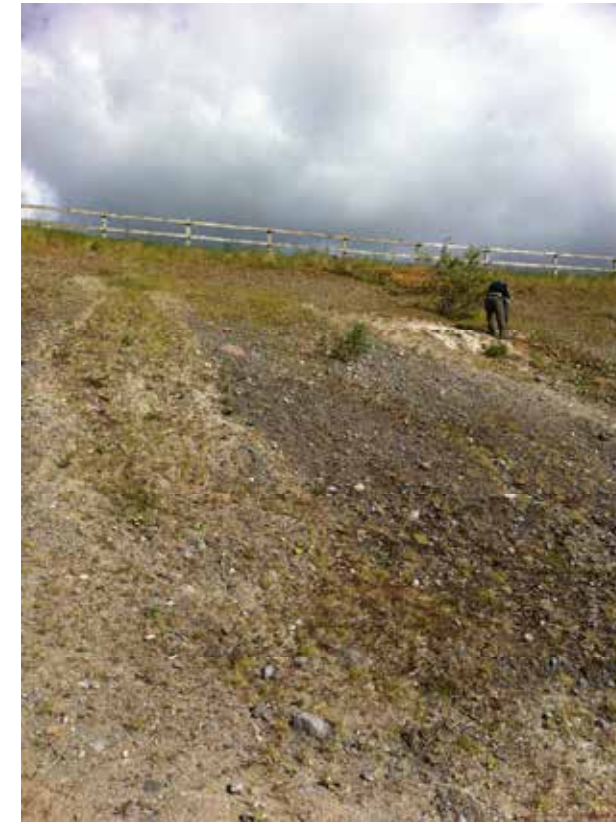
Photograph 2 – View of new tuffa formation (where person is standing) observed from a distance along slope break (ref Location 1 on Figure 3).

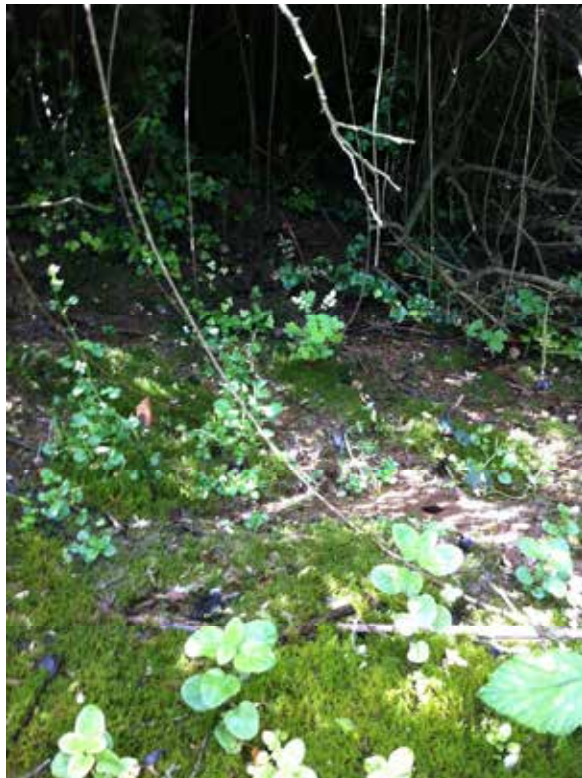
Photograph 3 – Close up of tuffa (orange material surrounded by moss) and spring located along southwest bank of valley at location 5 (refer to Figure 3).

Mature, high quality tuffa springs with active groundwater flow and calcareous carbonate precipitation with associated plant communities. Two large examples were present on the southwestern flank of the river valley to the southwest of the N11 (location 5 on **Figure 3**) and illustrated in Photographs 3 and 4 (**Appendix A**).

The mature tuffa spring formations observed at location 5 (**Figure 3**) are the only maturely developed tuffa formations within the limits of the SDZ. RPS also understands from Scott Cawley that the tuffa spring formations at location 5 correspond to an EC Habitats Directive Annex I habitat. These factors combined ensure that location 5 will be most important for the proposed SDZ in terms of the impacts of the development on the hydrogeology - ecology interaction of the area.

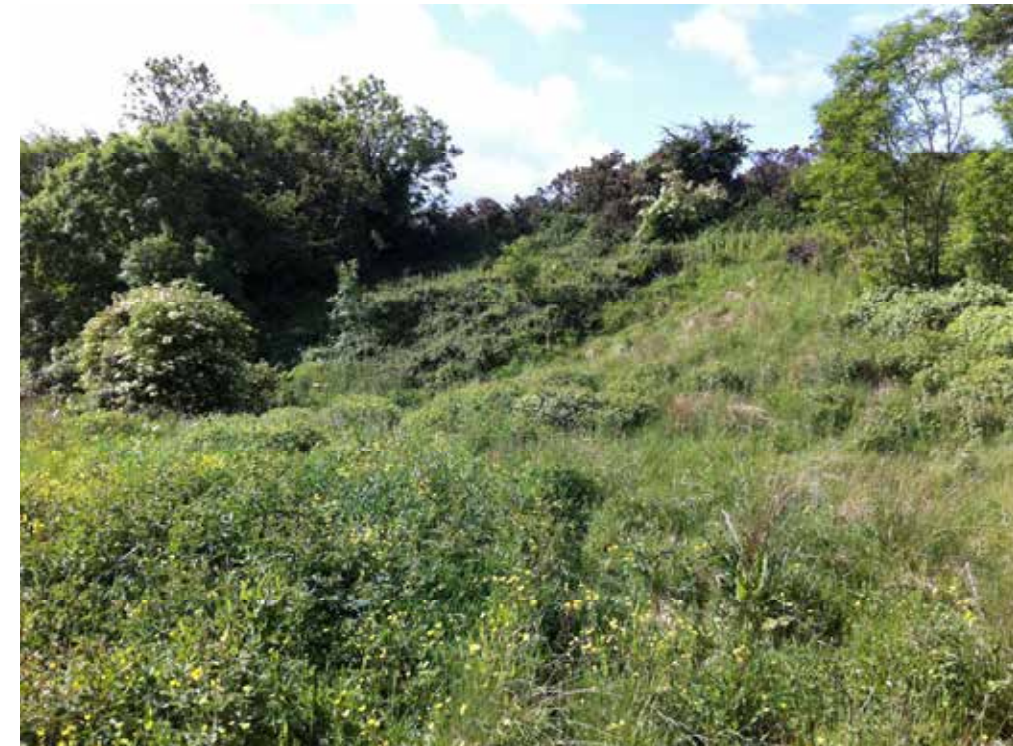
Photograph 4 – Distant view of tuffa spring (heavily overgrown area to the left of trees) located along southwest bank of valley at location 5 (refer to Figure 3).

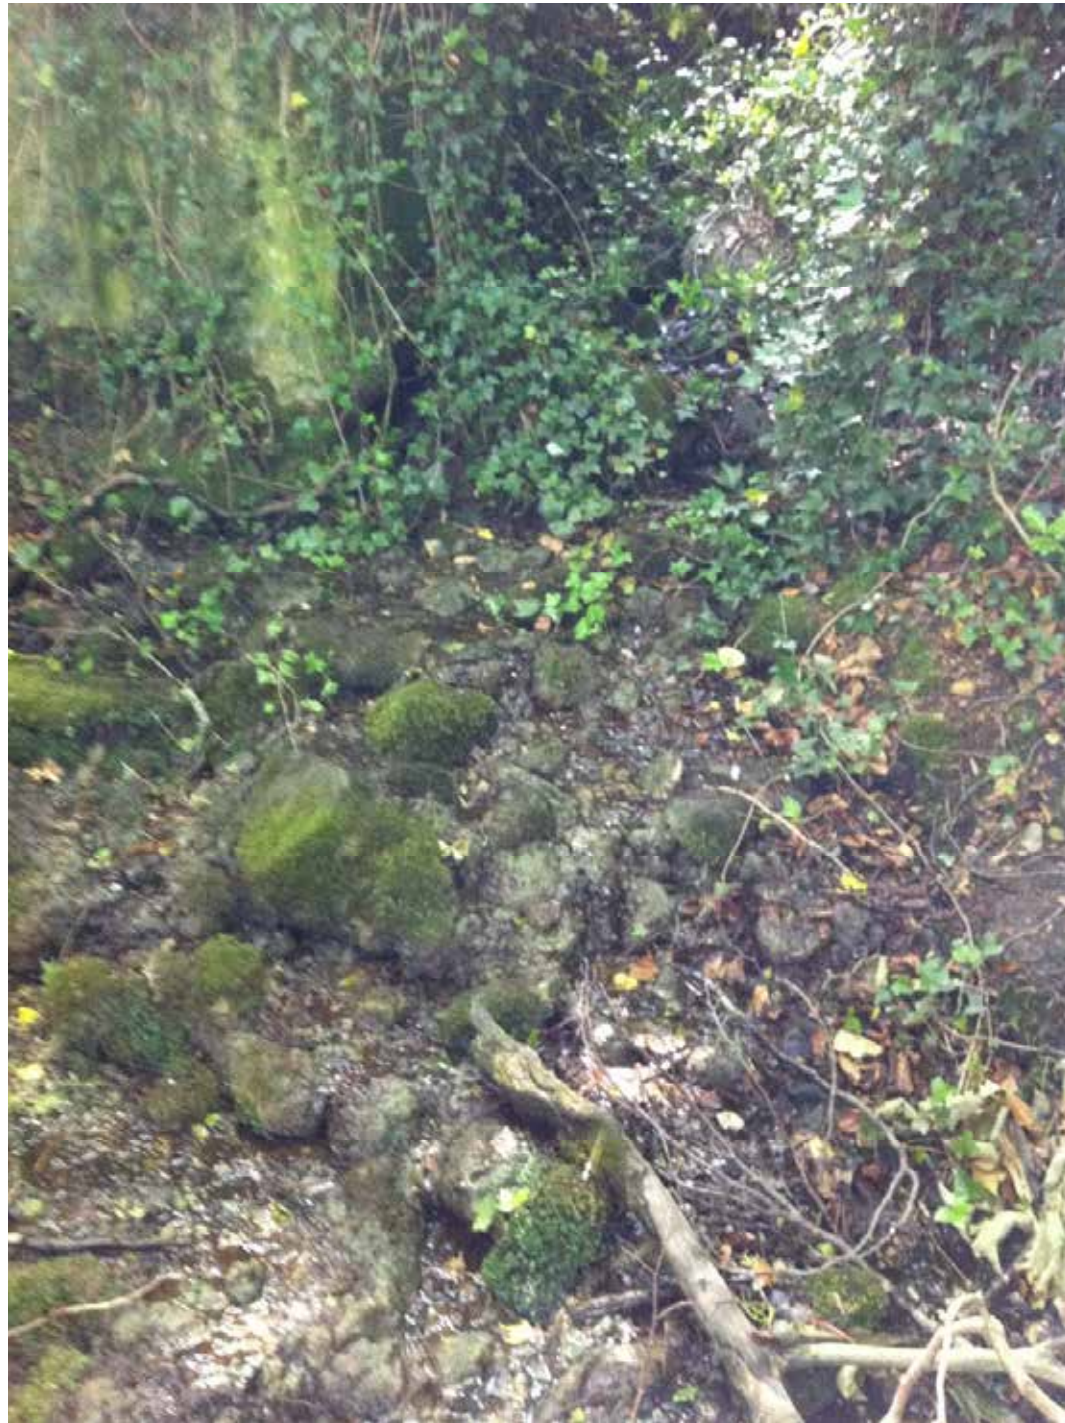
Photograph 5 –Tuffa formation along drainage stream from spring emergence at location 11. Concrete water holding tank visible at top left corner of image.

Lower quality tuffa spring formations were located along small drainage channels (with the associated plant communities less dominant). An example occurs at spring seepage to the south of Brennanstown Road on the southern slope of the river valley (location 11 on **Figure 3**) and illustrated in Photograph 5 (**Appendix A**). A rare species of mollusc was also identified by Scott Cawley at location 11.

The more immature tuffa formations identified around the site are insufficiently developed at this time to be considered an issue of high hydrogeological protection, with the exception of location 11. Location 11 has been identified by Scott Cawley as an ecologically sensitive area within the SDZ and as such the hydrogeological impacts of the SDZ development on this site will also be important to consider.

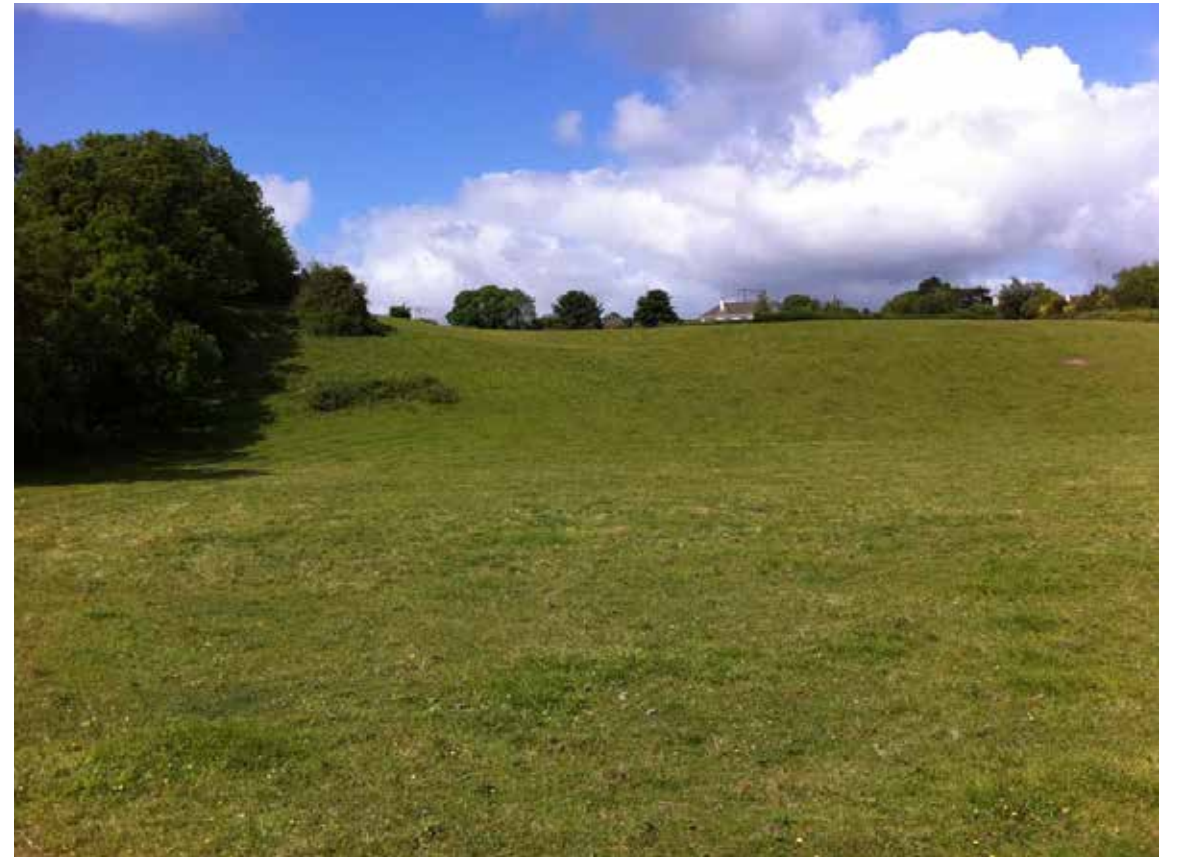
Photograph 6 – Dry well drained land without spring or tuffa emergence along western bank of River valley, refer to location 6 on Figure 3.

The absence of extensive tuffa spring formations along the southwest side of the river valley indicates that the groundwater flow systems supporting these formations are relatively limited in aerial extent. Photograph 6 (Appendix A) illustrates the nature of a well drained slope without any spring emergence 100m to the northwest of the large tuffa springs observed at location 5.
