1 Introduction

This interim note summarises the updated assessment of a catchment study to spatially assess areas that may be important in supporting a sensitive groundwater fed tufa spring bounding the Cherrywood Strategic Development Zone. An initial catchment study was presented in 2018 on behalf of the County Council. This update is based on additional intrusive site investigations carried out by developers and by JBA in the catchment.

NOTE TO FILE

2018s1302
Dún Laoghaire - Rathdown
County Council
May 2019
Alex Jones BSc MSc CGeol
Tufa Catchment Study

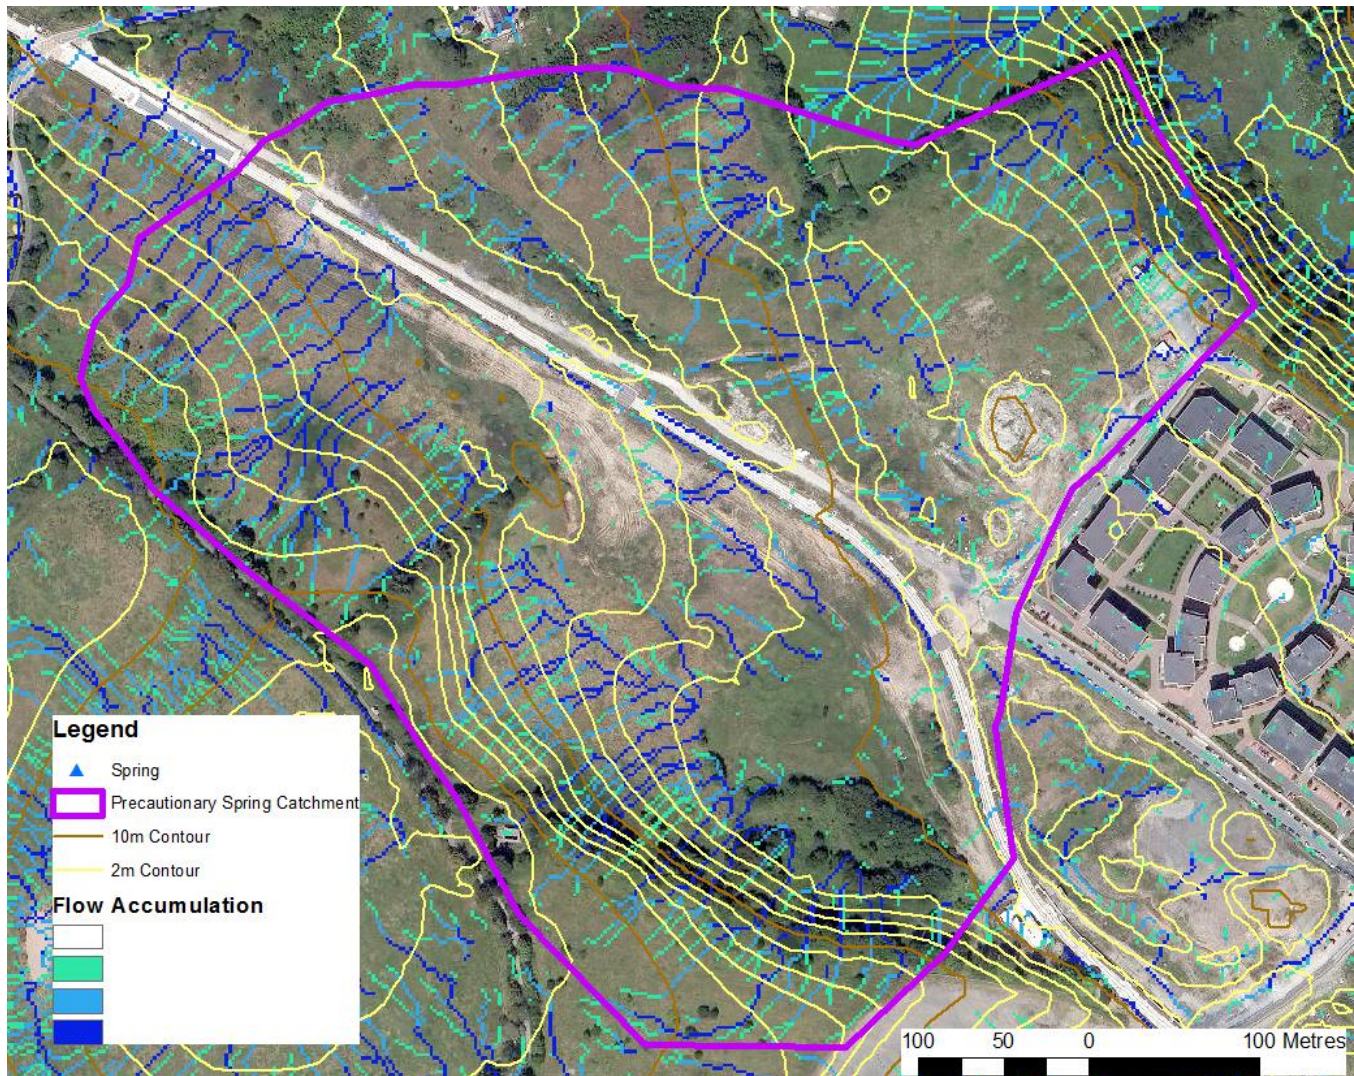
Figure 5-1: Precautionary Catchment Area

A Precautionary Catchment Area is shown in Figure 5-1. It is likely to be slightly larger than the true spring groundwater catchment and its extent has been defined based on the following:

- ArcGIS flow accumulation analysis to identify watersheds and main overland flow paths.
- Recharge calculations (in SBEC 2016), which suggest the catchment should be circa 28ha to account for the flow at the spring.
- The catchment excludes the existing development immediately to the south, which appears not to have affected the spring.

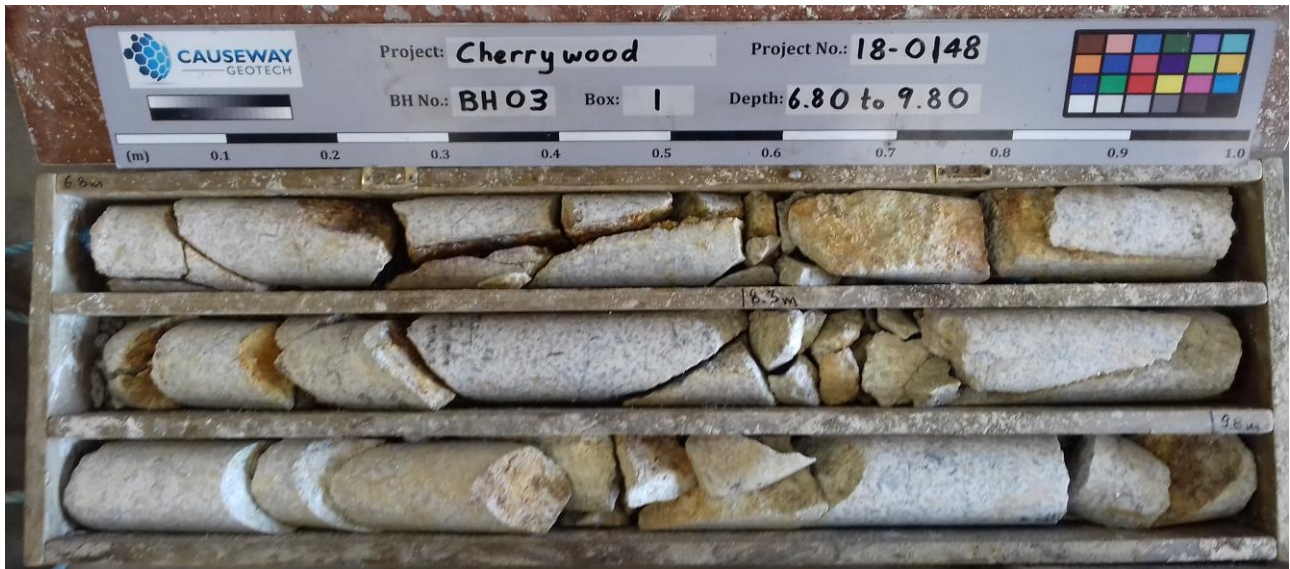
BH03 Box 1 6.80 – 9.80m

5.50	3.00	22-03-2019		(5.30)				
		5.50	3.00	25-03-2019						
7.80	100 71 56				47.94	6.80		Medium strong white phaneritic GRANITE. Partially to moderately weathered. Discontinuities: 1. 60 degree fracture closely spaced (45/85/350) planar, rough, open, orange staining present on surface. 2. 80 - 90 degree joint, probably medium spaced, planar, rough, open, orange staining present on most surfaces.

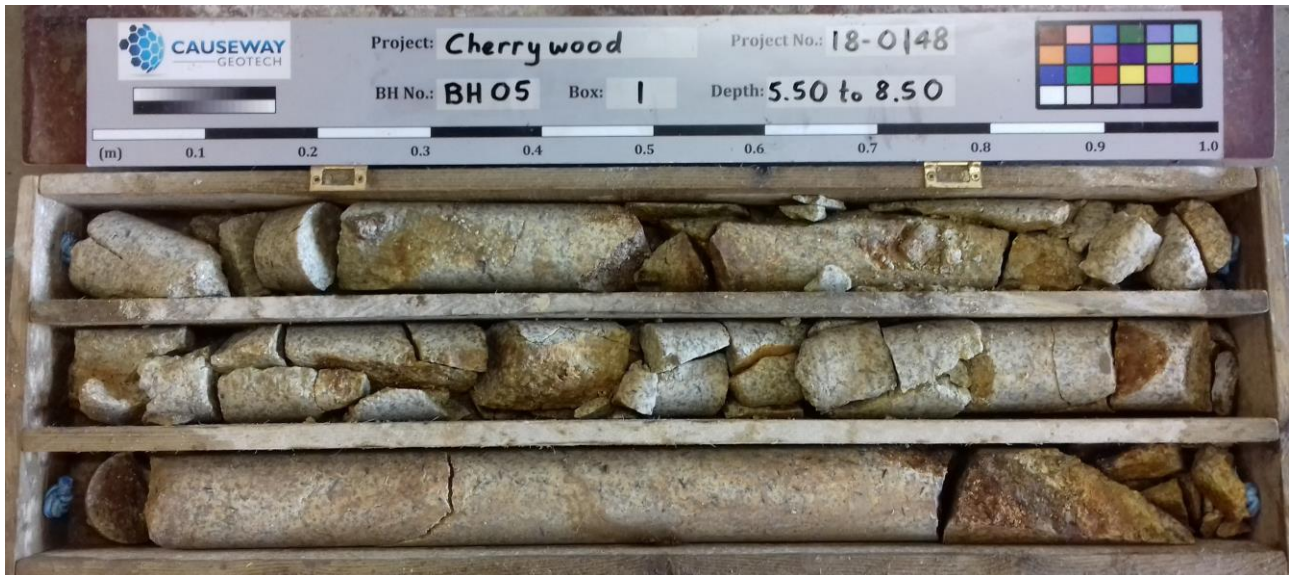
BH05 Box 1 5.5 – 8.50m

6.50	100	57	53		45.41	5.50	[Pattern]	Medium strong white phaneritic GRANITE. Partially to moderately weathered. Discontinuities: 1. 0 to 30 degree, horizontal to sub-horizontal fractures, medium spaced (60/300/680) undulating, rough, open (2-3mm) with an orange/brown staining present on surfaces. 6.00m to 7.40m: 80 degree sub-vertical joint, undulating, rough, open with an orange staining penetrating up to 25mm.
