Dun Laoghaire Harbour

Inventory of Structures, Buildings and Elements

Prepared By: Shaffrey Associates Architects for Dun Laoghaire Harbour Company

July 2007

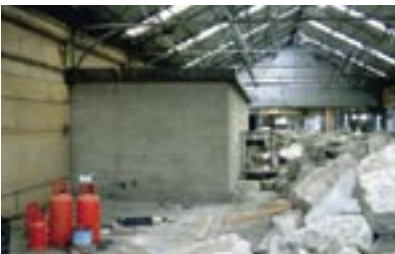
Interior of warehouse, Carlisle Pier.

Condition: The 1969 ferry terminal structure is in poor condition, not having been maintained since the opening of the new ferry terminal. The cast-iron columns of the warehouse structure are generally in good condition but require stripping, priming and repainting. The roof structure appears to be corroded in places but this appears to be only superficial. Several openings have been knocked through the concrete block section. The glazing of the clerestory windows has also been broken. The asbestos sheeting is failing throughout. The entire structure is pigeon infested.

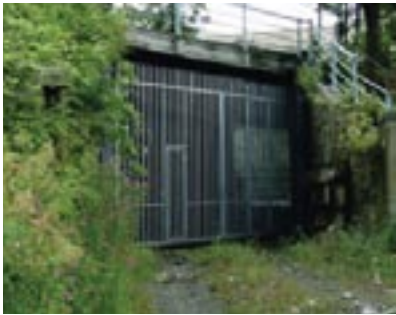
Tunnel entrance near Royal St. George Yacht Club. This area requires maintenance having suffered neglect over the years.

The area surrounding the railway tunnel appears neglected. The original walls and railings are buried beneath overgrown vegetation. The retaining wall facing the National Yacht Club has extensive vegetation growth due to an amount of open joints requiring pointing. The railings are in reasonable condition, though some corrosion has occurred at joints. Staining has occurred beneath the railings, possibly caused by water run. The slipway is generally in good condition. However, the joints have been repointed over the years using cement mortars which is accelerating decay of granite, in particular at the arrises. There is extensive ribbon pointing which has been continued recently with fresh pointing. Concrete repairs have been carried out in several locations.

- ✦ The area surrounding the railway tunnel is dilapidated and requires an overhaul. This should include clearing the vegetation and various debris. The granite wall requires pointing with a suitable lime mortar. The original cast iron railings should be repaired. A more sympathetic solution should be sought to replace the gates to the entrance.
