# Harbour Master's Lodge Dún Laoghaire

A case study on retrofitting historic fabric while preserving architectural heritage

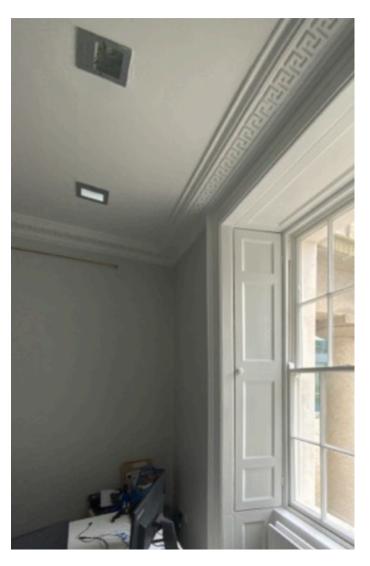
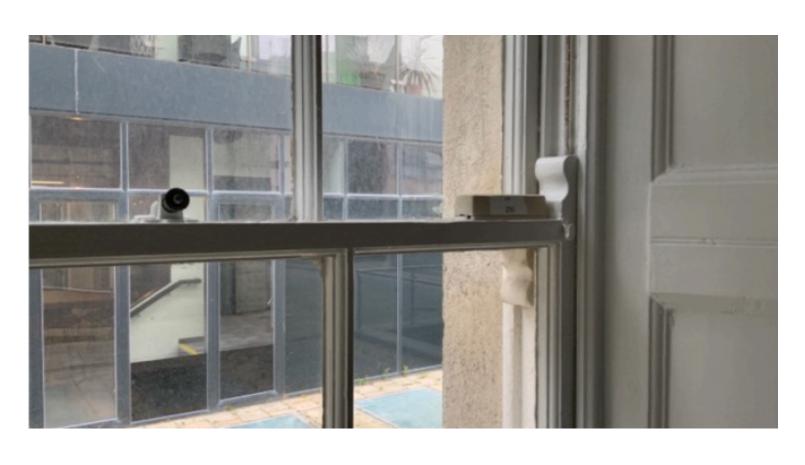
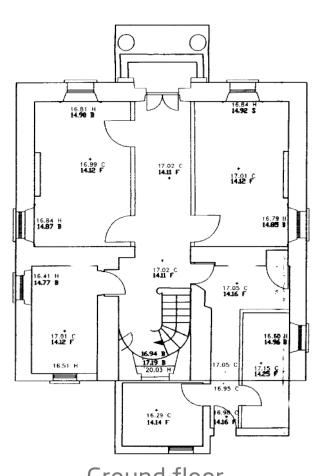
Images of windows pre-retrofit

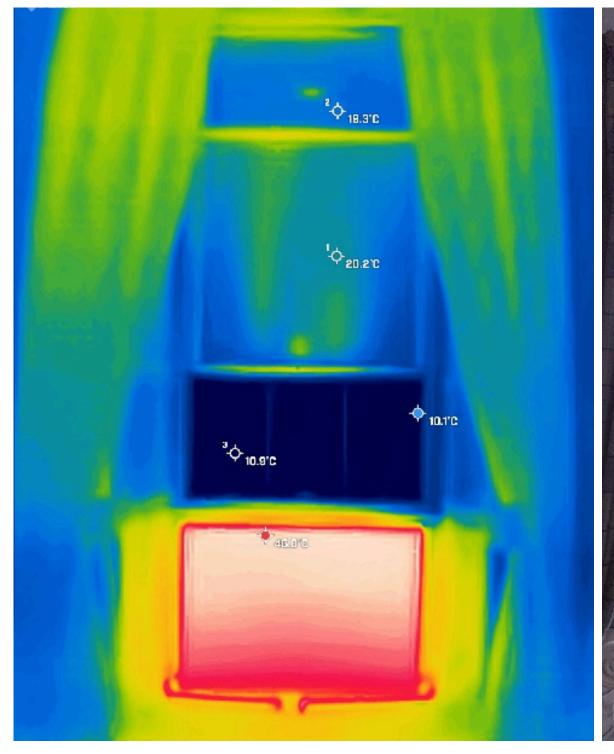
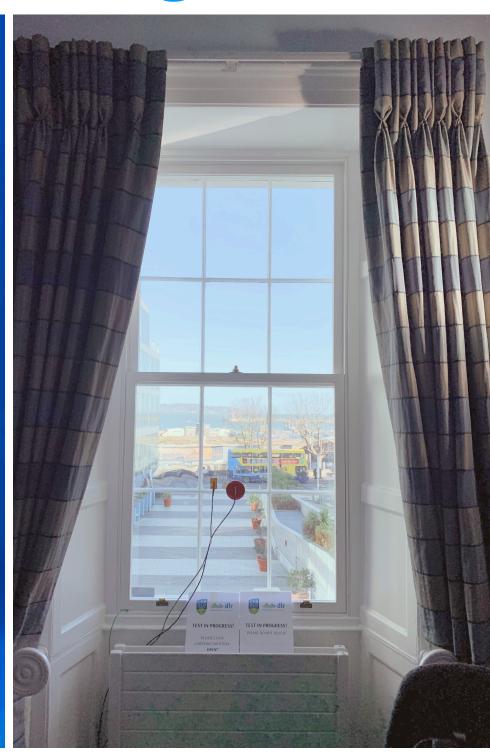
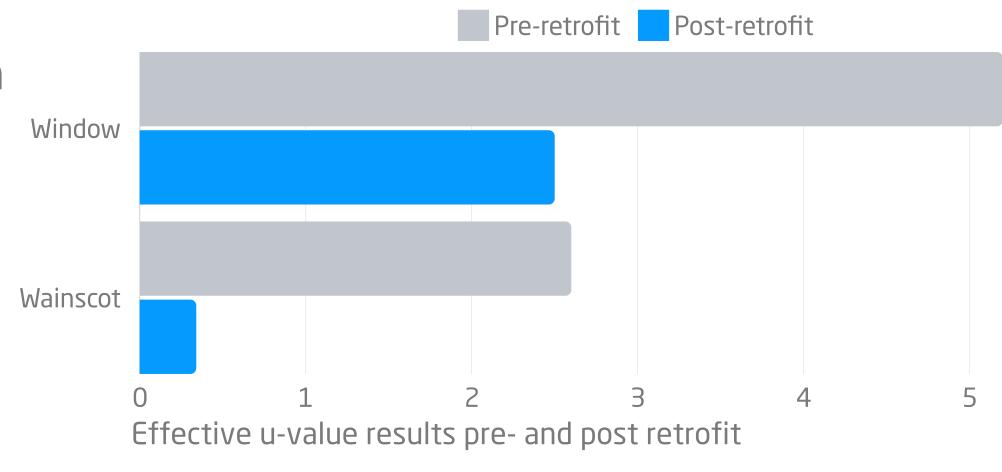
### Post-retrofit monitoring

The results show a ~50% reduction in the effective u-value of windows and 77%-87% reduction in the case of the wainscots.

Upon completion of the retrofit works, which included:

- Window reconstruction
- Secondary glazing
- Insulation behind wainscot
- Insulation behind shutters
