COAST GUARD STATION HARBOUR ROAD DÚN LAOGHAIRE

ARCHITECTURAL HERITAGE SURVEY

22nd July 2025

Historic Building Consultants Old Bawn Old Connaught Bray

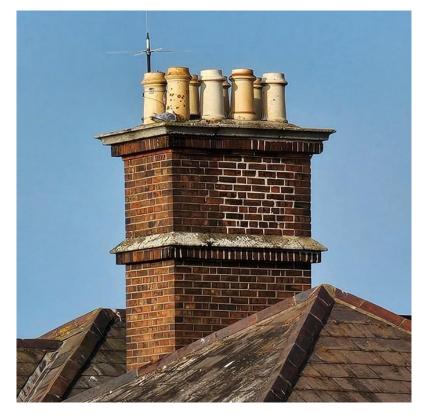
Plate 20: View of chimneystack from the south-east

A single chimneystack rises from the valley between the main roof to the north and the pyramidal roof to the south. This stack is of brick, with a projecting brick course at mid-height, having a weatherproofing course of cut granite fillet. The topmost brick course also projects and the stack has a capping of cut granite. The stack supports eight chimney pots in two lines of four, each being a traditional Dublin buff-coloured ceramic pot.

It was noted on the survey that the chimney stack rising from the roof of the officer's house has eight pots. However, beneath this stack there are two rooms on each of three floors and there is no surviving evidence for the existence of eight hearths. It would be common to add a dummy chimney pot for sake of symmetry if there was an odd number of flues and two rows of pots. However, there would be little point in adding two dummy pots.

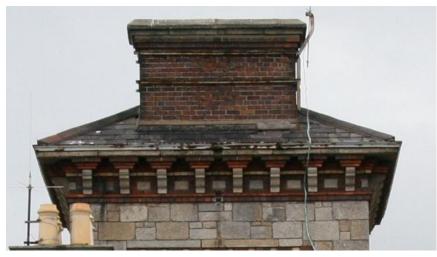
Plate 21: Western elevation of former chimneystack in 2006

A second stack formerly rose from the western side of the roof of the tower. This was a brick stack with brick corbelling at the top and granite capping this stack had six flues in a single line. The stack was removed in about 2015 and the roof reslated.

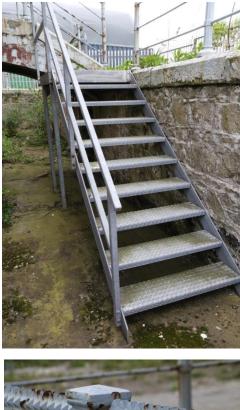
Plate 29 (left): Steel steps to basement area

The basement area is accessed from the land to the front of the house via a flight of steel steps of late date.

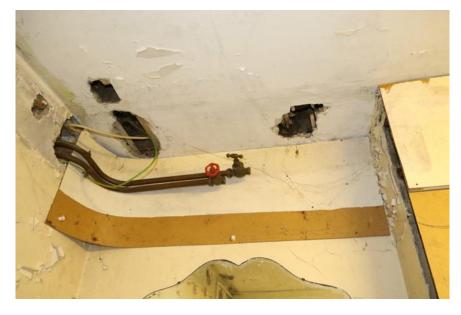
Plate 42: Services and holes in ceiling in room B2

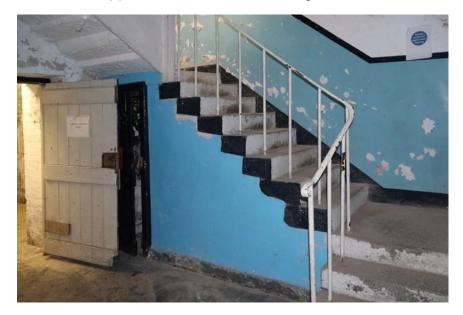
Plate 52: Stairway at basement level

The walls in this area are painted, though the paint is peeling, probably due to use of a non-breathable paint on damp walls. A painted faux-dado divides two colours on the walls.

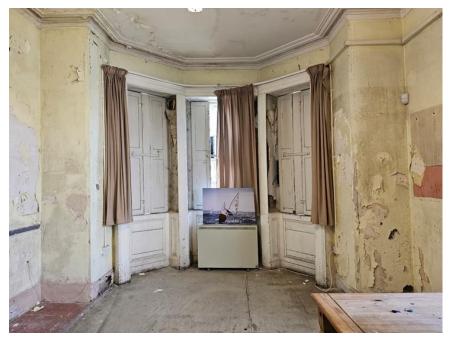
Plate 84: View to west in room G4

Room G4 is in the north-western corner of the ground floor of the officer's house. The room is lit by the canted bay window on the western elevation, with a central six-over-six timber sash flanked by narrower six-over-six sashes, all of which have quadrant horns and segmental heads. A window on the northern wall is also sixover-six with quadrant horns and segmental heads. The windows all have panelled shutters set in moulded-timber architraves and with panelled boards beneath. The ceiling is flat and has a run cornice. The walls are plastered and painted with peeling paint. The moulded-timber skirting has been replaced in part with plaster.

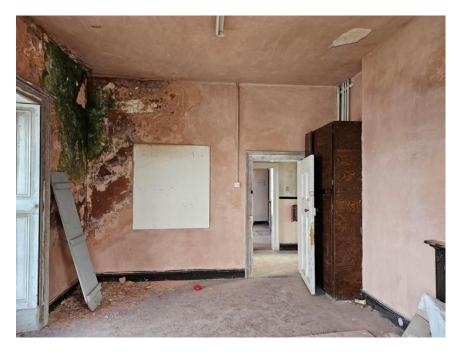
Plate 106: View to east in room F3

The walls and ceiling in room F3 are plastered with pink gypsum plaster, unpainted. There are significant areas of damp and mould in the south-western and north-eastern corners. The room is entered via a four-panelled door set in a moulded-timber architrave. The door has the longer panels in the lower section and shorter panels above. There is a moulded-timber skirting. The floor has a covering of vinyl or similar material. A shallow chimneybreast in the southern wall has a small cast-iron chimneypiece.

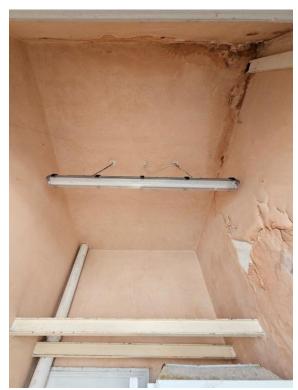
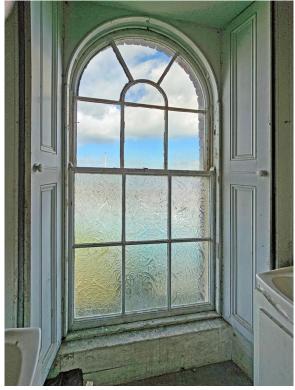
Plate 112: Ceiling in room F4

The walls and ceiling in room F4 have a covering of pink gypsum plaster that is boasting in places. There is no cornice.

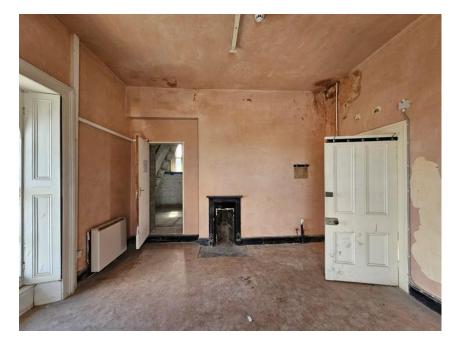
Plate 116: View to south in room F5

Room F5 is accessed via a four-panelled door set in a moulded-timber architrave. The floor has a covering of vinyl or similar material. The walls and ceiling have a skim of pink gypsum plaster and no cornice. There are areas of damp near the southern end of the ceiling. Near the eastern end of the southern wall is a recessed area of the wall in which is a doorway leading to the first floor of the tower, the floor level in the tower being a step up from room F5. The door to the tower is a modern hollow door and the opening is of late date, as described below in the description of the tower.

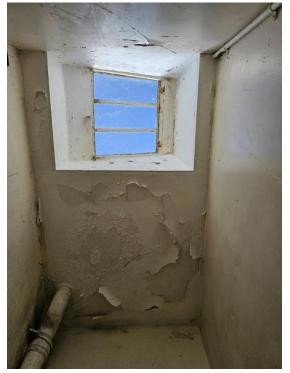
Plate 123: Ceiling in room

The walls and ceiling are plastered and painted with the paint peeling in places.

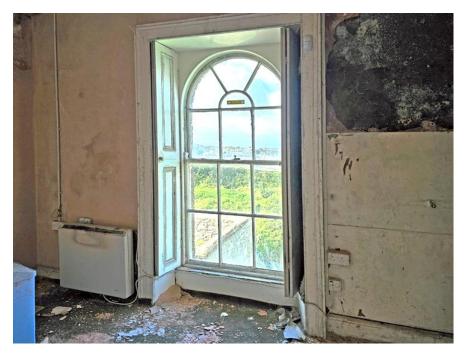
Plate 127: Western wall of room F8

The walls and ceiling are skimmed with pink gypsum plaster and there is no cornice. There is significant damp in the north-western corner and the southern wall.

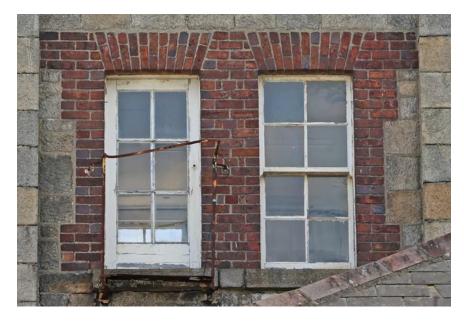
Plate 135: Second-floor windows on northern side of tower

As noted above, one window on the second floor of the tower, on the northern side, is a timber casement, while the other window is a four-over-four sash similar to the others on that floor. The casement gave access to a small iron balconette that is now in poor condition. This consisted of an iron plate laid horizontally as the floor of the balconette and supported on two cantilevered iron brackets, of which only one now survives. Two wrought iron bars rising vertically from the outer corners of the iron plate support a horizontal wrought iron bar as a protective railing, now badly bent.

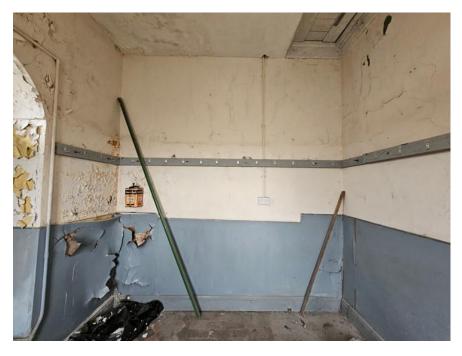
Plate 146: Western wall of ground floor room

The western wall of the ground-floor room is plain, except for a timber rail fixed to the northern, western and part of the eastern walls on which are fixed aluminium alloy hooks of relatively late date. The walls are painted, the lower part in a different colour, and the paint is peeling in a number of places.

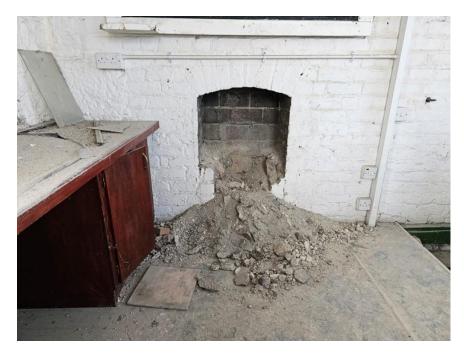
Plate 165: Hearth on second floor of tower

To left of centre of the western wall is a small hearth with a segmental brick arch and no chimneypiece. The lower part of the hearth opening is narrowed by brick and the fireback is of brick. A large pile of mortar and brick fragments emanating from the hearth opening is likely to result from the removal of the brick stack from the roof above.

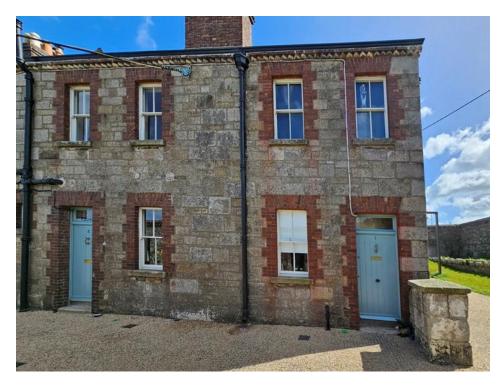
Plate 173: Western side of houses 1 and 2 at southern end of terrace

The western side of the terrace is faced with granite rubble brought to courses. For the most part the granite is squared, though there is a small number of unshaped stones. The houses are two-bay and two-storey, having a door and a window on the ground floor and two windows above. Houses 3 to 8 have small high-level windows adjacent to the front door. The window and door openings have brick surrounds, with granite sills and a granite step at the doorway.

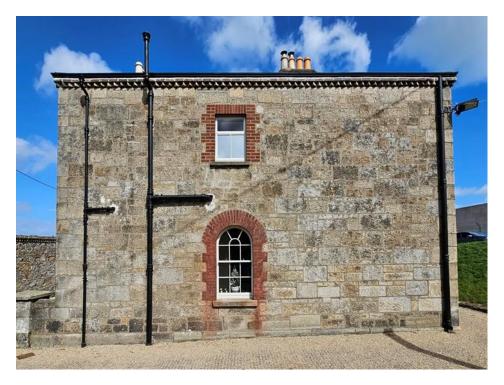
Plate 181: Southern side of house number 1

The eastern and southern façades of house numbers 1 and 2 are faced with squared hammer-dressed granite of random size, brought to courses and with hammer-dressed granite quoins all above a plinth course of granite ashlar. The southern elevation of house 1 has a narrow soil stack, a more substantial soil stack and a downpipe leading from ogee guttering, all of which is of cast iron.

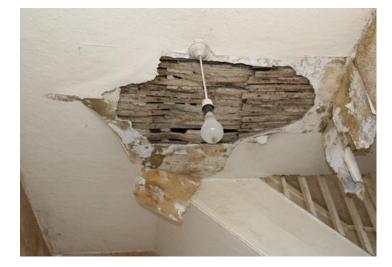
Plate 197: Ceiling in the entrance hall of house 3

The ceiling in the entrance hall is of lath and plaster, part of which has collapsed.

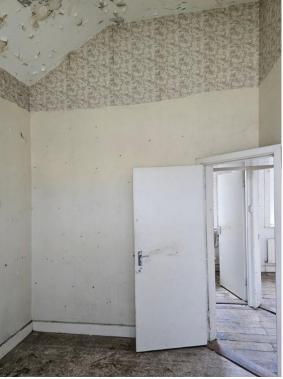
Plate 229: Ceiling in room F4

The ceiling in room F4 has a flat section in the north-western part, while the remainder of the ceiling slopes towards the east and the south. The ceiling is painted and the paint is peeling.

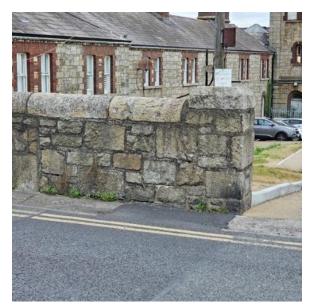
Plate 242 (above): Eastern gate pier

The eastern gate pier has been rebuilt, while the western pier appears to be original. The gate is modern and is a steel truss with a box-section rectangular frame and slender webs.

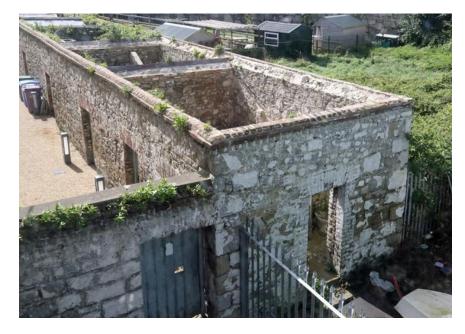
Plate 251: View of southernmost yards from above

The photographs above and below show the yards as seen from the adjacent buildings. The photograph below shows the dividing walls between the shed and the privy in the two yards to left of centre where the roof is missing, while the roof in the centre is largely intact and is slated. The tops of the walls have a course of brick near the outer edge, while the rest of the wall tops are capped with small stones set on a slope and mortared.

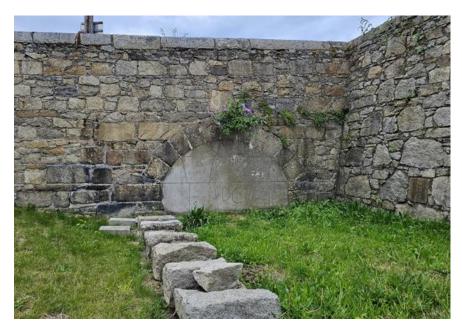
Plate 263: Arch of bridge beneath access ramp

At the eastern end of this raised platform is an arch in the wall to the side of the ramp that gives access to the Coast Guard Station. This arch is semicircular and the arch ring consists of cut granite voussoirs. The arch is open at the eastern side of the ramp, but the archway is largely backfilled.
