Dun Laoghaire Harbour

Inventory of Structures, Buildings and Elements

Prepared By: Shaffrey Associates Architects for Dun Laoghaire Harbour Company

July 2007

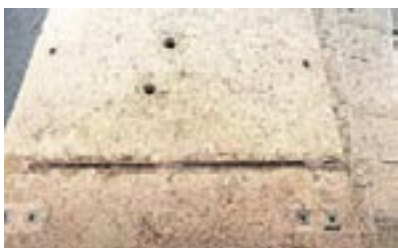
Borehole to granite pier edging.

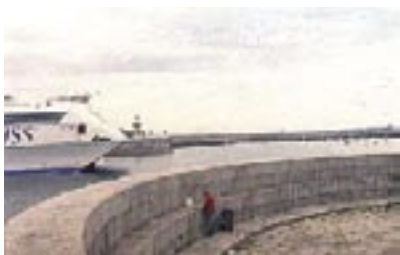
Curved wall of pier end.

There is serious erosion on the seaward side of the granite wall to the rounded pier end. Rough seas have undermined the concrete slabs that make up the sloping breakwater. Elsewhere the stone work is generally in fair condition. Erosion is mostly apparent on the top/coping stones and prevalent at stone arrises at joints, in particular where cement pointing repairs have been carried out. There is some graffiti evident on some stones. Remedial repairs have been carried out in inappropriate cement based ribbon pointing. Ferric oxides are visible on faces of stone blocks, possibly from embedded iron and/or the matrix composition of the stone. The joints of the ground surface granite paving are generally open with some cement infill in areas. Vegetation is evident in sheltered areas, but not excessive. Sections of the ground surface have been overlaid crudely with concrete and the junction between concrete and the granite coping stones of the inner wall edge are notably ragged. The stone work at the pier end is of particularly fine quality design and craftsmanship. The iron handrail serving the steps to water level has corroded badly and there is further corrosion of services conduits.

- ✦ Stone: replace concrete repairs/replacements with matching stone above water level; remove graffiti; remove corroded iron fixings where these are causing decay of the stone and replace with non-corrosive material, e.g. stainless steel; monitor and treat organic growth with approved biocide as necessary, taking care not to destroy any significant plant and or wildlife species.
- ✦ Pointing: retain any original sound mortars. Rake out replacement cement mortars and repoint using hydraulic lime mortars based on analysis of historic mortars. Point all open joints following similar approach.

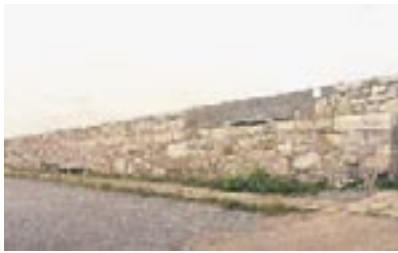
View of two levels of 5th kant – note concrete to upper wall section.

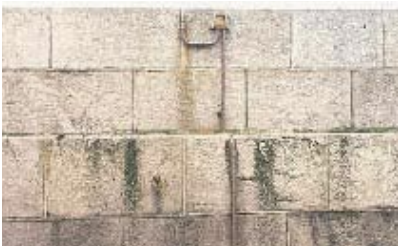
Fine stonework with inappropriate strap pointing.

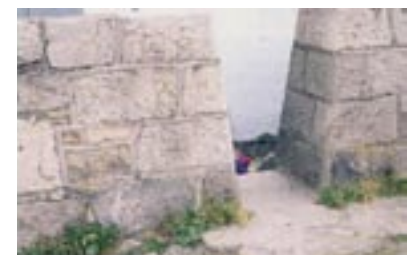
Break in upper wall giving access to rear breakwater. Note inappropriate cement strap pointing.

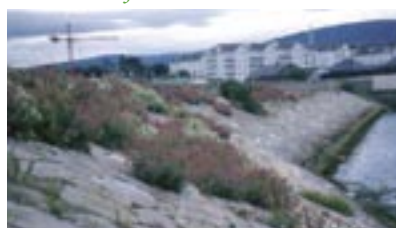
Overgrown breakwater to rear of 3rd and 2nd kants.

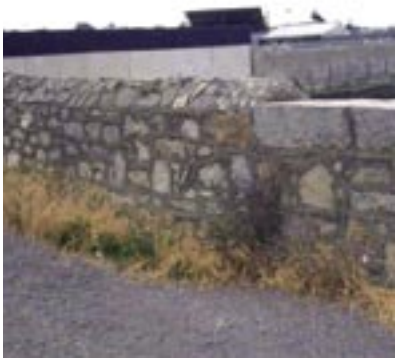
Detail, junction of upper walls, 2nd kant.
Note poor concrete strap pointing.

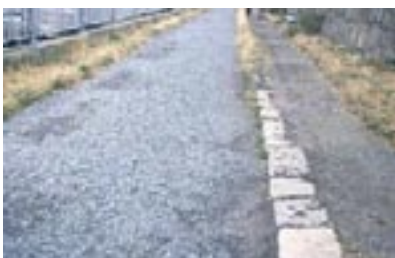
Lower walkway. Any improvements should include the retention of the granite edging to inner pathway.

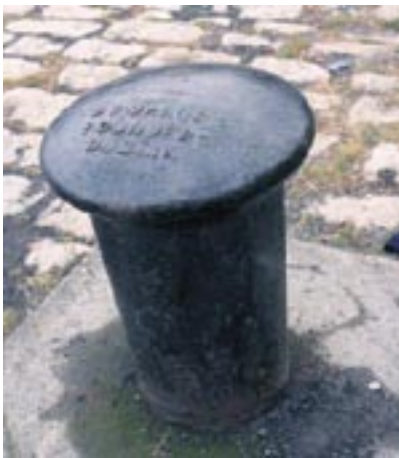
Cast iron bollard, 1st kant.

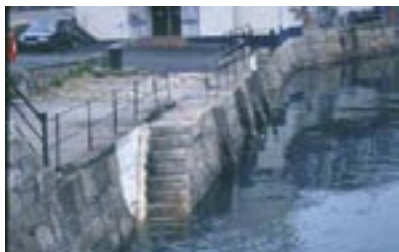
Fine masonry to 1st kant.

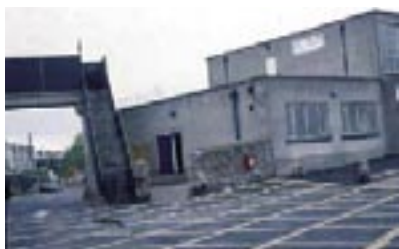
Footbridge and Marine Activity Centre.

- ♦ Simplify signage and rationalise signs where possible.
- ♦ Railway footbridge is crude and should be upgraded/replaced.

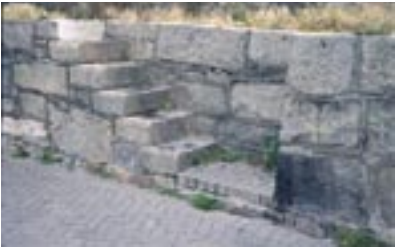
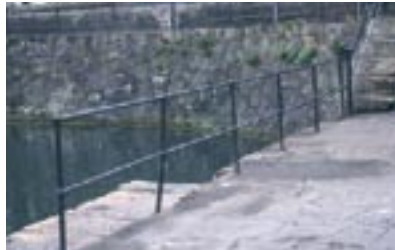
Fine masonry steps contrasting with inconsistent and unsympathetic tarmac and concrete pavier surfaces.

Simple cast iron railings in keeping with the harbour area. Poor concrete ground surface.

Front site to small single storey building, 2nd kant. Public information signs such as the bird watching sign shown are to be encouraged. Shop use brings litter problems which require greater maintenance.

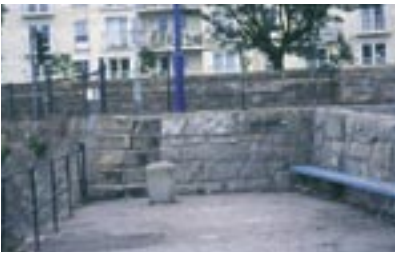
Pleasant seating area, 1st kant, could be improved by resurfacing, removal of graffiti and maintenance of seating.

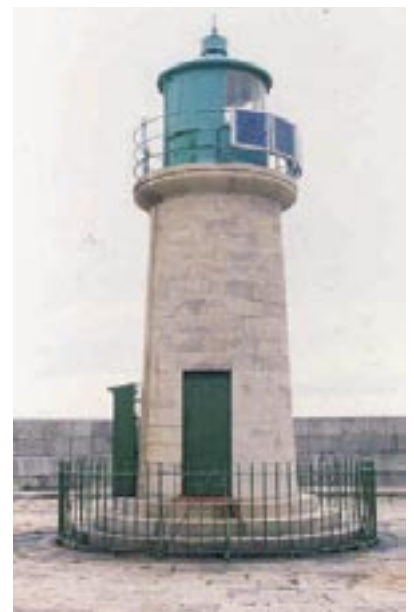
Red Flash Lighthouse.

Some crude ribbon pointing has been carried out to fine joints using cement mortar. This may suggest water ingress problems. A metal section embedded in 1 no. granite base step is rusting, causing cracking in one of the major stones of the door threshold. Cables have been repositioned in the past and redundant drill holes in external stone blocks have been crudely filled with cement mortar. Base railings have recently been repainted.

Signs of rust at fixing points to base plinth. Bitumen coating evident around base of steps to lighthouse. There is significant rust on granite blocks beneath railings.

- Rake out cement pointing and repoint using lime based mortars derived from analysis of historic mortars.
- Remove any corroding iron cabling and fixings, etc., and replace with non-corrosive metals. Ensure all cast or wrought iron railings are adequately coated with protective primers before painting.
- If possible run service cables internally to reduce negative visual impact.

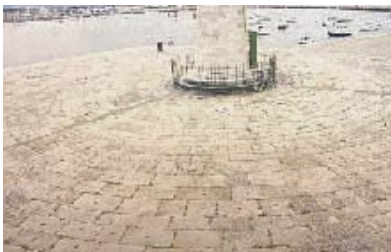
Fine radial granite paving surrounding lighthouse.

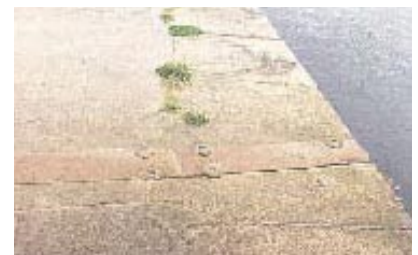
Service duct.

Services: Ground surface duct runs from structure and terminates at inner face of lower wall. Duct discharges into hopper head to 225mm-diameter pipe fixed to wall face. Pipe is in a serious state of decay with extensive rusting. Degraded white paint from pipe surface has stained wall face. Hopper contains organic growth.

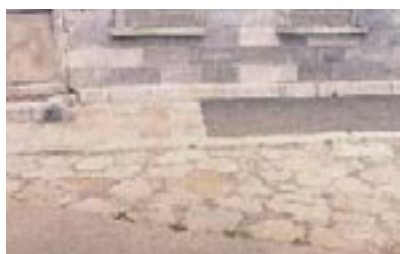
Detail of patchy ground surface in front of structure.

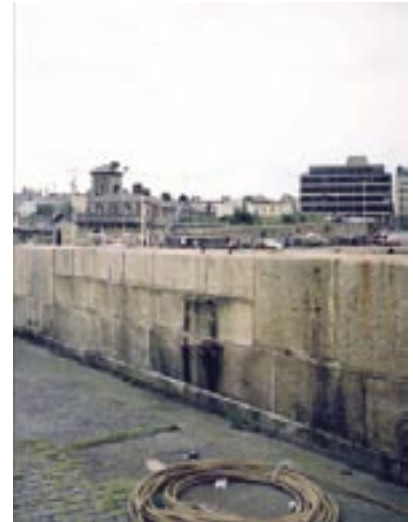
Inner pier wall, Trader's Wharf.

The stone work is generally in good condition. Erosion is mostly apparent on the top/coping stones and prevalent at stone arrises at joints, in particular where cement pointing repairs have been carried out. Ferric oxides are visible on the faces of many of the granite blocks, possibly from embedded iron and/or the matrix composition of the stone. Vegetation is evident particularly on the north side of the pier. The cast iron mooring posts, railings and other fittings are badly corroded and this is damaging the stone work.

- **Stone:** replace concrete repairs/replacements with matching stone above water level. Remove corroded iron fixings where they are causing stone decay and replace with noncorrosive material, e.g. stainless steel. Monitor and treat organic growth with approved biocide as necessary, taking care not to destroy any significant plant species.
- **Pointing:** retain any original sound mortars. Rake out replacement mortars and repoint using hydraulic lime mortars based on the analysis of historic mortars. Point any open joints using same approach. Refer to more detailed specification regarding mortar mixes and application methods in Maintenance Schedule.
- **Ironwork:** Ensure that all iron and metalwork is adequately coated with protective primers before painting.

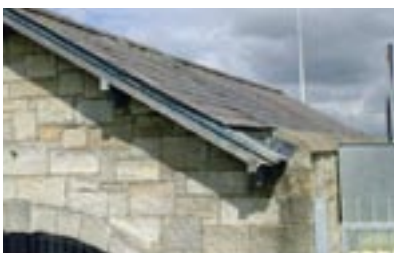
Boathouse, roof detail.

- This boathouse is a significant structure within the harbour area and as such merits restoration work in order to fulfil its potential. A similar project was carried out on the R.N.L.I boathouse at the East Pier.
- **Pointing:** retain any original sound mortars. Rake out replacement mortars and repoint using hydraulic lime mortars based on the analysis of historic mortars. Point any open joints using same approach.
- Repair roof using matching natural slate.

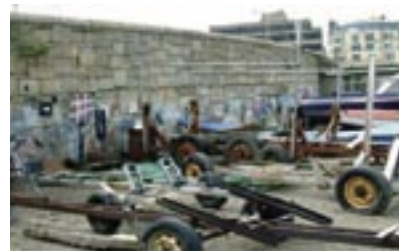
The stone work is generally in good condition. However there is extensive graffiti, in particular on the curved granite wall. Erosion is mostly apparent on the top/coping stones and prevalent at stone arrises at joints, in particular where cement pointing repairs have been carried out. Ferric oxides are visible on the faces of many of the granite blocks, possibly from embedded iron and/or the matrix composition of the stone. Vegetation is evident in some of the joints that require repointing. The cast iron mooring rings and other metal fittings are badly corroded and this is damaging the stone work.

Fine stonework wall, with extensive graffiti.

- A masterplan for the Boatyard is required which would address the orderly use of the boatyard for storage and marine related activities and would acknowledge immediate and future requirements taking into account available resources. Access, security and Health and Safety issues would also required to be addressed.
- **Stone:** replace concrete repairs/replacements with matching stone above water level. Remove corroded iron fixings where they are causing stone decay and replace with noncorrosive material, e.g. stainless steel. Monitor and treat organic growth with approved biocide as necessary, taking care not to destroy any significant plant species. Remove graffiti.

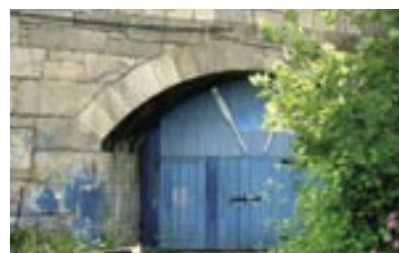
Archway to Rowing Club.

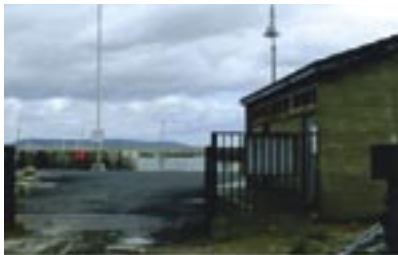
First structure abutting wall.

- Remove or upgrade structure—address within masterplan for boatyard.

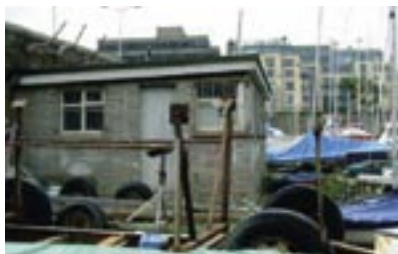
Second structure abutting wall.

- Remove or upgrade structure - address within masterplan for boatyard.

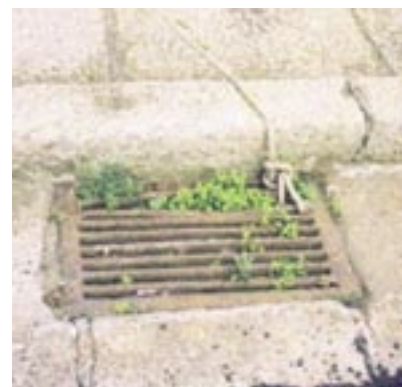
Boatyard, start of slipway, note fine granite paving.

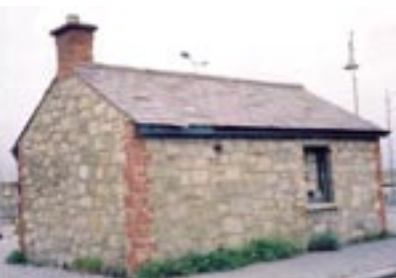
General view of Rocket House, note vegetation growth to base.

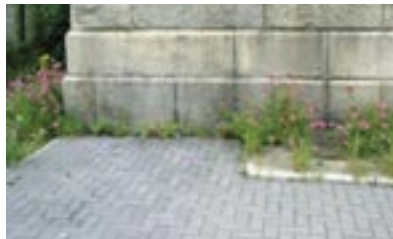
Detail, F.C.A. building, fine granite masonry. Note extensive vegetation growth.

- ♦ **Pointing:** retain any original sound mortars. Rake out replacement mortars and repoint using hydraulic lime mortars based on the analysis of historic mortars. Point any open joints using same approach.
- ♦ **Ironwork:** Ensure that all iron and metalwork is adequately coated with protective primers before painting.
- ♦ Remove overgrown vegetation to outbuildings.

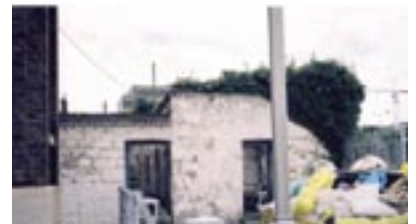
Site: Terrace of outbuildings to west of houses, with random rubble walls and brick dressings. Granite quoins to corners. A yard and shed, for each unit, are contained within the outbuilding structure. These structures are generally in poor condition. To the east of the houses is communal land, which is part grass and part hard surface. A fine granite boundary wall with curved granite capping encloses the site to the east and south. A crude boundary fence separates the site from that of the Irish Lights. Access to the houses is via a ramped road to the south, with granite steps and a brick and granite parapet wall with granite copings up to the higher level.

Coastguard cottages, outbuildings.

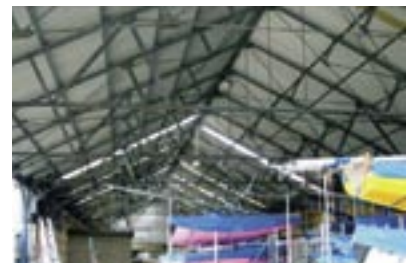
Early warehouse structure.

Condition: The 1969 ferry terminal structure is in poor condition, not having been maintained since the opening of the new ferry terminal. The cast-iron columns of the warehouse structure are generally in good condition but require stripping, priming and repainting. The roof structure appears to be corroded in places but this appears to be only superficial. Several openings have been knocked through the concrete block section. The glazing of the clerestory windows has also been broken. The asbestos sheeting is failing throughout. The entire structure is pigeon infested.

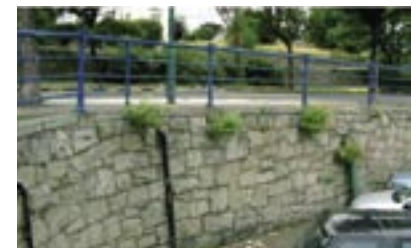
Fine snecked stonework to retaining wall. Note peeling railings and extensive vegetation.

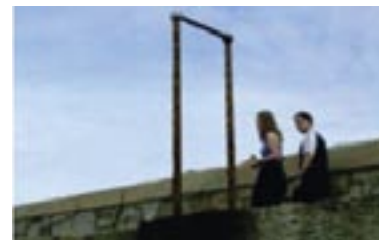
The stonework is generally in good condition. Joints have been repointed over the years using cement mortars and this is accelerating the decay of the granite, in particular at the arrises. The iron railings on this section of the pier are very rusted. Ferric oxides are visible on the faces of stone blocks, possibly from embedded iron and/or the matrix composition of the stone. The joints of the granite edging to the lower level are generally open with some cement infill in areas.

Corroded iron railing to steps, 3rd kant.

- ♦ **Stone:** replace concrete repairs/replacements with matching stone above water level. Remove corroded iron fixings where they are causing decay of the stone and replace with non-corrosive material, e.g. stainless steel. Monitor and treat organic growth with an approved biocide as necessary, taking care not to destroy any significant plant species.
- ♦ **Pointing:** retain any original sound mortars. Rake out replacement cement mortars and repoint using hydraulic lime mortars based on analysis of historic mortars. Point all open joints following a similar approach. Refer to more detailed specification regarding mortar mixes and application methods in Maintenance Schedule.
- ♦ **Ironwork:** Ensure that all iron and metalwork is adequately coated with protective primers before painting.

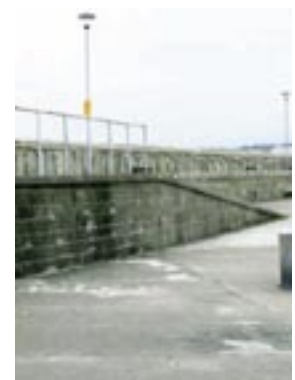
Ramp between levels at corner of 3rd and 4th kants. Note inappropriate concrete facing.

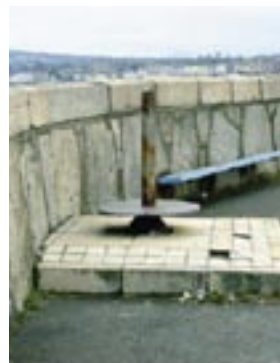
Platform with base of telescope, now redundant. Removal is recommended.

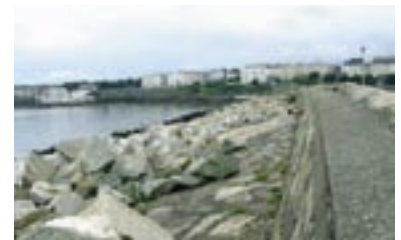
Exposed rock armour to breakwater of 4th kant. Note extensive use of concrete and vegetation growth to open joints.

- ♦ **Stone:** replace concrete repairs/replacements with matching stone above water level. Remove corroded iron fixings where they are causing decay of the stone and replace with non corrosive material, e.g. stainless steel. Monitor and treat organic growth with an approved biocide as necessary, taking care not to destroy any significant plant species.
- ♦ **Pointing:** retain any original sound mortars. Rake out replacement cement mortars and repoint using hydraulic lime mortars based on analysis of historic mortars. Point all open joints following a similar approach. Refer to more detailed specification regarding mortar mixes and application methods in Maintenance Schedule.
- ♦ **Ironwork:** Ensure that all iron and metalwork is adequately coated with protective primers before painting.
- ♦ **Ground surface:** a coherent ground surface plan is required.

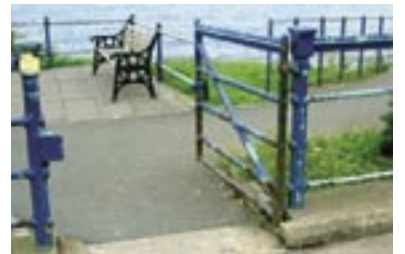
Entrance to East Pier Gardens from road. The railings clearly require maintenance.

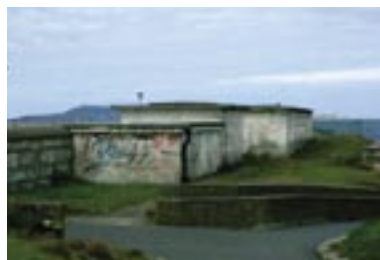
Dilapidated public toilets abutting upper pier wall.

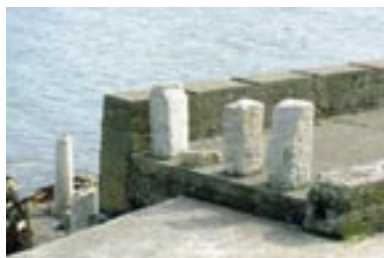
Granite bollards imbedded in concrete adjoining shelter pavilion.

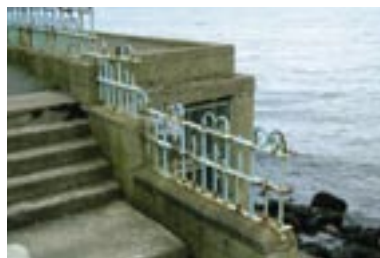
Wrought iron railings to parapet of shelter in need of maintenance. Modest details such as this are an important element of the history of the harbour and its surroundings.

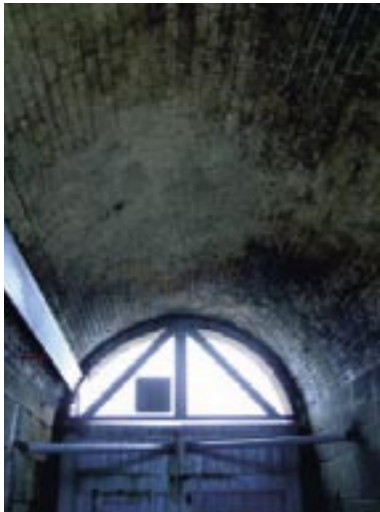
Condition: The walls, while in good condition, require repointing. Brick to vault requires urgent repointing.

Vaulted brick ceiling to entrance passage.

- Run services underground.
- Repoint brick to vault using an appropriate lime mortar.
- In cases where brick has disintegrated past the point of repair, the individual brick should be removed with care and replaced.
- **Pointing:** retain any original sound mortars. Rake out replacement cement mortars and repoint using hydraulic lime mortars based on analysis of historic mortars Point all open joints following similar approach. Refer to more detailed specification regarding mortar mixes and application methods in Maintenance Schedule.

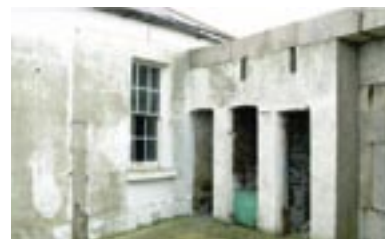
Former W.C.s.

Condition: Poor condition. Brick has corroded due to water penetration and mortar loss. Pipes feeding from structures into the harbour are rusted, causing staining to stone.

- Brick repair and consolidation.
- Treat lime leaching and repaint.

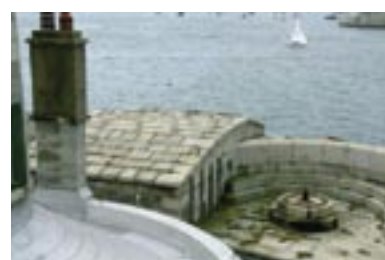
View of Artillery Store and gun position. Note extensive vegetation growth to joints.

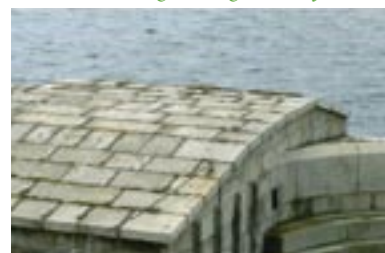
Detail, granite roof to Artillery Store in need of pointing.

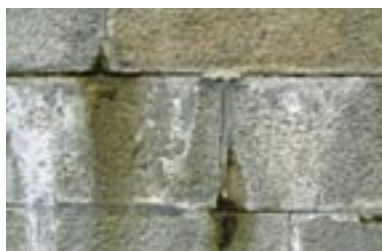
Detail, stonework to Artillery Store showing inappropriate cement strap pointing. The wall is suffering from wide spread water penetration.

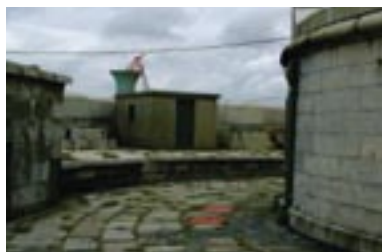
Machine room located on gun position.

Condition: Stonework to exterior is in poor condition with extensive staining from rusting iron railings and salt build up. Windows in poor condition.

- Repair stone, repair and consolidate brickwork, removing salts. Repair windows.

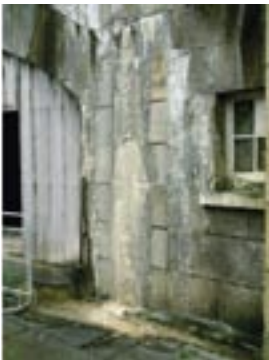
Detail of Battery Structure. Note extensive calcium deposits.

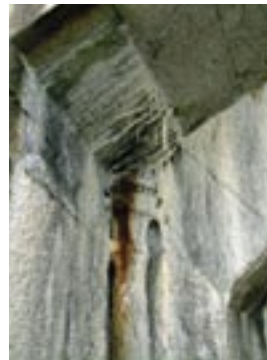
Iron downpipe and hopper encased in calcite deposit.

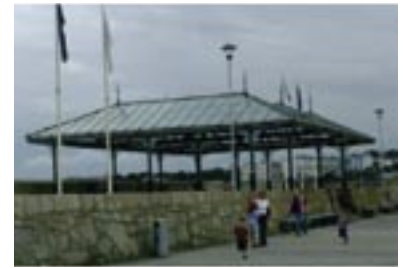
Condition: The pavilion is in reasonably good condition. The ironwork, in particular the brackets, is rusting. The paint to the timberwork has peeled away in parts. Some of the roof glazing has slipped.

East Pier Shelter.

- Repair and repaint the ironwork, ensuring that a protective primer is used first.

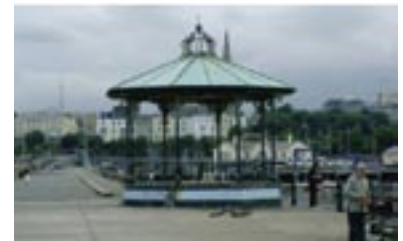
Bandstand.

Condition: This structure is in a fair to poor condition. The roof finial is rusted and is staining the surrounding surfaces. The cast iron columns and brackets are also rusted in places. The paintwork to the railings is flaking. The decorative timber detailing to the top of the plinth is in poor condition.

- Repaint the metalwork and timber, ensuring that a protective primer is used first.
- General refurbishment is recommended and consideration should be given to reinstating the original roof.

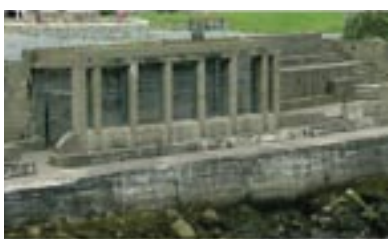
Pavilion No. 2.

Condition: Fair condition. The wrought iron railings are corroding and require repainting.

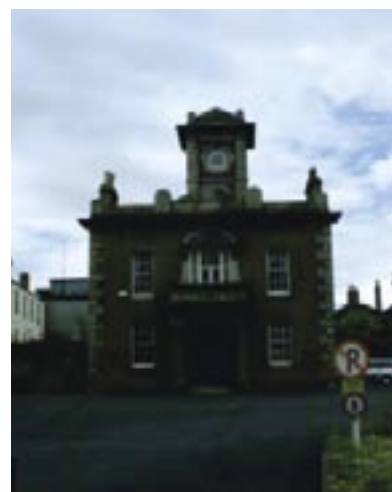
Stonework is generally in good condition, but is badly stained. Most of the stonework at the upper levels require repointing. Expansion of iron fixings is causing a coping stone to crack. Render, which is not original, is in reasonable condition. However cracking has occurred between the brick of the later side rooms and the granite facing to which it has only a butt joint. Windows in good condition. Roofs appear to be in good repair though the rainwater goods require maintenance. Tall chimney to rear has some serious cracking. The brickwork to the tower was originally tuck pointed, but this pointing has all but disappeared. There is some vegetation growth to the joints of stonework.

Harbour Master's Lodge, north elevation.

♦ **Stone:** remove corroded iron fixings where these are causing decay of the stone and replace with non-corrosive material and/or carrying out appropriate priming and surface treatment of ironworks to be retained; monitor and treat organic growth with approved biocide as necessary.

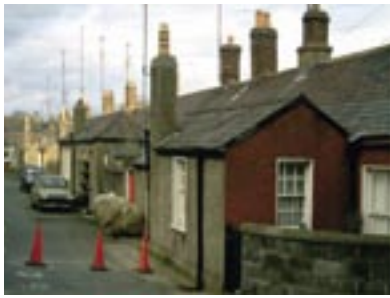
Harbour Cottages, Front Elevation.

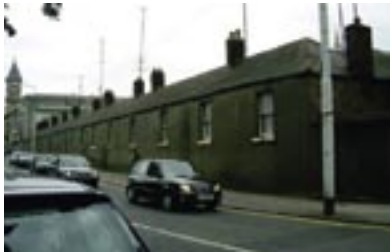
Harbour Cottages, Rear Elevation to Crofton Road, taken from west.

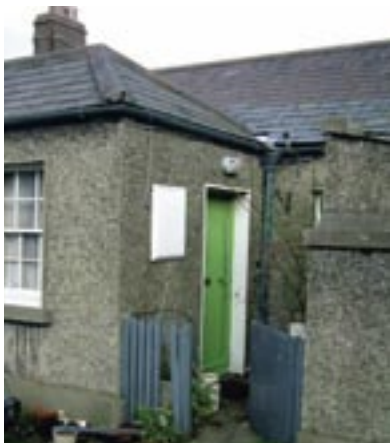
Porch, note fine original window.

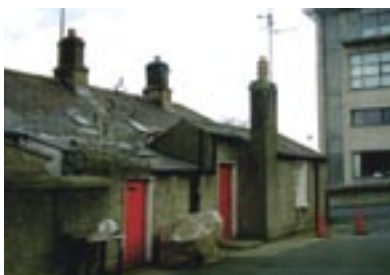
Harbour Cottages, Front Elevations, viewed from west with Civic Offices in the background.

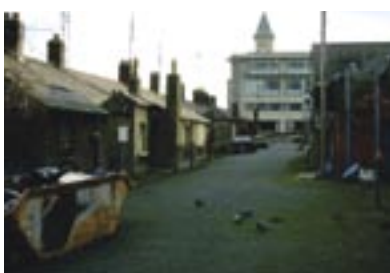
Harbour Cottages, Front Elevations, viewed from west from end of terrace, with Civic Offices in the background.

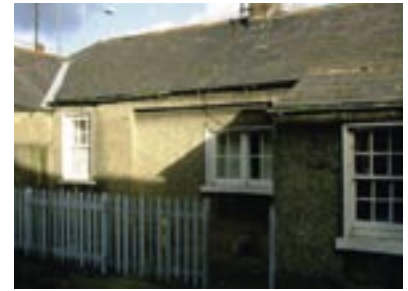
Harbour Cottages, Front Elevation, mid-terrace house, note original sash windows.

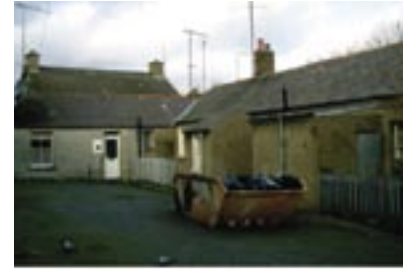
Harbour Cottages, Front Elevations, end of terrace, viewed from east.

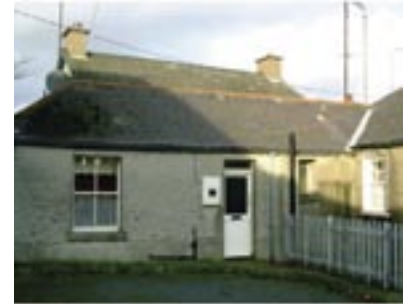
Harbour Cottages, Front Elevation, house to end of terrace.

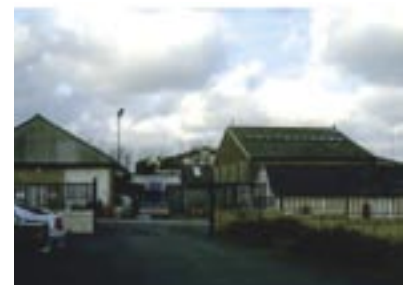
Maintenance Sheds.

Condition: Fair

- The most recent maintenance shed is in good condition and could be dismantled for re-use elsewhere.
